Seismic vulnerability and preservation of historical masonry monumental structures

Adem Dogangun*¹ and Halil Sezen²

(Received January 31, 2011, Revised September 30, 2011, Accepted October 12, 2011)

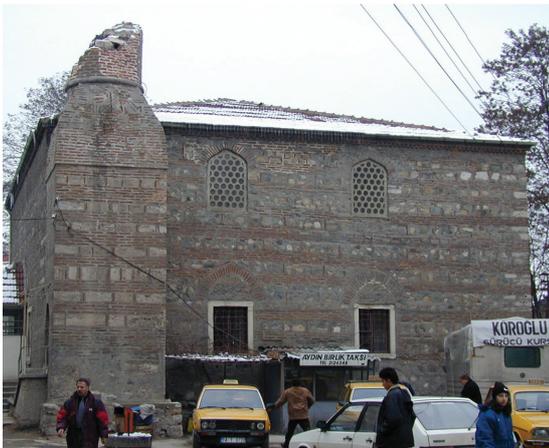
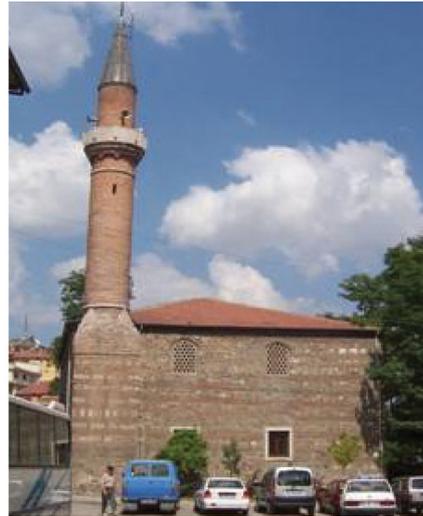
Fig. 1 Imaret mosque: (a) minaret collapsed during the 1999 earthquakes and (b) after the minaret is rebuilt

Old brick masonry minaret collapsed and Imaret mosque was closed after the 1999 earthquakes due to cracks in the walls (Sezen *et al.* 2003). The collapsed unreinforced masonry minaret was rebuilt (Fig. 1) and the large cracks in the walls were repaired by injecting mortar inside the cracks. Some of the vertical and diagonal cracks in the east and north walls were 2 m or longer (Fig. 2).

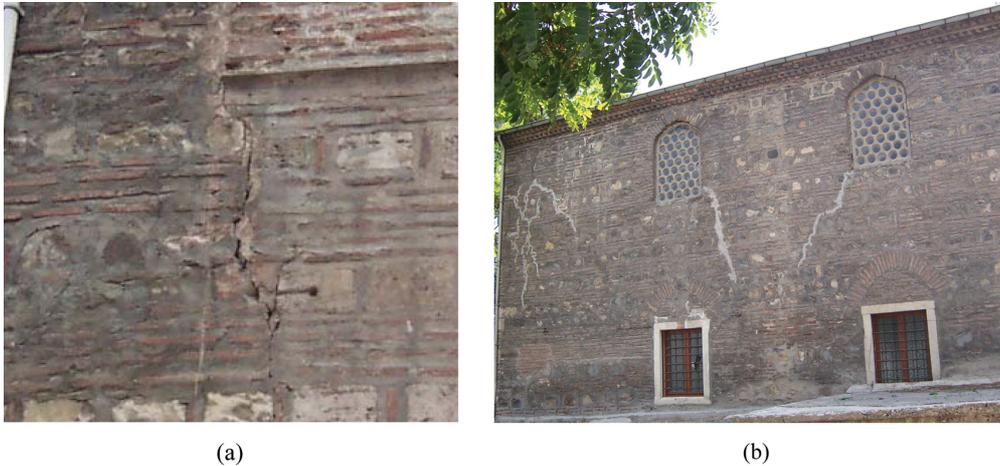
Fig. 2 (a) Vertical wall crack observed after the 1999 earthquakes and (b) repaired cracks in the Imaret mosque

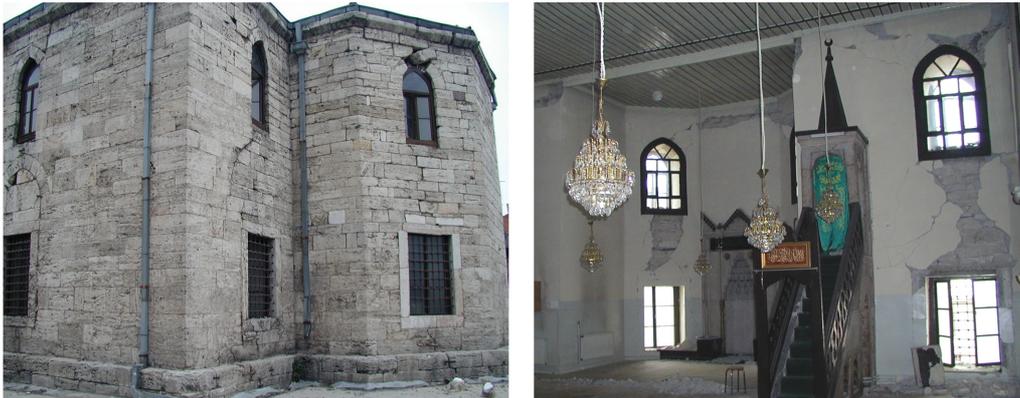
The Kadi mosque sustained substantial damage during the 1999 earthquakes and had to be closed after the earthquakes. Severe cracks and stone dislocations were observed at several critical locations. The wall damage was also exposed inside the structure as the wall covers and plaster fell down at those critical locations. Damaged walls on the south and west side of the mosque are shown in Fig. 4. Damage was mostly concentrated below or above the windows. The reduced wall area along the vertical section through the windows was stressed more, causing considerable damage. Note that two key stones on top of the top window are missing while another one barely stays in place (Fig. 4).

Fig. 4 Damage to southwest walls of Kadi mosque (outside and inside views)

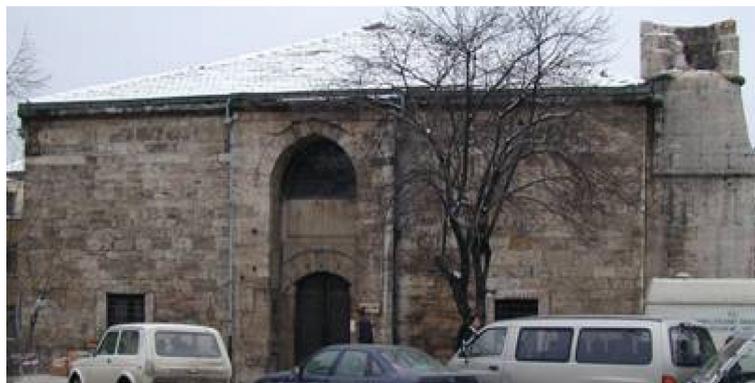
Several cracks formed through the mortar and stone blocks on the sides and above the main entrance door during the earthquakes (Fig. 5). The stone masonry minaret collapsed right above its base because the minaret base was integral with minaret walls (Fig. 3) and was quite stiff compared to the cylindrical minaret body. The Kadi mosque recently went through a retrofit program. The walls were repaired and a new minaret with a more modern appearance was constructed (Fig. 6(b)).

Fig. 5 Entrance of Kadi mosque showing failed minaret

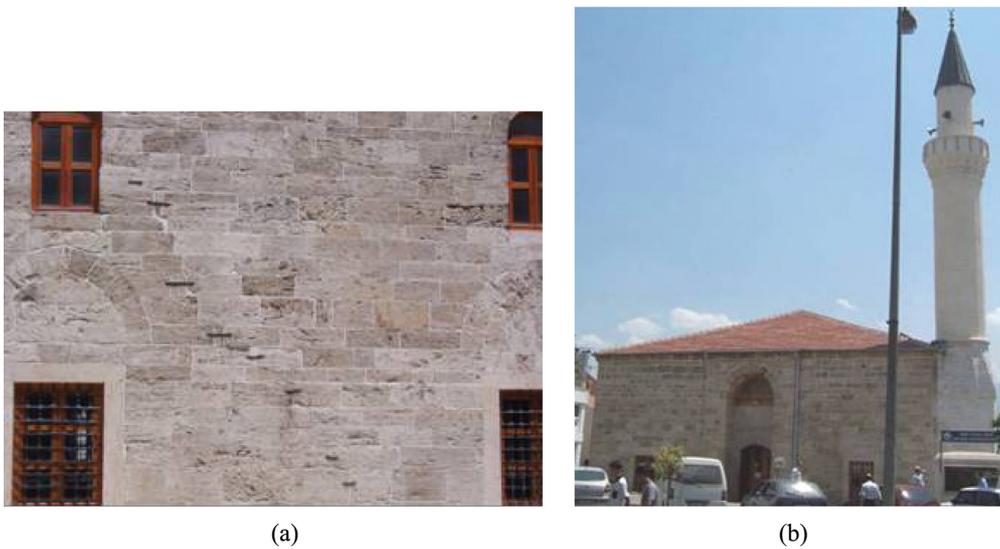
Fig. 6 (a) Repaired wall and (b) recently constructed minaret

Steel clamps were used to tie together the stone blocks on each side of the diagonal crack in the wall shown in Fig. 6(a).

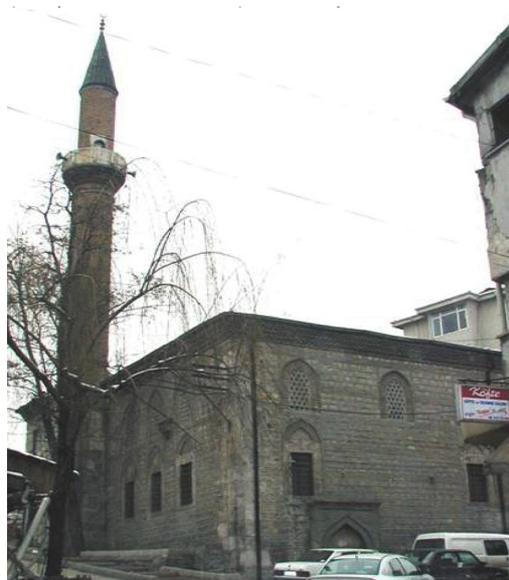
Fig. 7 Sarachane mosque and its undamaged minaret

The 1999 earthquakes caused very limited damage to the mosque and there was no visible damage to its minaret (Fig. 7). Some large cracks were observed in the walls at locations similar to those observed in other mosques discussed in this paper. Fig. 8 shows examples of couple such cracks; one immediately above a window and another in a corner near the roof. Plaster spalled off at several locations inside the walls. The cracks seen in Fig. 8 were still visible in 2006, indicating that the mosque or minaret was not repaired or strengthened since the 1999 earthquakes.

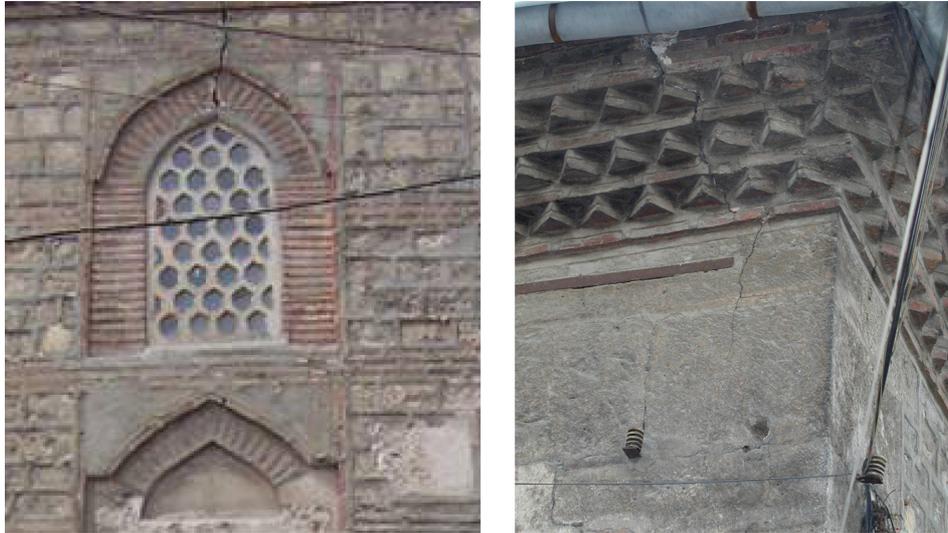
Fig. 8 Cracks developed in walls of Sarachane mosque

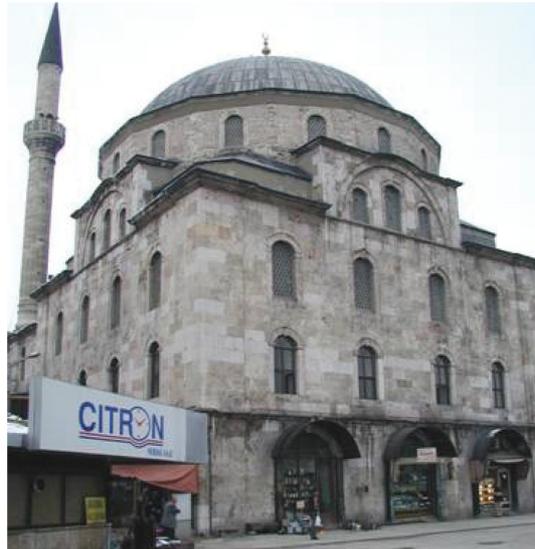
The Yildirim Bayezid mosque was originally built in 1382 and was burned down in the 19th century (Kenthaber 2006, Archive 2006). A new structure was constructed after the fire, and it was severely damaged during the 1944 Gerede-Bolu earthquake ($M_s = 7.3$). Subsequently, the structure was rebuilt (Fig. 9). The plan view of the current mosque is shown in Fig. 10. The top of the square main prayer hall is covered by a large dome. The square bases of two circular unreinforced stone minarets are constructed monolithically with the eastern and western walls near the entrance.

Fig. 9 Yildirim Bayezid mosque after the 1999 earthquakes

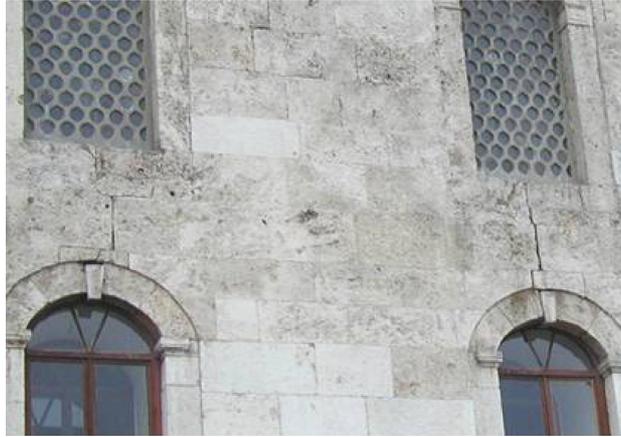
The mosque was damaged during the 1999 earthquakes and was closed for a period of time. The shops under the mosque were back in business a few weeks after the November 12 earthquake. On the south side of the mosque, portion of the walls above and below the windows were subjected to larger shear stresses (compared to solid wall sections) during the strong ground shaking. Higher shear demand in those parts of the relatively thick walls created serious cracks and openings between the stone blocks (Fig. 11).

Fig. 11 Cracks in south walls of Yildirim Bayezid mosque

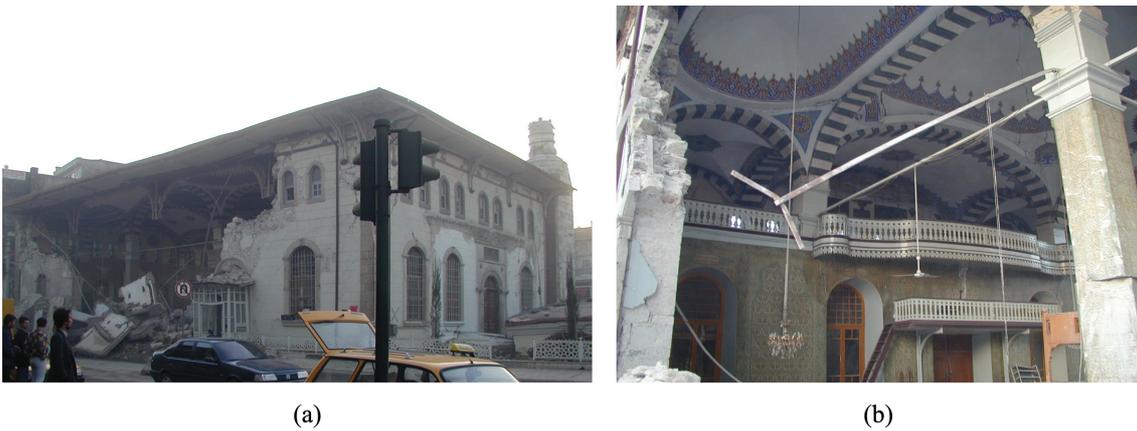
stone masonry walls as well as four very tall square stone columns in the middle of the structure. A large portion of side walls on the east and west side of the structure collapsed during the November 12, 1999 earthquake (Fig. 12(a)). The main entrance door was exposed as a result of collapse of the secondary structure at the entrance. Square stone columns in the middle of the mosque were twisted during earthquake (Fig. 12(b)). This suggests that demands on the interior columns were high

Fig. 12 Damage in the Duzce Merkez mosque after the November 12, 1999 earthquake

during the earthquake. It should be noted that failure of one of the interior columns would lead to collapse of the decorated roof of this historical mosque. Part of the mosque near the entrance and walls along the shorter side had less damage compared to the other parts of the mosque.

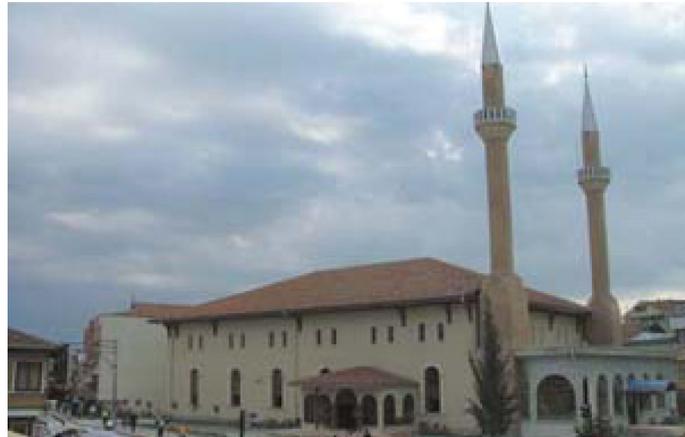
Fig. 13 Duzce Merkez mosque after retrofit (Duzcetanim 2008)

The mosque was retrofitted and re-opened in 2004 (Fig. 13). It appears that window openings in the lower story level were too large and there were too many windows in the upper floor level in the collapsed structure. This considerably reduced the lateral resistance of longer exterior walls in the east-west direction. Apparently similar window sizes and a placement scheme were also adapted in the recently retrofitted structure (Fig. 13). Unreinforced stone minaret also collapsed couple meters above its base (Fig. 12(a)). It should be noted that the base of the stone minaret was attached to the mosque wall. On the other hand, there was no constraint or support just above the square minaret base where relatively slender cylindrical minaret body failed. Two new minarets were constructed as part of the recent retrofit work (Fig. 13).
