19th May 2011 Simav (Kütahya) earthquake and response of masonry Halil Aga Mosque

Ali Ural*

Keywords: structural damages; simav (Kütahya) earthquake; masonry buildings; strong ground motions

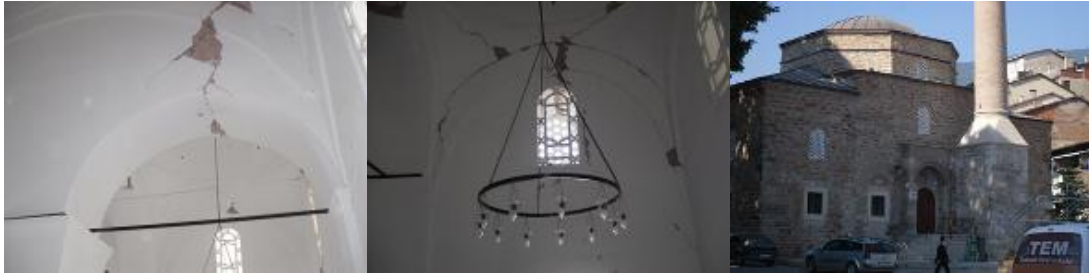
Fig. 5 Shear cracks on the load carrying walls of Halil Aga Mosque

widely observed and constructed all over the world. Most of the load-carrying walls are composed of clay brick units and mortar and there is no wall reinforcement such as steel reinforcing bars provided within the walls in both vertical and horizontal directions. During the site survey the author found the opportunity to investigate two of the mosques that remain from Ottoman Period and one mosque dating from 1959 in which were composed both stone and brick units. Nasuh Ağa Mosque, which is located at the district of Simav, was severely damaged due to the 2011 Simav Earthquake. Although external load-carrying walls of the mosque was constructed both of stone and brick units, inner parts of it was constructed with only brick units, which has a dimension of $18 \times 8 \times 5 \text{ cm}^3$. Due to this structure, although the external walls has slightly damaged, the inner parts of the mosque has severely damaged (Fig. 5). Similar damages can be seen from the Ulu Mosque, which was also remained from the Ottoman period. Typical out of plane damage can be clearly seen from the east façade of the Ulu Mosque (Fig. 6).

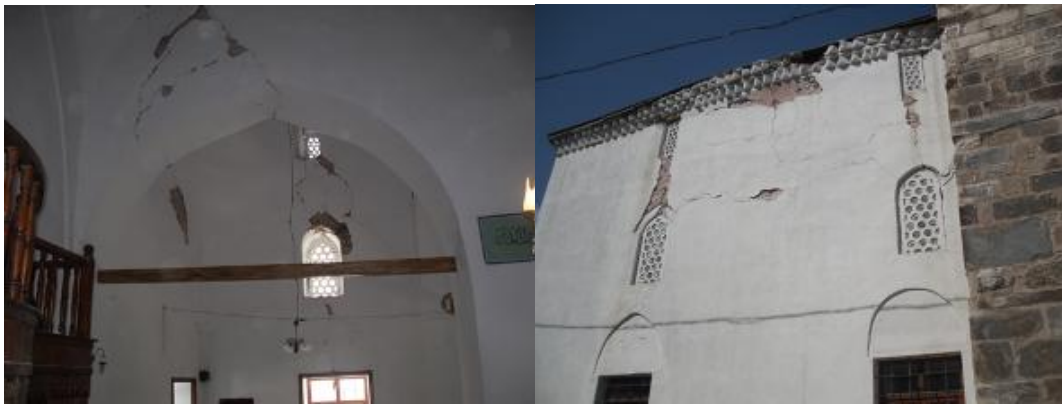
Fig. 6 Severely damage to unreinforced masonry mosque (Ulu Mosque) and example of out-of-plane damage

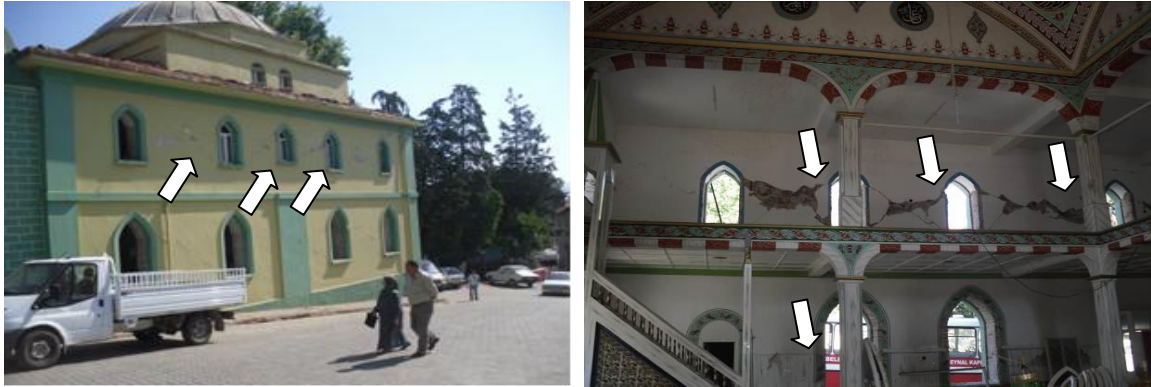
Fig. 7 Shear cracks on the load carrying walls of Halil Aga Mosque

The mosque has two floors and sits in an area of $18 \text{ m} \times 17 \text{ m}$. Total height of the structure is approximately 8.15m and the exterior walls have 0.75m width. The first floor has 16 window openings ($1.1 \text{ m} \times 2 \text{ m}$ dimensions) and the second floor has 20 window openings ($1.5 \text{ m} \times 0.8 \text{ m}$ dimensions). Each window has an arch form at the top. The mosque has one main dome and four small domes. The main dome has approximately 9.2 m diameter and 3 m height. Small domes have approximately 3.1 m diameter and 1 m height. The minaret was built adjacent to the mosque and has a 2 m diameter. The length of the pedestal, transition segment, the cylindrical body between transition segment and balcony, upper part of the minaret body between balcony and spire and spire are 8 m, 2 m, 11 m, 6.3 m and 5.3 m, respectively. The average length of the minaret is approximately 32.5 m. This structure was badly suffered during 2011 Simav Earthquake. Shear cracks were dominantly occurred on the façades of the structure. Besides, the masonry minaret was totally demolished after the earthquake due to heavy damage. In order to investigate the seismic response of this structure, linear elastic dynamic response spectrum analyses were performed in the following section of this paper. Some illustrative photos can be seen from the following Fig. 7.

- According to the conversation with the city manager, they intended to destroy this damaged mosque. However, this structure can be survived with some simple strengthening methods.

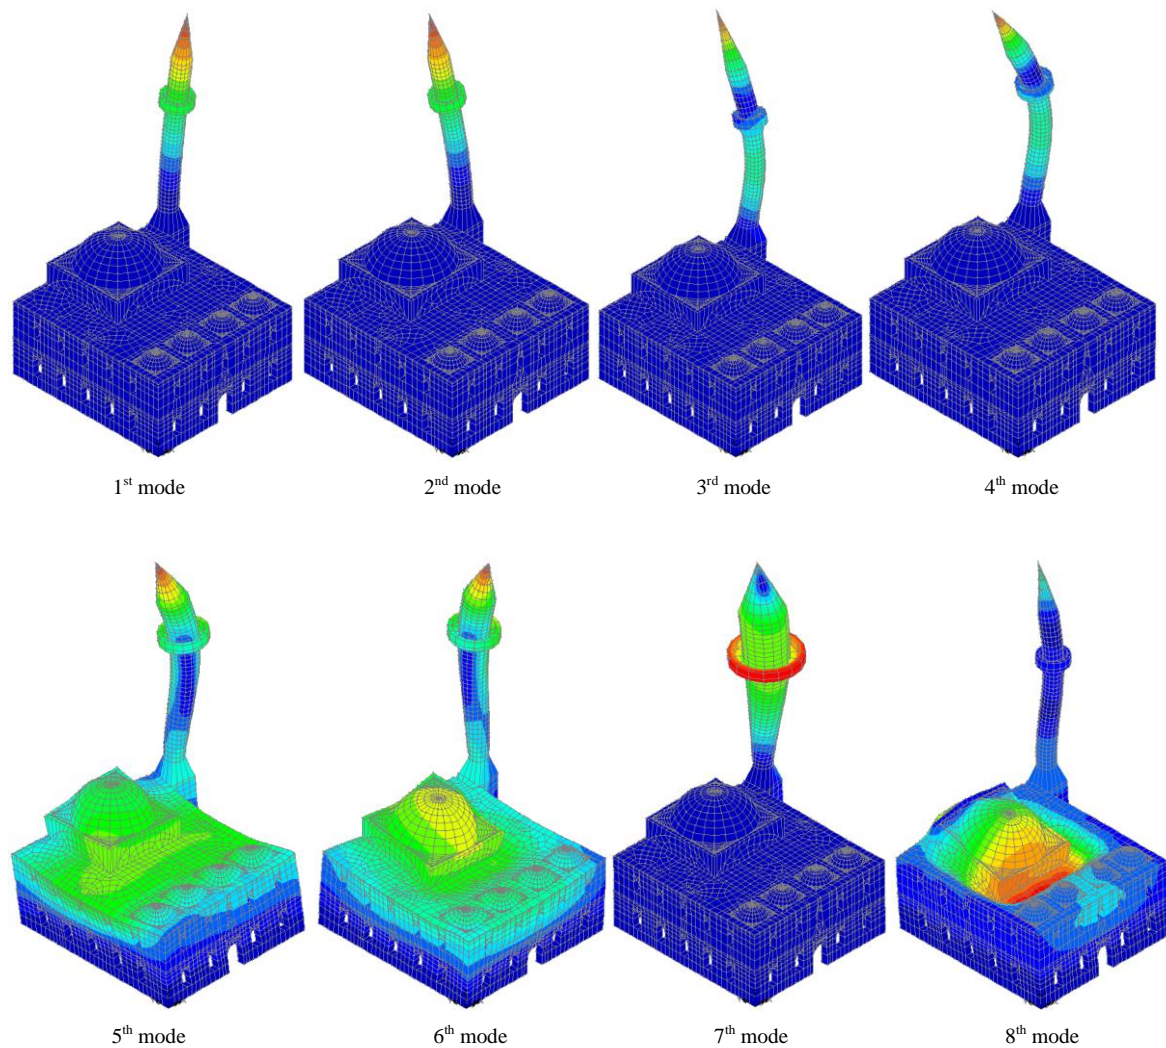
Fig. 9 First eight modals shapes in the two directions and torsional

Fig. 9 shows the first eight mode shapes with displacement contours. According to this figure, only minaret of the mosque was greatly affected on first four modes. Besides, the entire structural model was affected on the fifth and sixth modes.

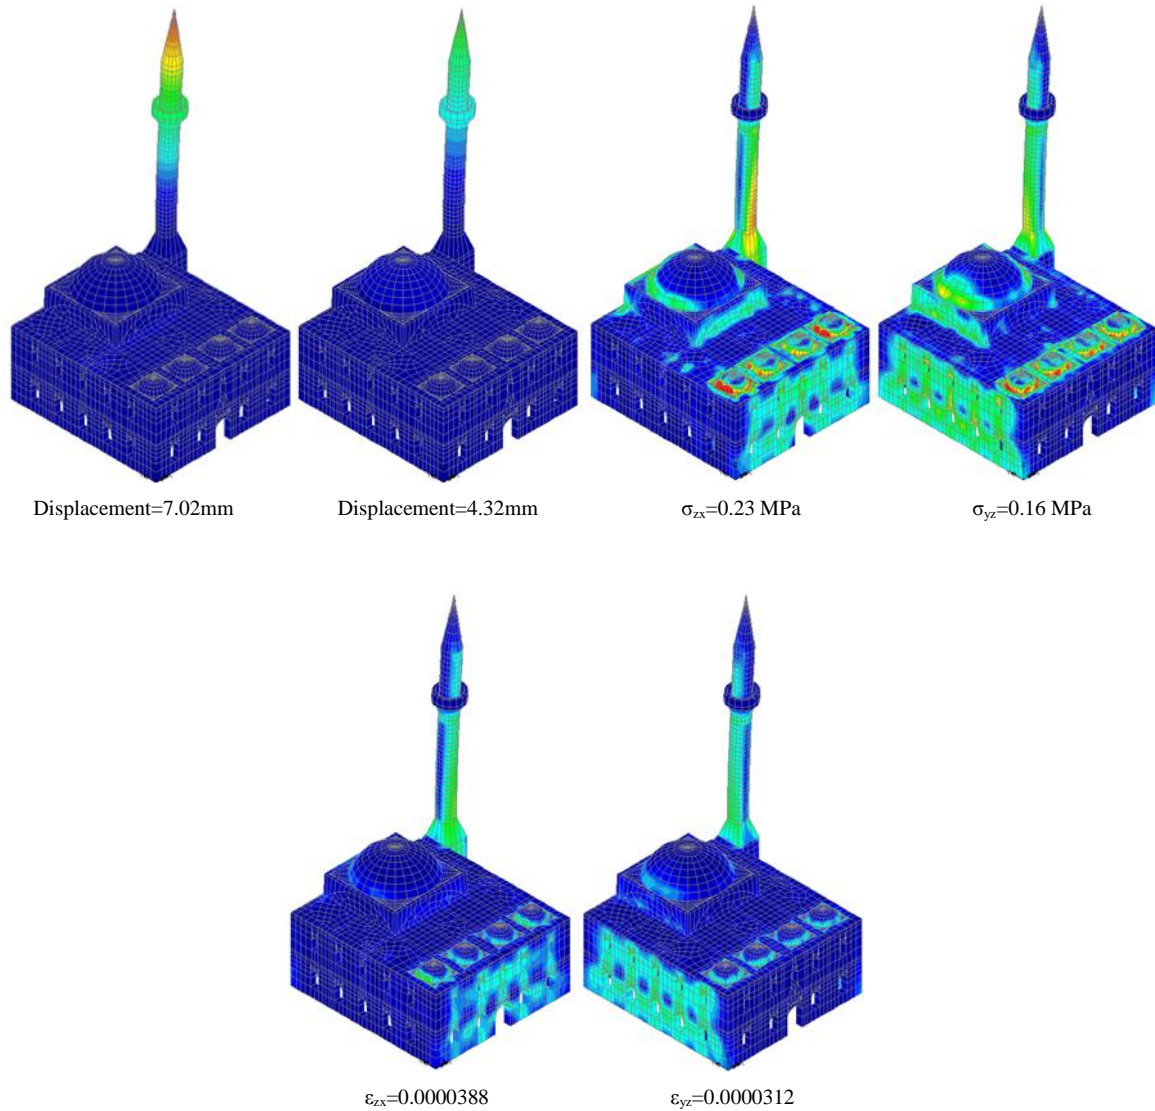
Fig. 10 Response Spectrum Analysis results

used to determine weak zone and region of cracking in the structure. The weak regions imply that zone where there is a concentration of maximum shear stresses. Fig. 10 shows the deformed mesh of The Halil Aga Mosque from response spectrum analysis.

The lateral displacements both on X and Y directions, as calculated from the response spectrum analysis, were 7.02 and 4.32mm for the Simav Earthquake. Displacement of the minaret is naturally higher than the main body. Due to the large window openings in the masonry walls, the shear strength was exceeded and macro level cracks were occurred. The direction of the application is on X-direction as the real earthquake (EW component). As a result of this, masonry walls parallel to the direction of the earthquake were more damaged and this situation can be seen

Besides, Fig. 10 shows the shear concentrations both ZX and YZ directions on the external walls of the mosque. Masonry minaret was severely affected according to this seismic excitation and it was badly damaged.

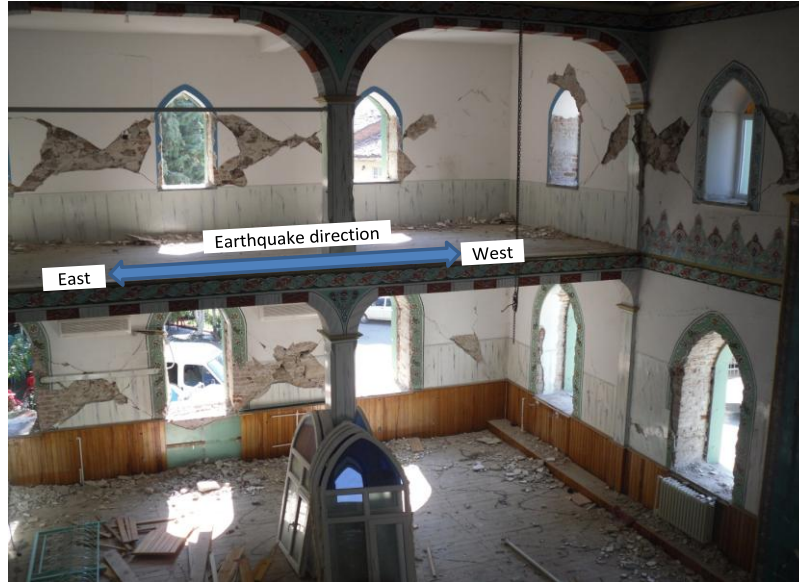
Fig. 11 Shear cracks on the façade of the masonry mosque

from the results of FEM analyses and from the following Fig. 11. There were few damages around the corners, because window openings are not close to this area.

- An earthquake analysis was performed using 2011 Simav Earthquake acceleration response data. It can be seen from the analysis results, the minaret of the main structure was mainly affected. The maximum horizontal displacements were occurred on the top of the minaret. The mosque was mainly affected due to the shear forces. Therefore, dominant shear stresses were occurred on the façades of the structure between window openings.
