Field investigation and seismic analysis of a historical brick masonry minaret damaged during the Van Earthquakes in 2011

Abstract. The paper presents the field investigations and seismic analyses of a historical masonry brick minaret damaged during October 23 (Erciş) and November 9 (Edremit), 2011 Van earthquakes in Turkey. Ulu Mosque Minaret located on Tebriz Kapı Street in the city centre of Van, Turkey is selected for investigation. Two earthquakes hit the minaret within seventeen days, causing progressive damage. It was seen from the field investigations that the minaret was heavily damaged. To validate the field investigations, three dimensional finite element model of the minaret is constituted by ANSYS software using relieve drawings. Finite element model of the minaret is analyzed under the Van earthquake records to determine the seismic behavior. The displacements, maximum and minimum principal stresses and strains are obtained from the analyses and compared with field observations.

4.1 Ulu Mosque Minaret

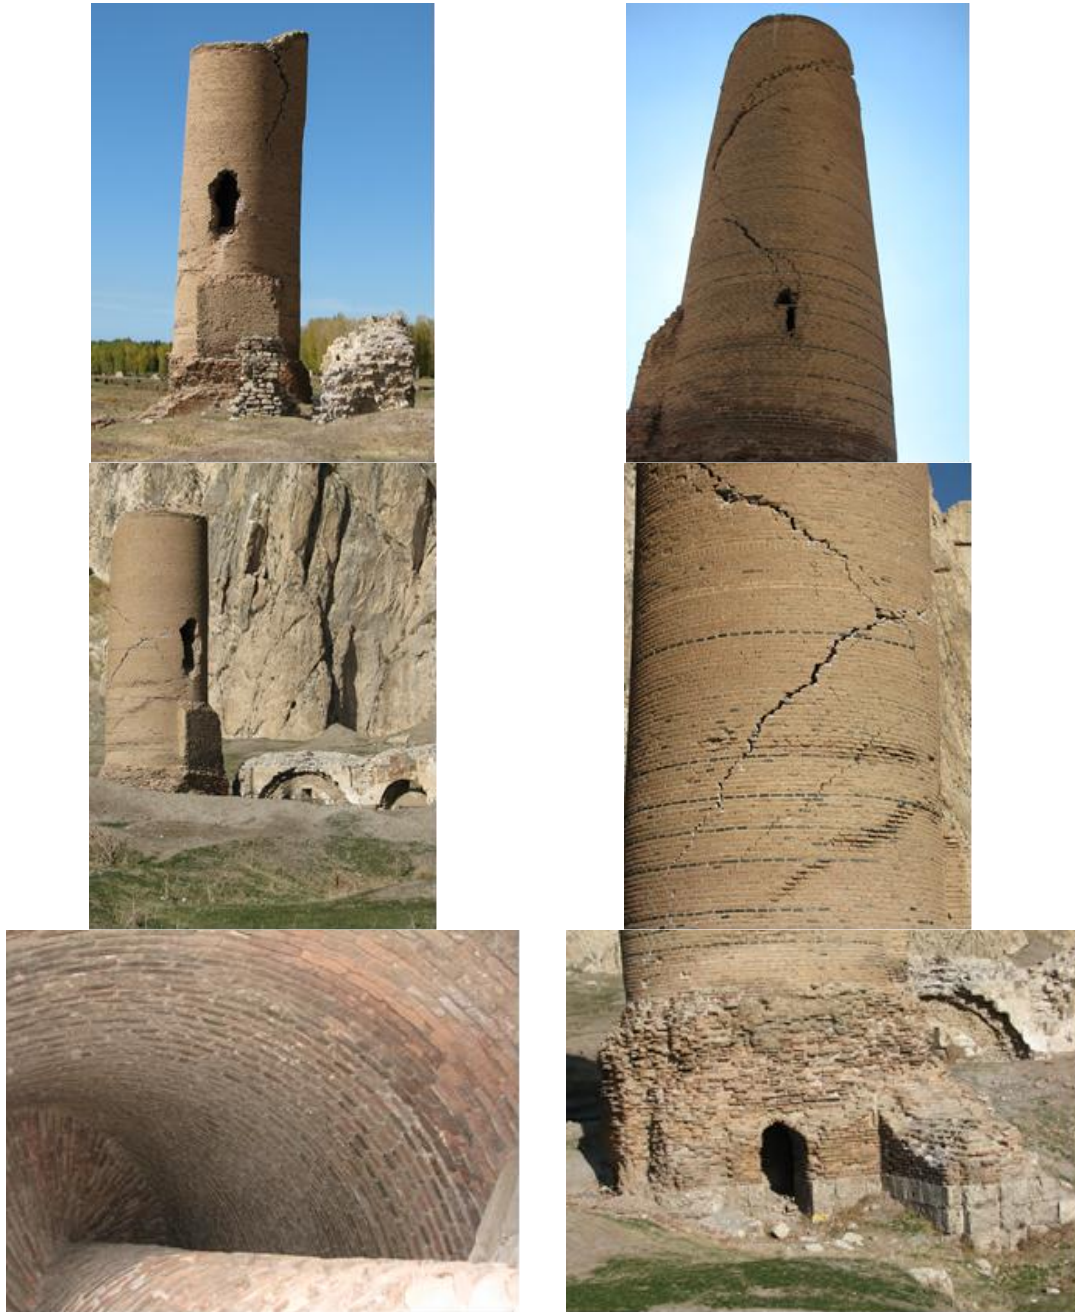
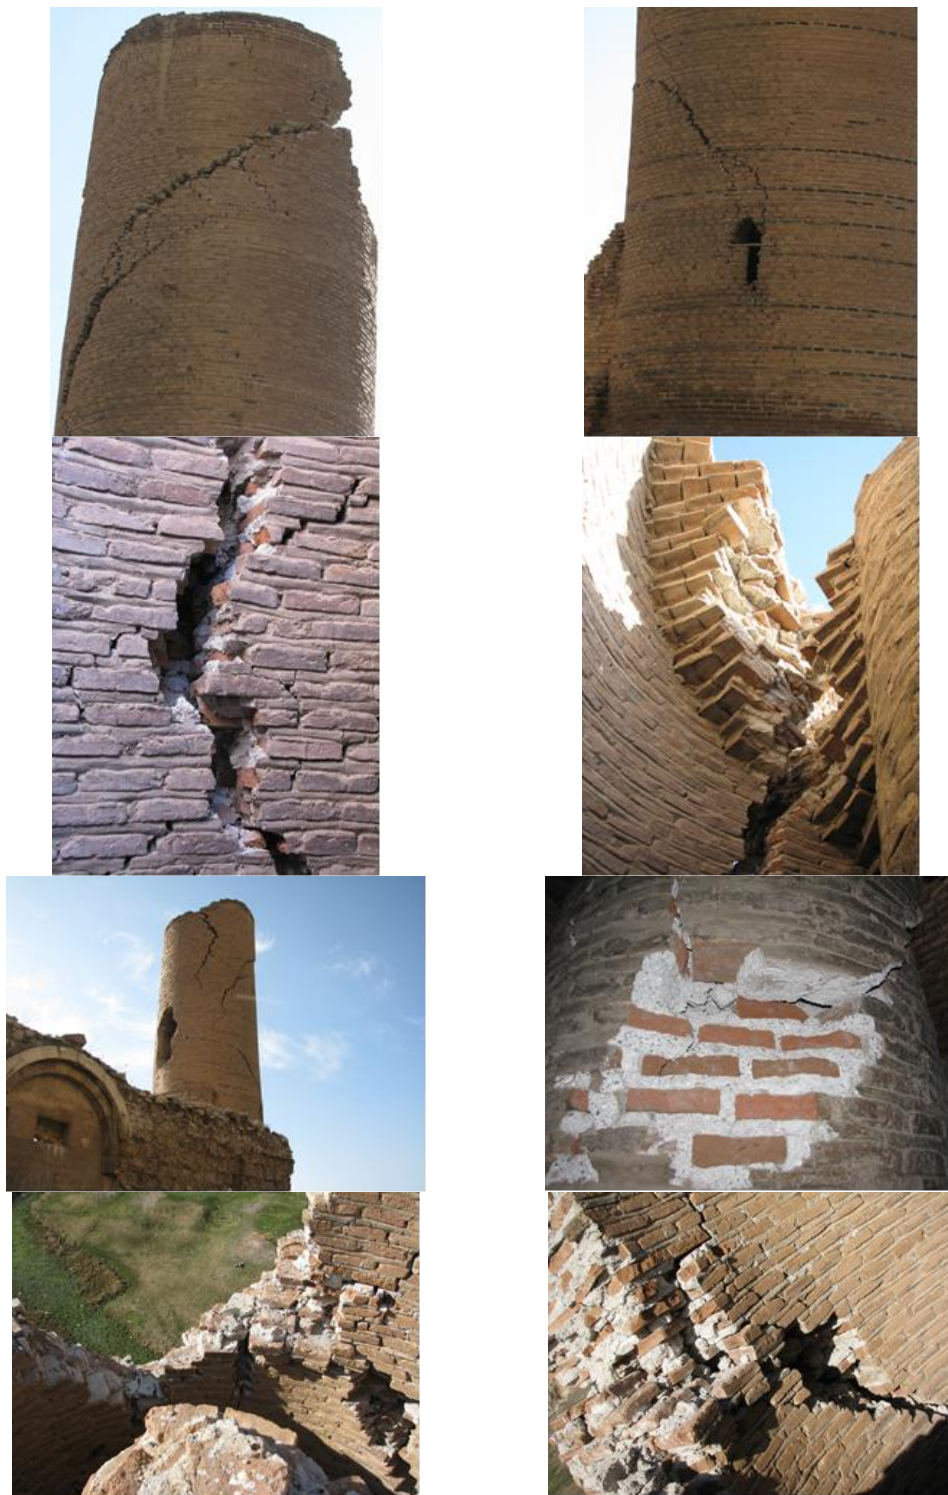
From the field investigations, it is seen that the damages on Ulu Mosque Minaret occurred during the earthquakes. The view of the deteriorations and damages on Ulu Mosque Minaret can be seen in Fig. 7. The minaret is heavily damaged and should be restored.

2. It can be seen from Table 2 that the cylindrical body of the minaret divided into three groups. The terms of Part 1, Part 2 and Part 3 are used to imply the current situation of the minaret such as less damaged, moderately damaged and fully damaged, respectively.

Fig. 6 The view of the deteriorations and damages on Ulu Mosque Minaret

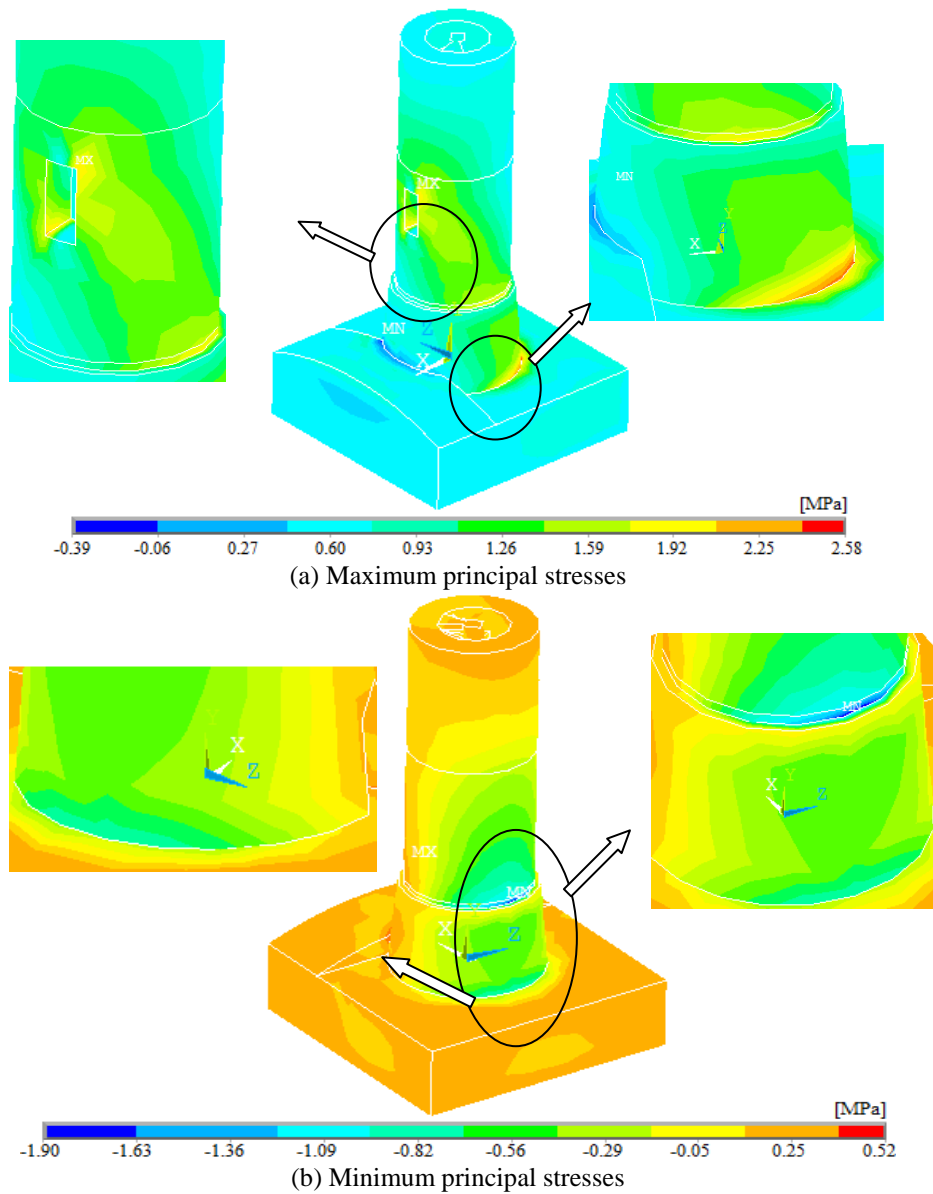
The maximum and minimum principal stresses contours which represent the distribution of the peak values reached by the principal stresses at each point within the section are given in Fig. 12. It is clearly seen from Fig. 12 that maximum and minimum principal stresses are occurred at the region between transition segment and cylindrical body. Also, extra stress distributions are obtained at the spaces such as door and windows. The maximum and minimum principal stresses were occurred as 2.58 MPa and 1.90 MPa, respectively. It can be said that the values of minimum

principal stresses (compressive) obtained as 1.90 MPa does not cause any damage, but the values of maximum principal stresses (tensile) obtained as 2.58MPa caused the existing damage on the minaret.

Fig. 12 Maximum and minimum principal stress contours of the historical minaret
