Structural damage distribution induced by Wenchuan Earthquake on 12th May, 2008

Abstract. Based on the reconnaissance of buildings in Dujiangyan City during 2008 Wenchuan earthquake, China, structural damage characteristics and the spatial distribution of structural damage are investigated, and the possible reasons for the extraordinary features are discussed with consideration of the influence of urban historical evolution and spatial variation of earthquake motions. Firstly, the urban plan and typical characteristics of structural seismic damage are briefly presented and summarized. Spatial distribution of structural damage is then comparatively analyzed by classifying all surveyed buildings in accordance with different construction age, considering the influence of seismic design code on urban buildings. Finally, the influences of evolution of seismic design code, topographic condition, local site and distance from fault rupture on spatial distribution of structural damage are comprehensively discussed. It is concluded that spatial variation of earthquake motions, resulting from topography, local site effect and fault rupture, are very important factor leading to the extraordin

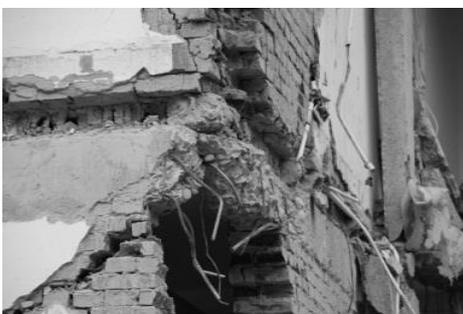
Fig. 3 Structural damage caused by not installing constructional column

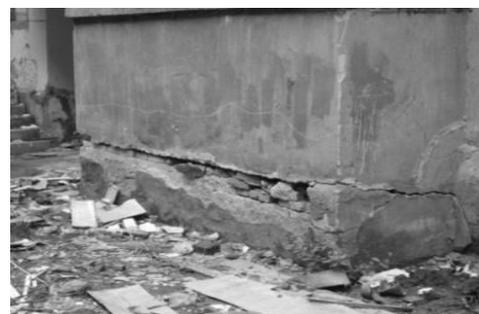
Fig. 4 Masonry structure with cut-through horizontal fracture or crack

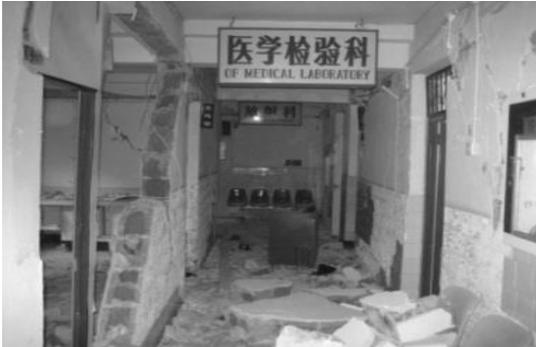
Fig. 5 Collapse of an infilled wall of the second hospital in Dujiangyan City

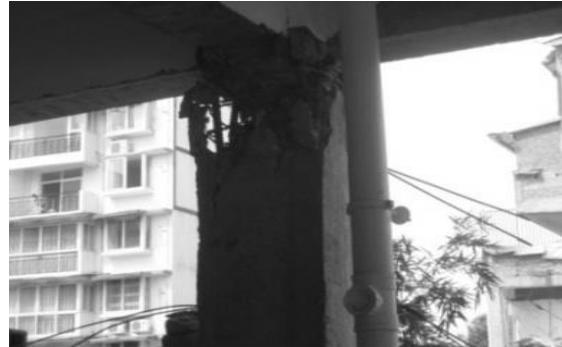
Fig. 6 The lantern-shaped damage of frame column

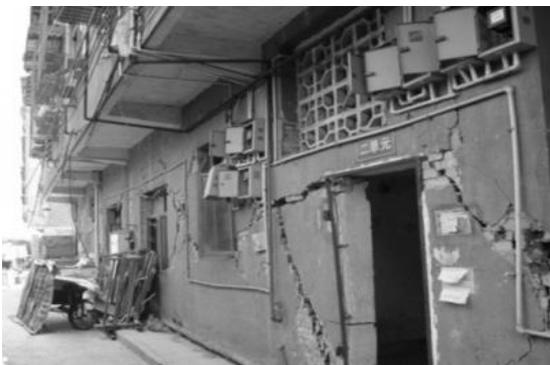
In the investigation, it is found that bottom-story of some buildings is a combination of half frame structure and half masonry structure. The structural bottom floor facing the main road is frame structure for commercial purpose while the other part of the hybrid bottom-story structure is masonry structure for residential purpose or warehouse. Other than the bottom-story, the upper part is the multistory masonry structure for residence. Under earthquake motion, without constructional column or ring beam, the bottom masonry structure will generally be first damaged and lose its bearing capacity due to its low shear strength. If there is further strong earthquake motion, only the bottom frame structure is at work and the whole structure may be severely damaged or even collapse. Thus this kind of structure should be abandoned in structural design or at least adopt enough structural constructional measures to balance the load of the frame and masonry structure. Fig. 7 and Fig. 8 show the damage of this hybrid structure. It can be seen that the masonry structure is relatively more severely damaged. The bottom-story frame structure and bottom-story hybrid structure were relatively severely damaged. Some bottom frames failed with partial or whole collapse, causing great casualties and economic loss. The possible reasons of this collapse include unreasonable structural design, lack of constructional column or ring beam or other structural measures, e.g., unreasonable stirrup settlement, insufficient lateral bearing capacity, and the strength degradation of building material. However, a large proportion of bottom-story frame structure, especially those built after 2000, performed well in the earthquake and were almost in good condition or slightly damaged. Further researches of these buildings can help to improve the seismic design method of bottom-story frame structure.

Fig. 7 Damage of masonry structure part in bottom-story hybrid structure

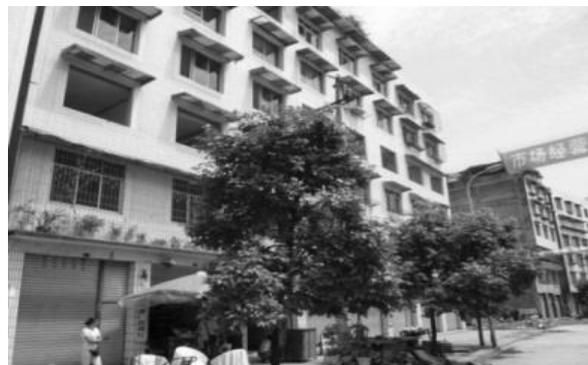
Fig. 8 RC frame structure part in bottom-story hybrid structure

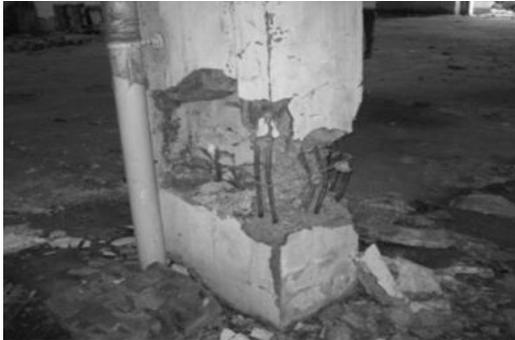
Fig. 9 Damage of bent column in single bent frame structure

In Dujiangyan City, the single story bent structure is mainly used for industrial factory while a few for large span structures like school sports buildings. Generally speaking, this kind of structure is also severely damaged. From the investigation, most of these structures were built before 1990s. Due to strength degradation of structural material, unreasonable design and other factors, many single story bent structures are damaged to variable degrees. The damage can be classified into two types: failure of main bearing structure and failure of building envelop. Bent frame column is the main bearing component of the single story bent structures. If the bent column is severely damaged and the longitudinal linkage of the roof is not strong enough, collapse of partial of the roof, or even a progressive collapse would happen. Fig. 9 reveals that the exposure and buckling of reinforcing steels at the bent column base of a printing house. Also, crack of the building envelop like the enclosure wall and severe collapse of the roof observed in the field survey. The main reason is that there lacks a reliable connection between the enclosure wall and the bent column, also the out-of-plane instability or the shear failure of the walls may contribute to the failure. Additionally, some bent structures lack wind-resisting column, which makes the enclosure walls more likely to collapse, as shown in Fig. 10.

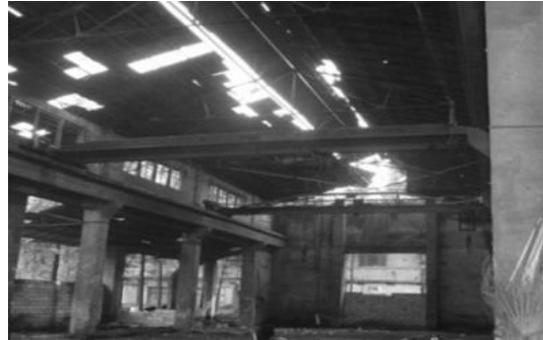
Fig. 10 Damage of envelop enclosure system in single bent frame structure
