Rainfall induced instability of mechanically stabilized earth embankments

Abstract. A 10.4-m high highway embankment retained behind mechanically stabilized earth (MSE) walls is under construction in the northeastern part of the Indian state of Bihar. The structure is constructed with compacted, micaceous, grey, silty sand, reinforced with polyester (PET) geogrids, and faced with reinforced cement concrete fascia panels. The connections between the fascia panels and the geogrids failed on several occasions during the monsoon seasons of 2007 and 2008 following episodes of heavy rainfall, when the embankment was still under construction. However, during these incidents the MSE embankment itself remained by and large stable and the collateral damages were minimal. The observational data during these incidents presented an opportunity to develop and calibrate a simple procedure for estimating rainfall induced pore water pressure development within MSE embankments constructed with backfill materials that do not allow unimpeded seepage. A simple analytical finite element model was developed for the purpose. The modeling results were found to agree with the observational and meteorologic

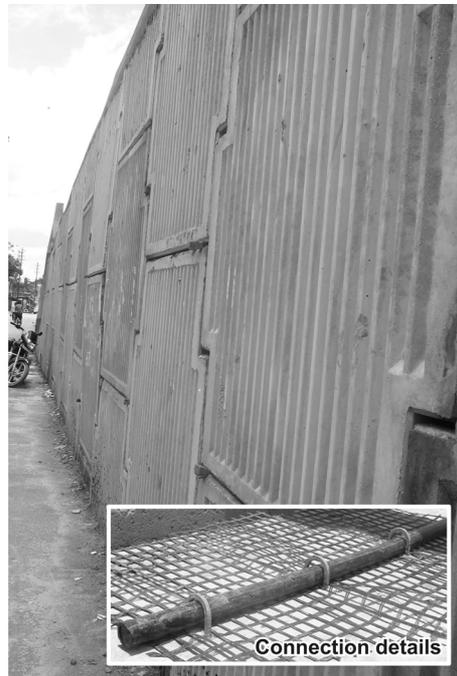
India. The vertical spacing of the geogrids was 750 mm. Reinforced concrete fascia panels, 1580-mm in height, 1480-mm in width and 180-mm in thickness equipped with hooks on their inside faces for connecting the geogrids were used to prevent erosion. The geogrids were connected to the fascia panels using mortar-filled PVC pipes. The batter of the finished outside face of the MSE wall is 1 (horizontal) to 20 (vertical). Geode PPEXT 140 (manufactured by Edilfloor, Italy) strips of 200-mm (for horizontal strips) to 400-mm (for vertical strips) width were pasted behind the fascia panels at all fascia panel joints to prevent washing out of backfill soil through the inter panel gaps. No chimney drain was used behind the fascia panels. Fig. 2 shows the appearance of finished MSE wall and the connection details between geogrids and fascia panels.

Fig. 2 MSE wall: Appearance and connection details between fascia panels and geogrids

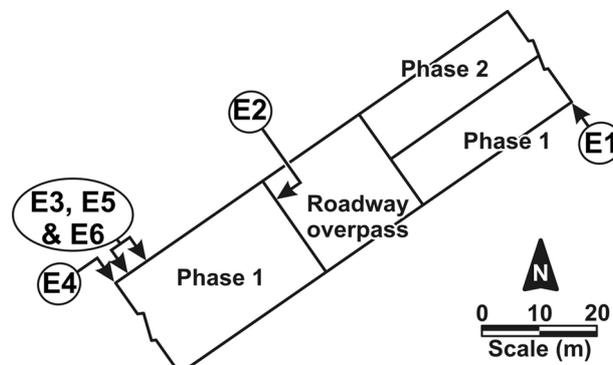
Fig. 3 Wall layout

There have been six major incidents of fascia panel instability: June 8, 2007; August 28, 2007; September 15, 2007; May 15, 2008; June 13, 2008 and June 17, 2008. The approximate locations of these incidents, referred to as E1, E2, E3, E4, E5 and E6, respectively, are shown in Fig. 3. The failures were caused by separation of fascia panels because of shear-related deformation or breakage of the polymer pipes used to connect the fascia panels to the geogrids as shown in Fig. 4. It needs to be mentioned here that the incident illustrated in Fig. 4 was initiated by separation of only nine fascia panels. The surrounding panels showing signs of distress were manually removed after the separation of nine fascia panels to ensure public safety. On certain occasions, e.g., E1, backfill washed out through the gaps in between fascia panels in spite of the presence of geotextile barrier to preclude such a soil loss. At the locations of the failures, no instability was noticed apart from the separation of fascia panels. Minor distress also developed at a few locations on the MSE embankment outer face involving bulging out of fascia panels and development of negative batter.

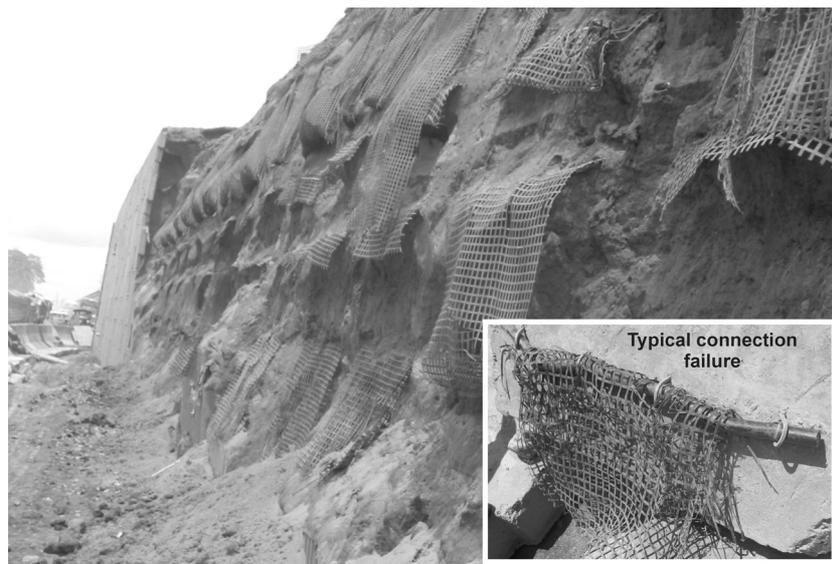
The fascia panel separation appears to begin with progressive bulging of inter panel joints near the top of the embankment. These observations indicate that the failures and the distress were caused by increase in the degree of saturation of the backfill material near the top of the MSE embankment because of rainwater infiltration and the consequent increase in pore water pressure. Similar pattern of infiltration-related pore water pressure development within partially saturated soils is reported by others (e.g. Lambe 1948).

Fig. 4 Location of fascia panel failures of June 28, 2008 (photograph looking north)

backfill material under use. The reconstruction is proceeding with a chimney drains behind the fascia panels, 300-mm in thickness, constructed with select granular material. The connections between the fascia panels and the geogrids were also strengthened to mobilize the long term design strength of the geogrids before failure for added safety.

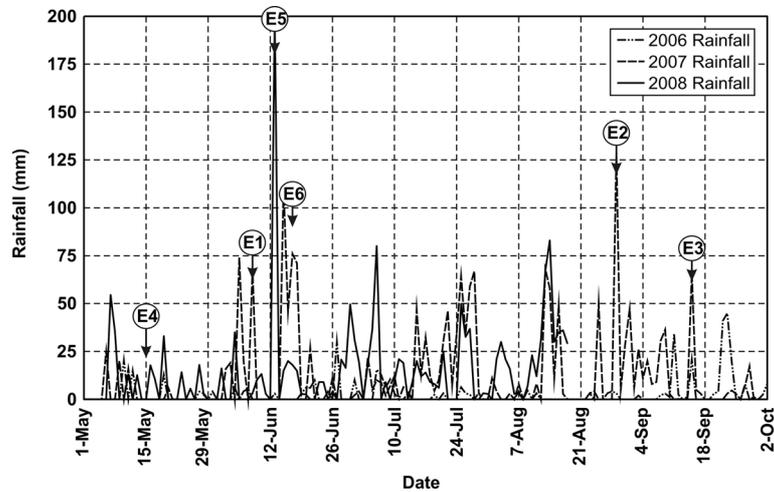
Fig. 5 Daily rainfall intensity and fascia panel instability

Review of rainfall data and the timing of failures indicate that incidents E1, E2, E3 and E5 closely followed episodes of heavy rainfall (Fig. 5). The remaining two incidents, E4 and E6 were preceded by two episodes of high 7-day antecedent rainfall (Fig. 6). Data up to August 18, 2008 from a local weather station were used to prepare these figures.

Thus, the first category of failures (E1, E2, E3 and E5) appears to have been caused primarily because of development of rainwater infiltration related transient pore water pressure, and the second category (E4 and E6) appears to have been due to the development of cavities underneath the geogrids and/or behind the fascia panels. It also appears that E6 is a direct aftermath of E5. Incident E3 may similarly have lead to the development of increased erosion rate in the vicinity of its location, which appears to be the possible cause of incident E4.

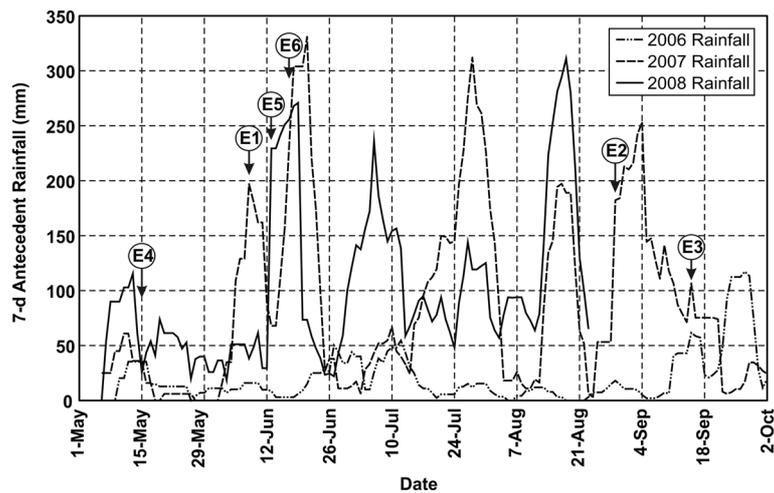
Fig. 6 Seven day antecedent rainfall and fascia panel instability

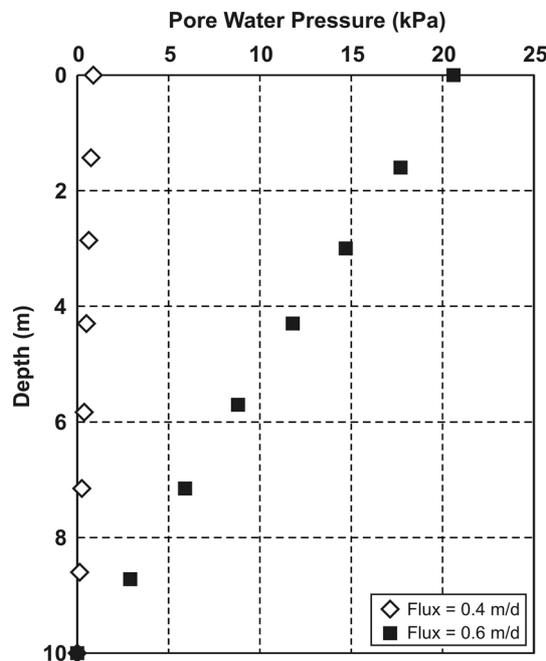
The pore water pressure response following 24-hour of simulated infiltration of a constant flux through the top surface is presented in Fig. 10. Results indicate that rainfall-related pore water pressure build up begins as the rainwater infiltration flux exceeds 0.4 m/d, which is equivalent to daily rainfall intensity of about 21 mm for the MSE wall configuration being studied, for the silty sand backfill used in constructing the MSE wall. From Fig. 10 it appears that the pore water pressure build up becomes significant when the infiltration flux exceeds 0.6 m/day, *i.e.*, daily rainfall intensity of about 32 mm. In comparison, the rainfall intensity and fascia panel instability data presented in Fig. 5 indicate that the threshold daily rainfall intensity for the development of fascia panel instability is about 50 mm. The difference between the observation and the results of seepage analyses is explained by the conservatism in the numerical model used in this study and the fact that the strength of the connections between geogrids and the fascia panels was neglected while making the assessments.

Fig. 10 Pore water pressure development due to rainwater infiltration

Based on the results of seepage analyses, no pore water pressure build up is expected when a 300-mm thick chimney drain is used immediately behind the fascia panels characterized with a hydraulic conductivity of 1000 times that of the backfill material for an infiltration flux of up to 55 m/day.

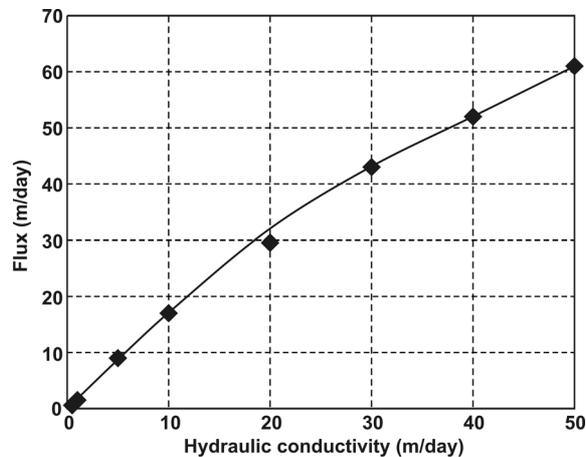
Fig. 11 Flux required for pore water pressure development

Fig. 11 presents the critical infiltration flux above which the infiltration-induced pore water pressure begins to build up as a function of the saturated hydraulic conductivity of the backfill material. The hydraulic conductivity function presented in Fig. 9 was arithmetically scaled up for developing the hydraulic conductivity functions used in these computations. As for Fig. 10, these results represent the pore water pressure response of the backfill following 24-hour of simulated infiltration of a constant flux through its top surface. The results presented in Fig. 11 represent infiltration flux of up to 60 m/d. Such an infiltration flux is approximately four times greater than the maximum daily rainfall observed at the site (800 mm/d) over the last five years. The MSE wall designer needs to make a decision regarding the design infiltration flux with duly considering the severest expected rainfall intensity and the likelihood of piping and clogging, and the consequent reduction in the flow capacity through the backfill.
