Collapse of steel cantilever roof of tribune induced by snow loads

Ahmet C. Altunışık*, Şevket Ateş and Metin Hüsem and Ali F. Genç

Department of Civil Engineering, Karadeniz Technical University, Trabzon, Turkey

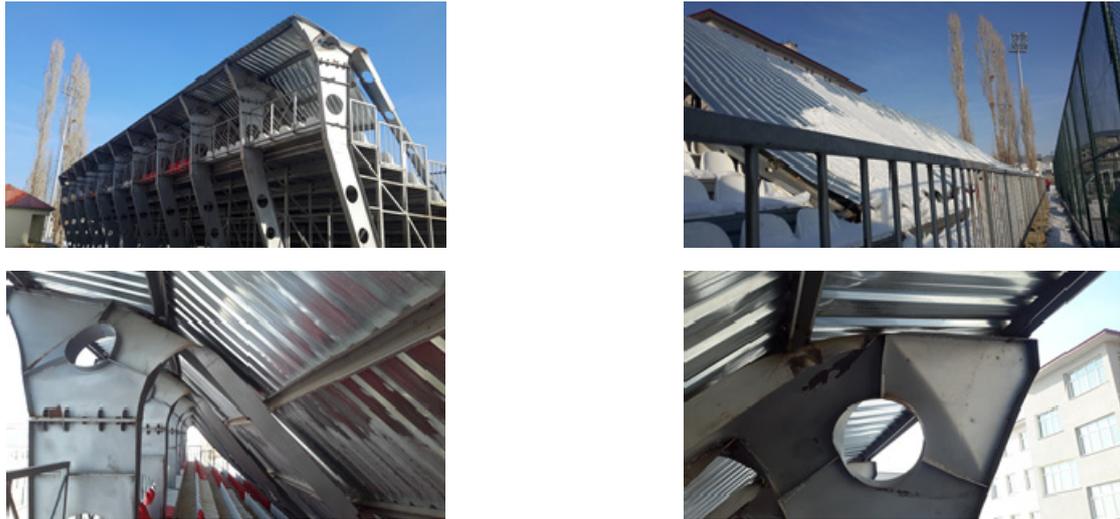
During the site investigations carried on December 11th, it was seen that the cantilever roof had been completely collapsed and 240 m² storage areas was affected heavily. Some views from the structure are given in Fig. 3.

Fig. 3 Some views of completely collapsed cantilever roof of tribune structure

checks pointed towards the buckling of the cantilever girder's stiffener-less web with big height and without any bracing at its supported ends to be the root failure cause.

It was observed from the Fig. 3 that the structural members in the collapsed tribune roof were laterally buckled and permanent plastic deformations were occurred. According to the site investigations, it is observed that the connection joints between column-girder and girder-purlin were not designed and constructed according to the engineering knowledge. There are not any stiffener/sheeting plates around the column-girder connection. Also, the inserts were formed on the alignment in cantilever beam (Fig. 4(a)).

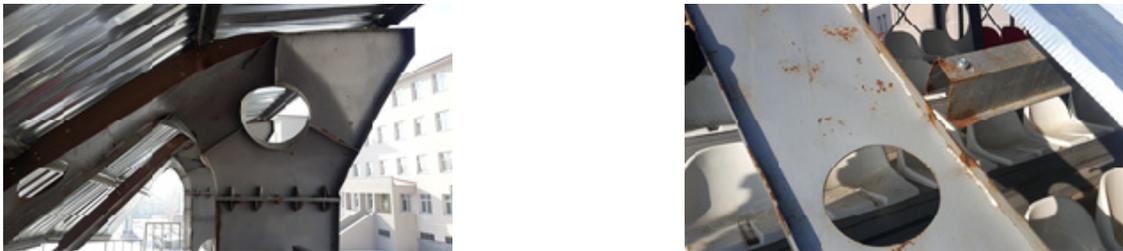
(a) Incorrect arrangement of column-girder and girder-purlin connection

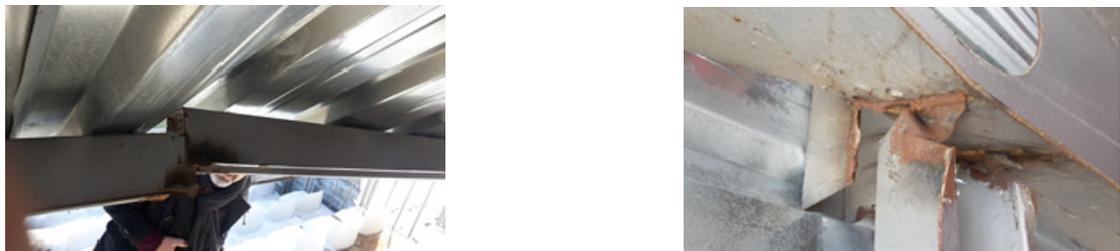
(b) Connection joints and plastic deformations

In addition, there are a lot of construction workmanship errors were observed. The joints were produced using overlapping techniques, spot welding and single-screw connections without the considering of static project (Fig. 4(b)). It can be evaluated without any comparison by limit values, the bolts, screws and spot welds were slipped and broken due to the internal forces such as shear forces, bending and torsional moments during the collapse.

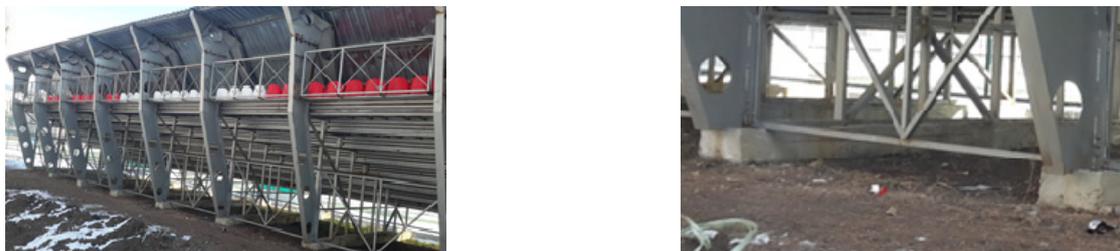
(c) Unbounded column-foundation junctions

Besides, the columns were not fixed to the strip foundation (Fig. 4(c)). According to the static project drawings (some drawings can be seen in Fig. 2), the

connection details should be constituted using bolts. But, only welded connections were practiced considering application simplicity.

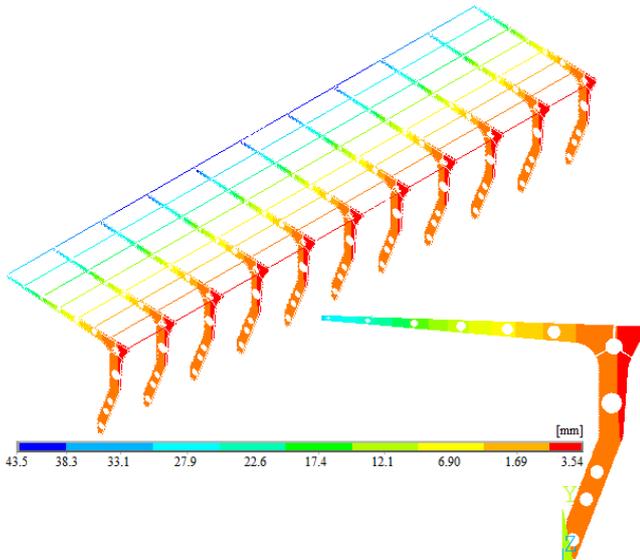
Fig. 6 Maximum displacement contours of the tribune roof under dead and snow load

The maximum vertical displacements contour diagram of the tribune roof under snow load is shown in Fig. 6. It can be seen from the Fig. 6 that the displacements have an increasing trend from column-beam connection to endpoint of the cantilever. The displacements reach the maximum values at the endpoint of cantilever as 43.50 mm. This value is bigger than the allowable displacement limits in design codes.

$$u_{\max} \leq \frac{L}{250} \quad \text{for cantilever} \quad u_{\max} \leq \frac{7890}{250} = 31.48 \text{ mm}$$

(insufficient design for displacement)

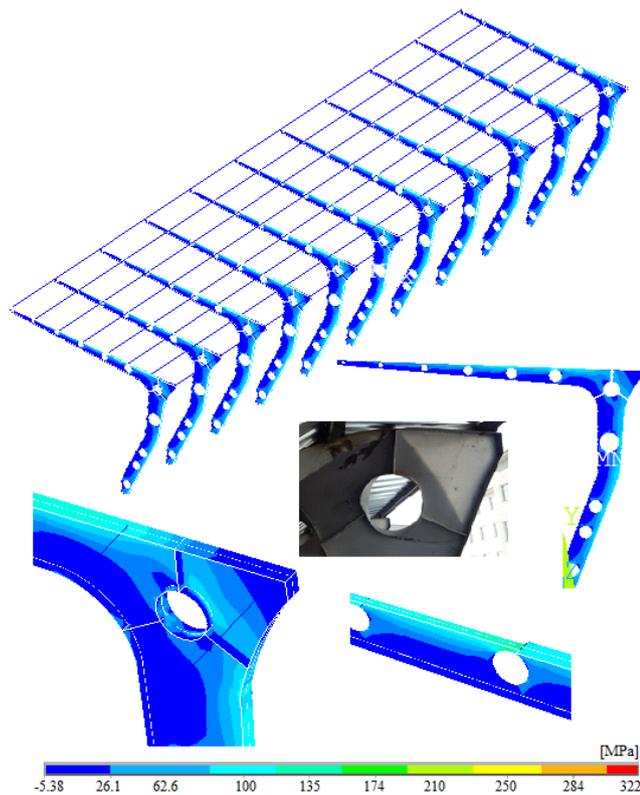
Fig. 7 Maximum tensile stress contours of the tribune roof under dead and snow load

The maximum tensile stress contour diagram of the tribune roof under dead and snow loads is shown in Fig. 7. It is seen from the Fig. 7 that maximum values of the tensile stresses occurred at web surface of column-cantilever connection section, top flange of the beam, back side of the column and section changing points between 210-280 MPa. Also, some local stress accumulations regions are observed with 322 MPa maximum stress value at the transition segment of columns. But, these points are supported by the frames under the seat. So, these local values are not

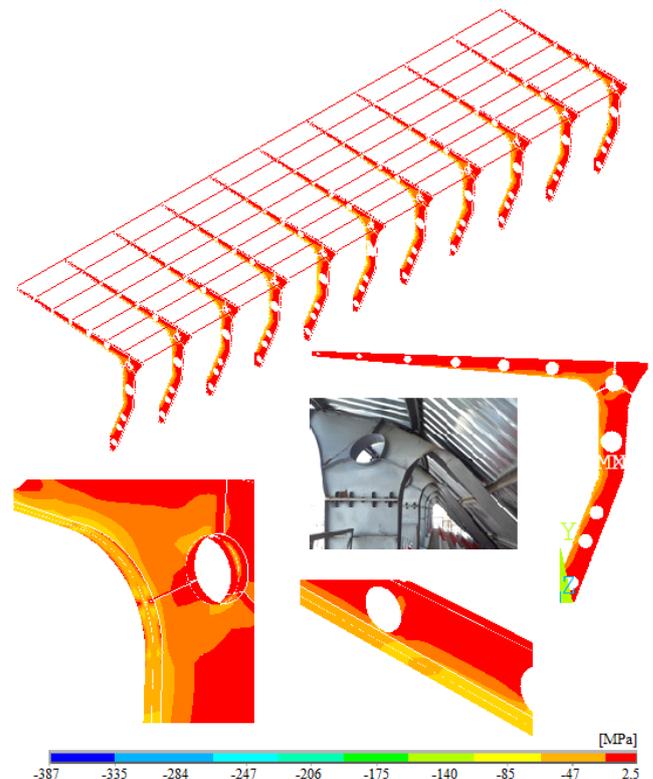
Fig. 8 Maximum compressive stress contours of the tribune roof under dead and snow load

The maximum compressive stress contour diagram of the tribune roof under dead and snow loads is shown in Fig. 8. It is seen from the Fig. 8 that maximum values of the compressive stresses occurred at web surface of column-cantilever connection section around the hole, bottom flange of the beam, front side of the column and section changing points between 150-335 MPa. Also, some local stress accumulations regions are observed with 387 MPa maximum stress value at the transition segment of columns. But, these points are supported by the frames under the seat. So, these local values are not considered to comparison.

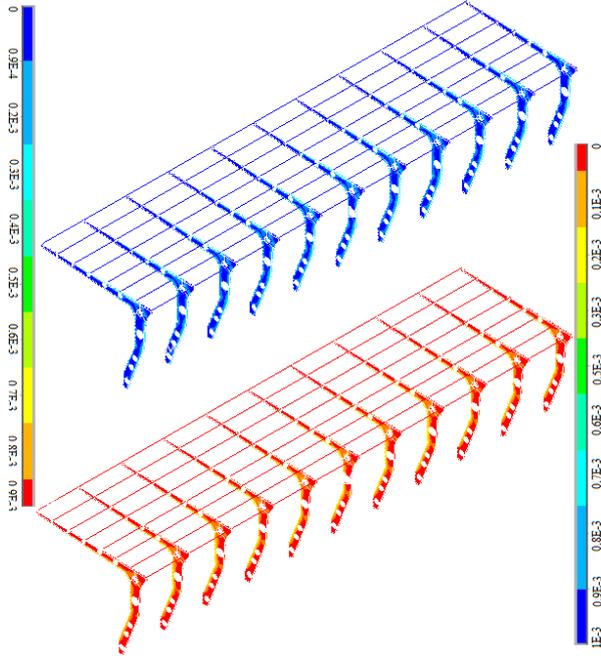
Fig. 9 Maximum tensile and compressive strain contours of the tribune roof under dead and snow load

The maximum and minimum elastic strains contour diagrams of the tribune roof under dead and snow loads are shown in Fig. 9. It is seen from the Fig. 9 that maximum and minimum elastic strains are attained as $0.90E-3$ and $1.00E-3$, respectively. Also, there are some strain accumulations regions with $0.30E-3$ maximum strain value at the collapsed and damaged regions. Moreover, there are some strain accumulations regions with $0.50E-3$ minimum strain value at the transition surfaces on the columns and cantilever beams.

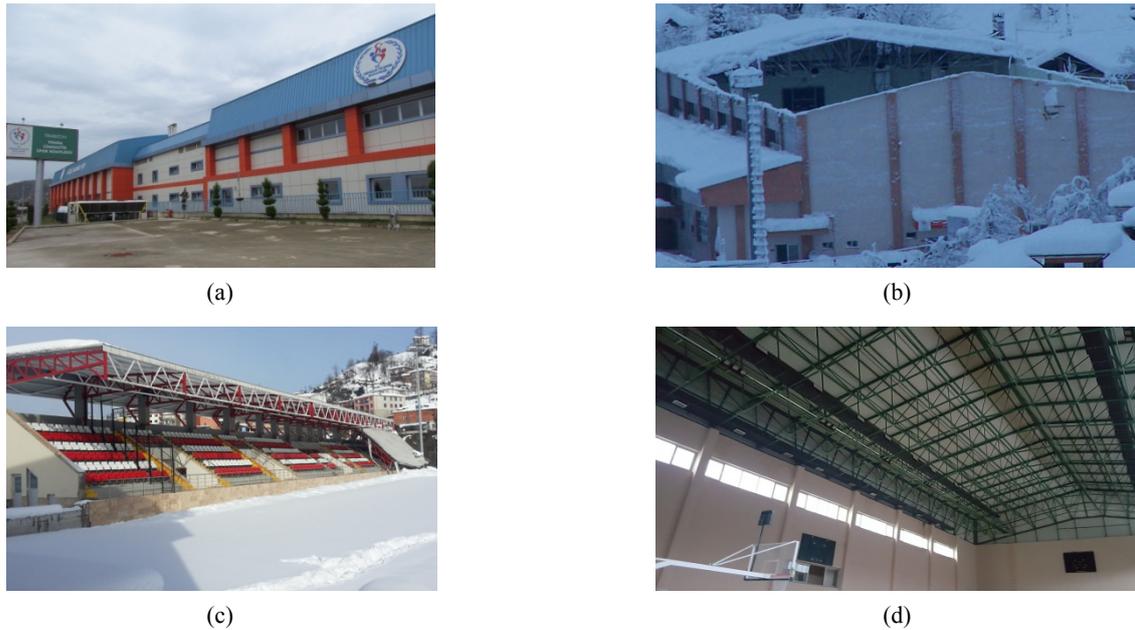
Fig. 12 Similar damage conditions and collapses in Turkey

Similar damage conditions and collapses have been occurred in Turkey since one and half year, Yomra athletic sport complex (Fig. 12(a)), Güneysu gymnasium (Fig. 12(b)), Kalkandere football tribune (Fig. 12(c)), space roof

of Of gymnasium (Fig. 12(d)) and etc. So, it is recommended that the snow loads should be considered as 1.50 kN/m^2 for the I-IV regions up to 700 m high from the sea level, 1.75 kN/m^2 and 2.25 kN/m^2 for the I-II and III-IV regions up to 1000 m, respectively. These values should be increased by 15% after 100 m sea level including engineering safety parameters.
