Analysis of a damaged industrial hall subjected to the effects of fire

Abstract. The results of diagnostics and analysis of an industrial hall located on the premises of a thermal power plant severely damaged by fire are presented in the paper. The comprehensive failure-related diagnostics, non-destructive and destructive tests of steel and concrete materials, geodetic surveying of selected structural members, numerical modelling, static analysis and reliability assessment were focused on two basic goals: The determination of the current technical condition of the load bearing structure and the assessment of its post fire resistance as well as assessing the degree of damage and subsequent design of reconstruction measures and arrangements which would enable the safe and reliable use of the building. The current mechanical properties of the steel material obtained from the tests and measured geometric characteristics of the structural members with imperfections were employed in finite element models to study the post-fire behaviour of the structure. In order to compare the behaviour of the numerically modelled steel roof truss, subjected to the effects of fire, with the real post-f

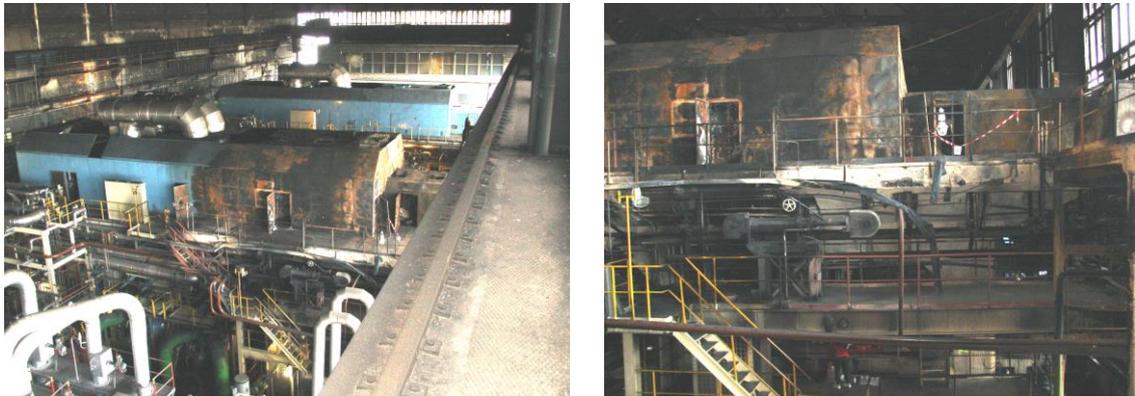
(a) A fire damaged turbine generator unit

(b) A fire damaged steel members of platforms

Fig. 3 A view of the burnt-out area inside the hall

A view of the burnt-out area inside the hall with a fire damaged turbine generator unit and steel members of platforms damaged by fire are shown in Fig. 3. In general, the effects of fire on the structure and its structural members are characterized by heat expansion and the degradation of mechanical properties of its materials.

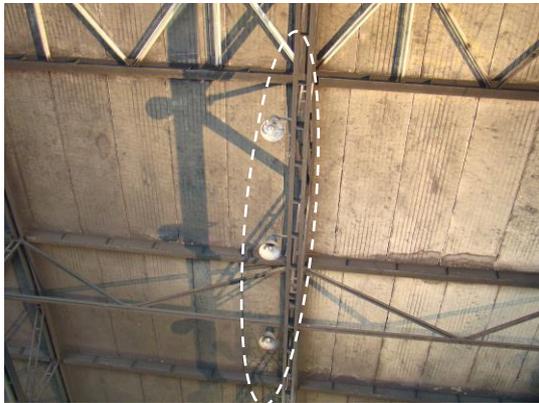
Plastic deformations of the top chords of the trusses in the 15 and 16 axes and their spatial displacement were identified. The damaged steel roof truss in axis 16 (over the burnt-out area) with the deformed top chord subjected to buckling is shown in Fig. 4(a). The steel material properties start to deteriorate when the temperature exceeds a certain value. When the temperature exceeds a critical value plastic deformations appear at some of structural members. These deformations then expand to the other members over time. The compressed top chord of the truss exhibited a significant flexural deformation which is mainly caused by additional bending moment. This additional bending moment in the top chord is produced by its buckling due to the ex-centric compression force affecting the arm against the original longitudinal axis of the non-deformed member.

(a) The deformed top chord of the truss subjected to buckling

For the analysis and reliability assessment of the damaged structure with current properties a deviation of the top chords of the trusses in the fire zone (between the 15 and 16 axes) with a size of 200 mm was considered (Fig. 4(a)). Computational models of the trusses with the introduction of imperfections as well as resultant distributions of stresses in the top and bottom chords of the trusses are shown in Fig. 14. Results of the static analysis confirmed that the stresses in the top

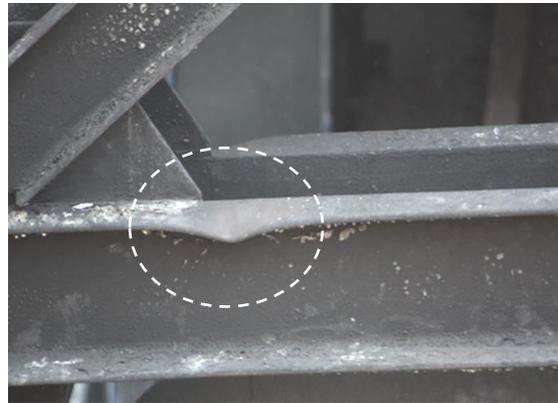
The bottom chords of the trusses in the 15 and 16 axes suffered local plastic deformations at the cross-sections near their supports (at the steel columns) as is shown in Fig. 4(b) for the truss in axis 16. This local deformation of the bottom chord is caused by compression due to the restrained elongation (thermal expansion) under elevated temperatures. It is important to mention, that all the joints and connections at the trusses' steel supports were able to resist the reaction forces during the entire fire period.

(b) The local deformation of the bottom chord of the truss

Computational models of the trusses with intermittent top chords in the damaged areas and resultant distributions of stresses in the top and bottom chords of the trusses are shown in Fig. 15. An analysis of the diminished structure with the current properties confirmed that the edge bars of the bottom chords near supports are subjected to compression which correspond to the real damage of the bottom chord of the truss as is revealed in Fig. 4(b).

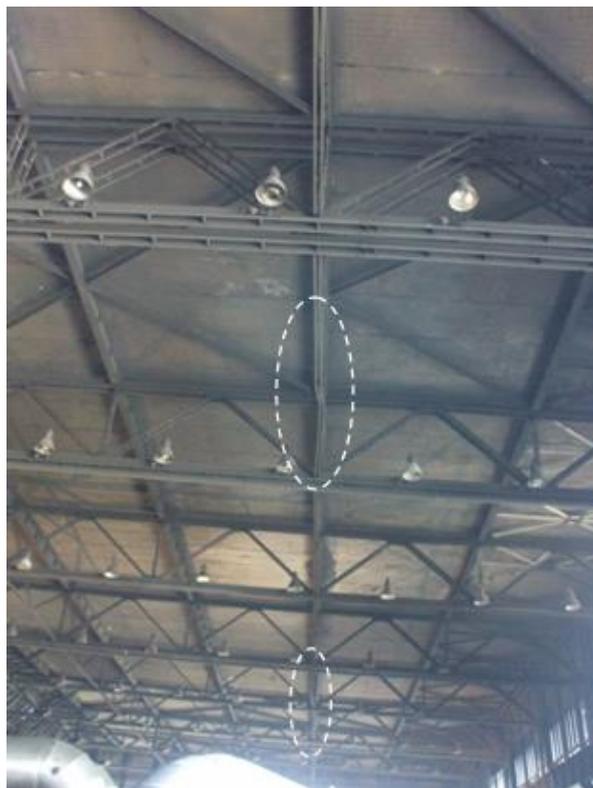
Fig. 5 Deformed longitudinal vertical roof bracings at both end parts of the dilatation unit of the hall where the fire was located

A detailed examination of the deformations of the structural members reveals that it is important to highlight the effect of thermal expansion (elongation). Vertical longitudinal roof bracings situated between trusses in the 13 and 14 axes and in the 18 and 19 axes are deformed as

is shown in Fig. 5. These deformed roof bracings are situated at the end parts of the dilatation unit of the hall in which the burnt-out area was identified. Both induced deformations and reaction forces in members located at the ends (supports) of the relevant dilatation unit are caused by compression due to restrained elongations of the bracing members subjected to elevated temperatures (restrained thermal expansions). The side horizontal roof bracings in the roof plane were not deformed.

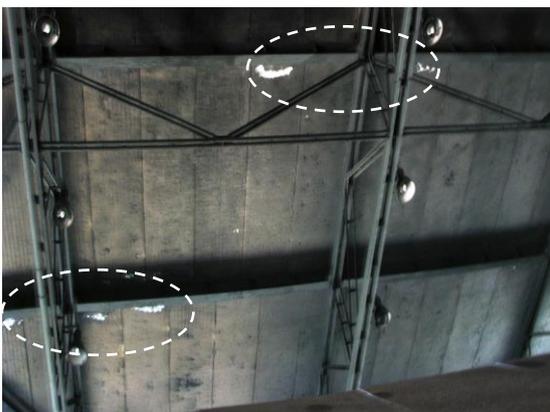
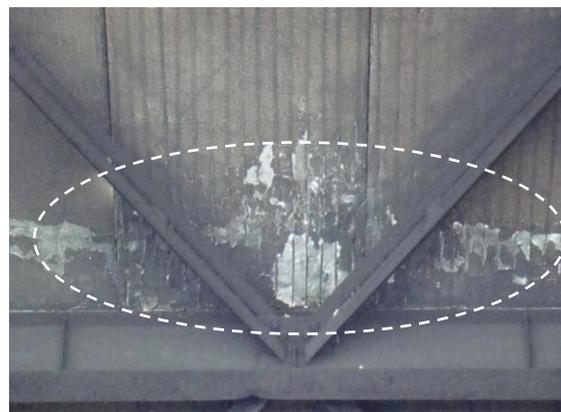
As a result of elevated temperatures the porous concrete roof panels in the area over the fire zone were damaged. The panels were excessively deflected and deformed. Some of the reinforcement, made of steel rods was subjected to plastic deformation. A bottom view of the roof above the damaged turbo-generator with visibly damaged panels in the anchorage zone and a detail of the damaged panels in the anchorage zone are shown in Fig. 6. During the investigation, initial manufacturing structural imperfections were found. For example, some of the roof panels did not have sufficient concrete cover over the reinforcement; the panels had no shear reinforcement near the supports and had in-sufficient actual lengths of the supports.

(a) Visibly damaged panels in the anchorage zone

(b) A detail of the damaged panels in the anchorage zone

Fig. 6 A bottom view of the roof above the damaged turbo-generator

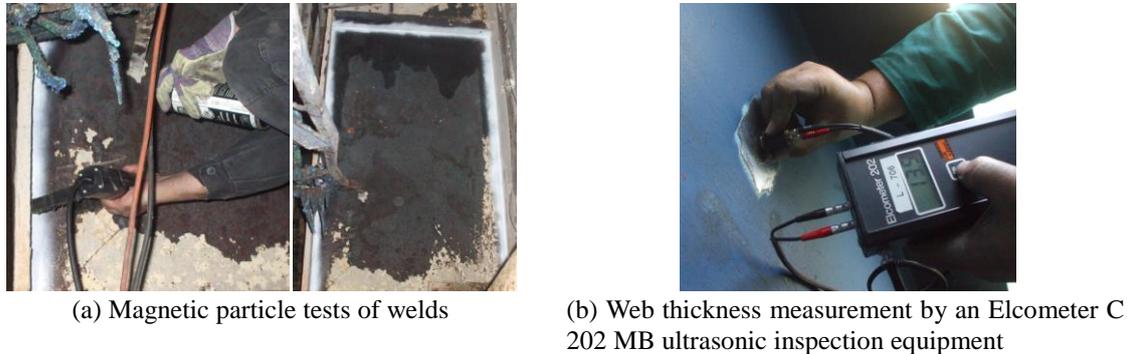
Fig. 7 Inspection of the column in the axis 16

zone were tested. Magnetic testing was performed using a Parker/220V magnetizer of a flaw detector. Inspection of the column in axis 16 and magnetic particle tests of welds are shown in Fig. 7(a).

No failures in the welds of the tested members were detected. Visual tests and magnetic particle tests confirmed a general conformity of welds and that their current properties met specifications.

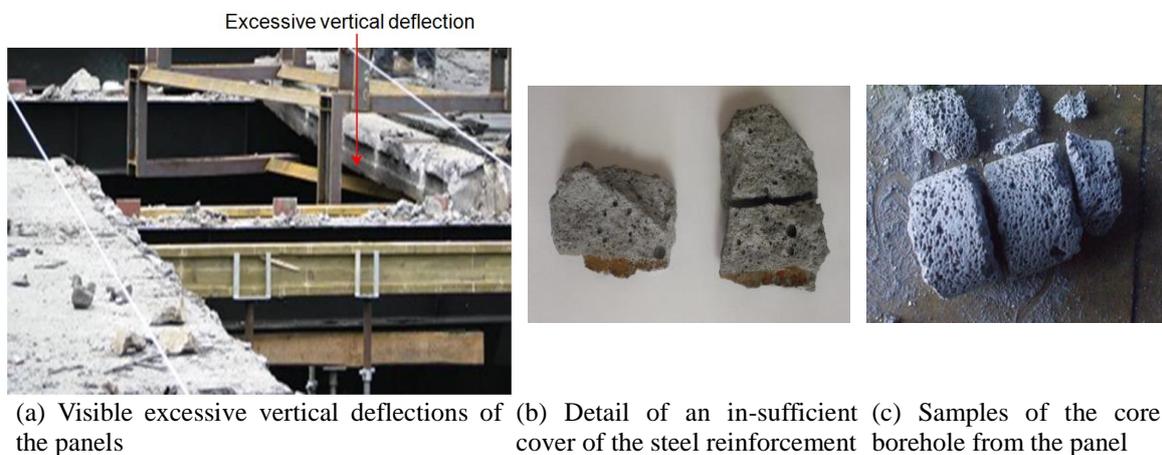
Fig. 8 A current state of the concrete roof panels

The current state of the concrete roof panels with visible excessive vertical deflections and a detail of in-sufficient cover of the steel reinforcement are shown in Fig. 8(a) and Fig. 8(b). In Fig. 8(b) are panel fragments (photographed in the laboratory with a flash) and in Fig. 8(c) is the borehole from the same panel (photographed directly at the sampling site). The actual strength of the concrete of the roof panel located over the fire area was examined by means of both non-destructive and destructive tests. Based on the tests, analyses and a reliability assessment (a codified verification using partial factors) it was concluded that these concrete roof panels could not be used in the reconstruction process and therefore must be replaced with lightweight roof

sandwich panels created from thin-walled trapezoidal profiles. Another reason for the removal of the concrete panels was an effort to reduce the load imposed on the damaged roof trusses in the critical zone.

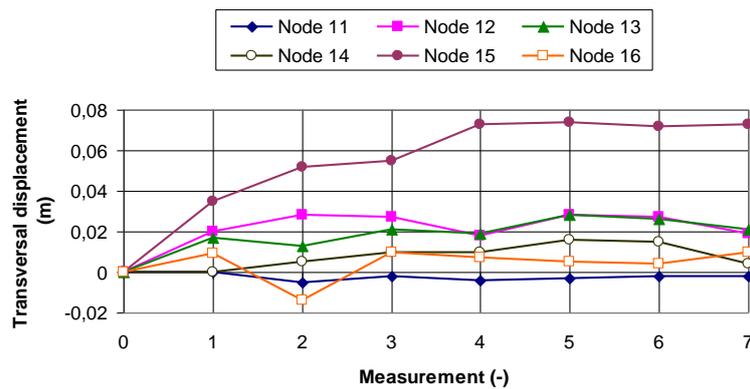
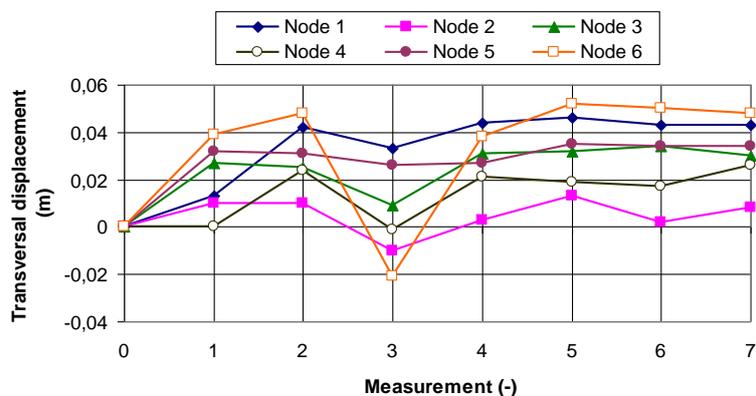
(b) Measured displacements of the truss in the axis 15

(c) Measured displacements of the truss in the axis 16

Fig. 9 A geodetic surveying of transversal displacements of selected nodes of the steel roof trusses

Geodetic measurements of the distorted shape of the steel roof trusses and their deflections as well as a measurement of the rail offset of the crane runway in order to obtain the real geometry of the current post-fire deformed members were performed. The current geometry and actual

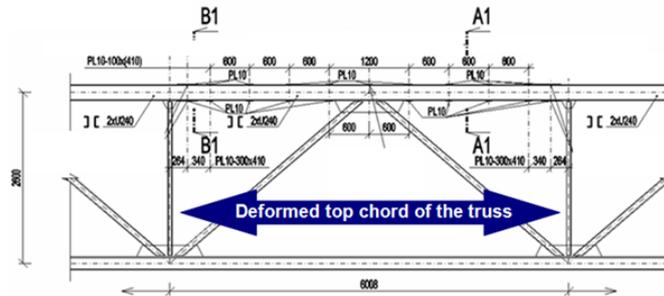
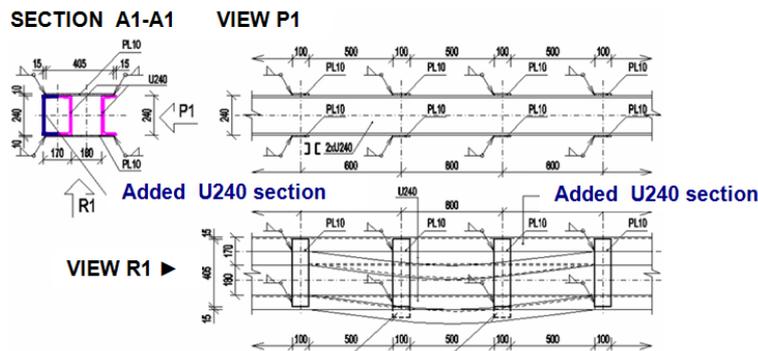
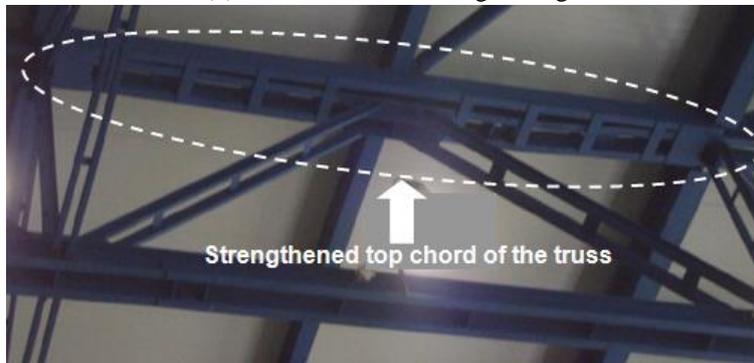
(a) Deformed top chord of the truss

(b) A scheme of the strengthening

(c) The strengthened truss with the new light-weight sandwich roof cladding after the reconstruction

temporary supporting system with damping members was placed on the bridge cranes. The top chords of the trusses were stabilized by brace struts at the nodes of the trusses in the places of deviations. After removing the porous concrete roof panels between the 14-15, 15-16 and 16-17 axes, the necessary strengthening of the top chords of the trusses was carried out. Reconstruction of the roof structure of the hall, the purlins supported by struts stored on the cranes and a view of the roof structure after the removal of the concrete roof panels are shown in Fig. 16. The concrete panels were replaced with a light-weight sandwich roof cladding. The steel truss with the deformed top chord was strengthened. A scheme of the strengthening and the strengthened truss

with the new light-weight sandwich roof cladding after the reconstruction is shown in Fig. 17.

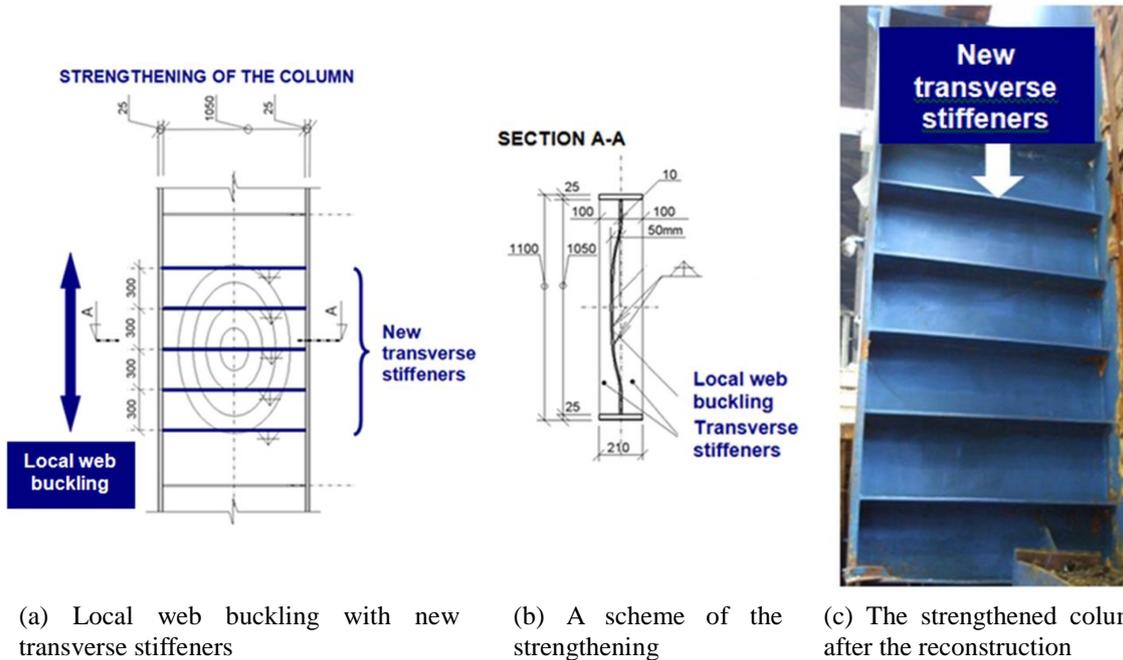
The columns fulfil reliability conditions in this case, providing that the locally damaged (buckled) web of the column in the 16 axis be reinforced.

Fig. 18 Strengthening of the steel column

Strengthening a locally failed web of the column in the 16 axis by the addition of transverse stiffeners was performed (Fig. 18(a) and Fig. 18(b)). The strengthened column after the reconstruction is shown in Fig. 18(c).
