Effect of tornadoes on residential masonry structures

J.-P. Pinelli[†] and S. O'Neill[‡]

Wind and Hurricane Impact Research Laboratory, Florida Institute of Technology, USA

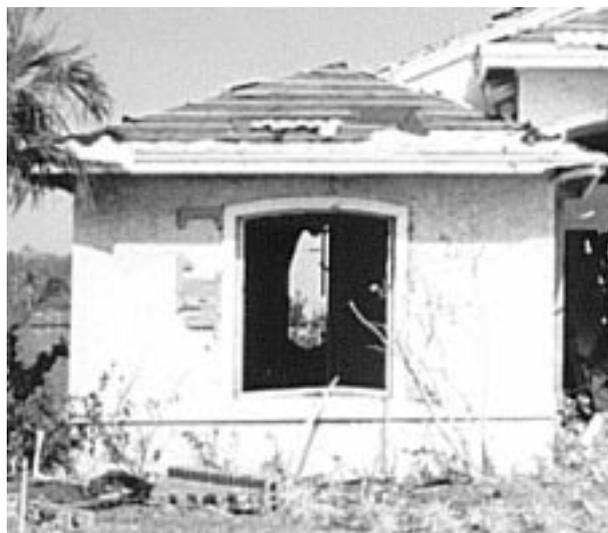
Window failures were observed throughout the damage path of the tornado. 152 of the more than 300 damaged houses in the Lakeside Estates were observed to have had at least one significant window failure (Fig. 1). Flying debris was assumed to be the primary cause of these failures and none of the observed buildings had any protective devices (i.e., storm shutters) installed on their windows to help mitigate missile impact damage.

Fig. 1 Window failures in the Lakeside Estates

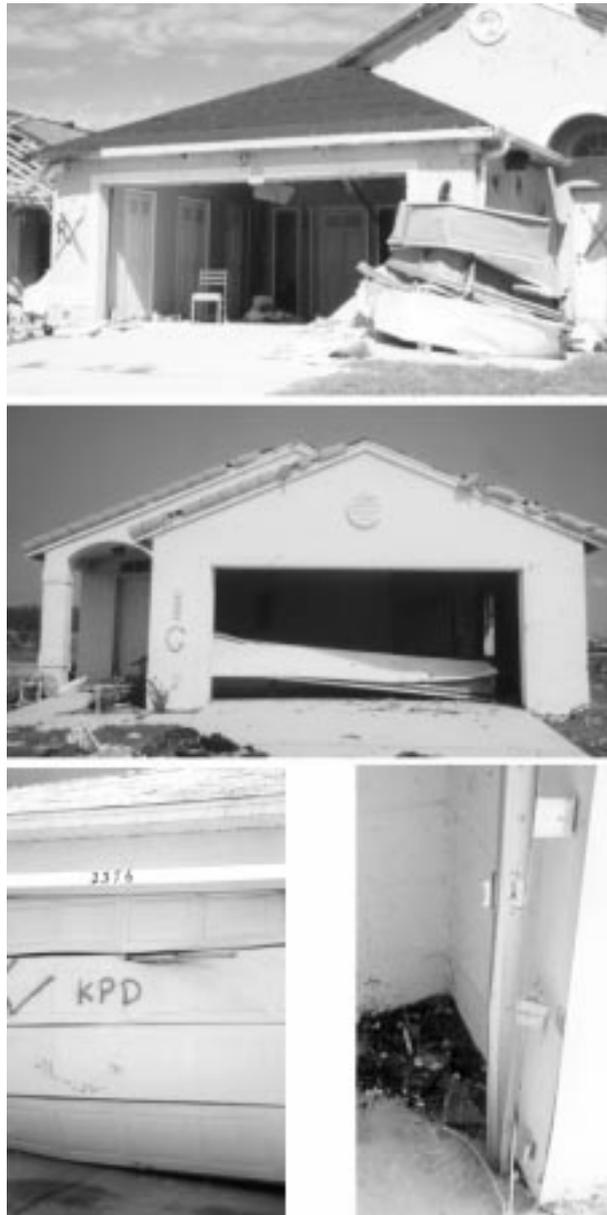
Door failures were another commonly observed type of envelope failure. *Garage doors* were by far the most prominent type of door failure (Fig. 2). Throughout the Lakeside Estates, a total of 115 garage doors failed due to both inward- and outward-acting wind pressures as well as air-borne missiles. Local inspections indicated several different failure mechanisms. In many cases, the garage door rollers separated from their tracks when the wind pressure caused large deflections of the garage door. In other cases, the rolling tracks themselves failed, either through torsional failure of the track or by failure of the connection between the track and the garage wall. A third commonly observed failure mechanism was due to the bending failure of the thin, flexible garage door panels, which span relatively long lengths and provide very little inherent bending resistance. The final observed failure mechanism was caused by missile impact on the light gauge metal garage doors. These failures were caused primarily by the impact of timber framing members from failed roof systems.

Interestingly, several cases were observed in which the garage door was the only envelope failure throughout the entire building. This confirmed that garage doors are a primary weak point in the building envelope and can fail at relatively low wind speeds.

Fig. 2 Garage door failures in the Lakeside Estates

Mitigation of the first sequence lies in strong garage doors and reinforced walls. The upper photograph in Fig. 2 is a particularly good illustration of this point. The houses on both sides of the home pictured there were destroyed. The house in question had also its garage door blown away like its neighbors. However, the owner had closets added all around the perimeter of the garage walls. This unexpected reinforcement of the walls gave them extra strength. They did not collapse and the home suffered only minor damage.

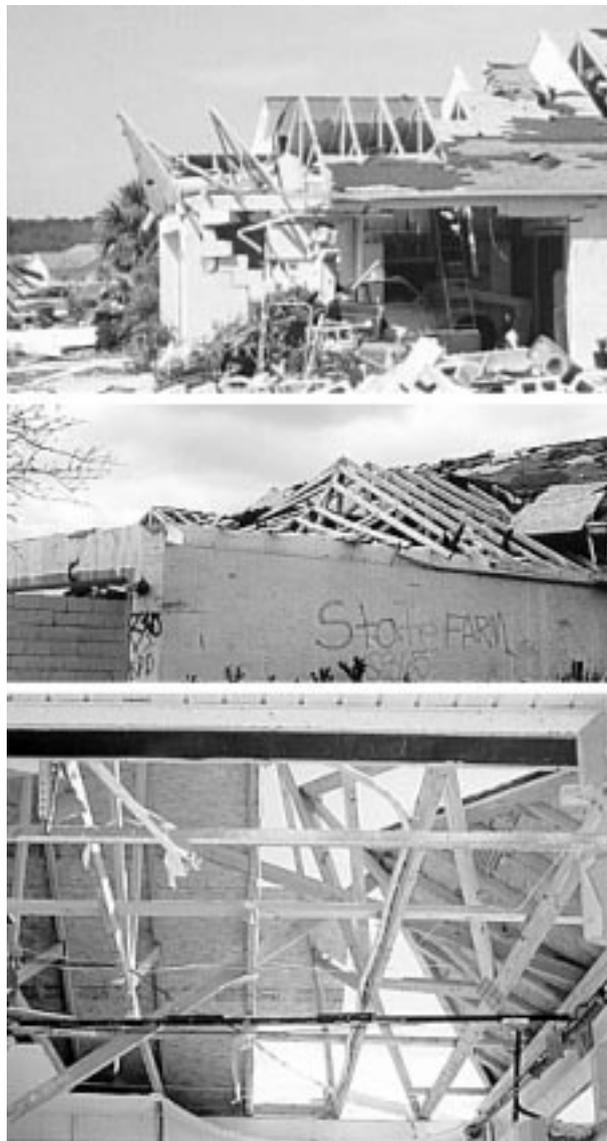
Fig. 3 Deflection of wooden roof trusses due to inadequate lateral bracing (Lakeside Estates)

plywood panels often provided the only lateral bracing to the wooden roof trusses. If the plywood sheathing separated from the roof system, the roof trusses deflected laterally and the system no longer provided any resistance to high wind pressures (Fig. 3).

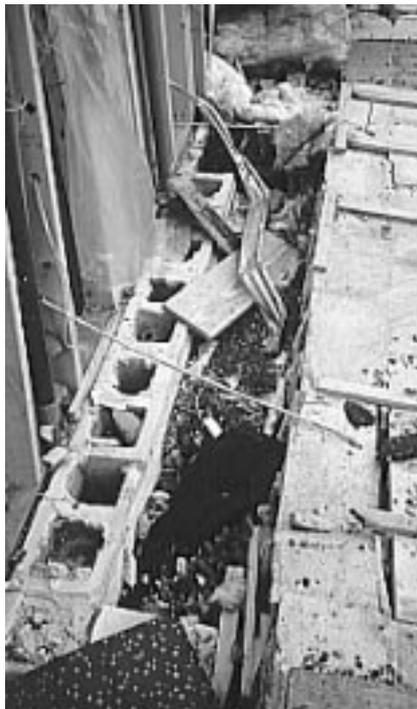
Fig. 4 Insufficient wall to foundation anchorage in the Lakeside Estates

Several failures were observed in the Lakeside Estates. Some failures were a direct result of insufficient anchorage between adjacent walls as well as between the wall and the foundation (Fig. 4). Wind pressures acting normal to the wall caused these failures, and they generally occurred after the wall lost lateral stability from either the roof diaphragm or adjoining walls. Preserving the integrity of the structural system, including the roof, and simply designing with sufficient amounts of steel reinforcement could prevent these failures.

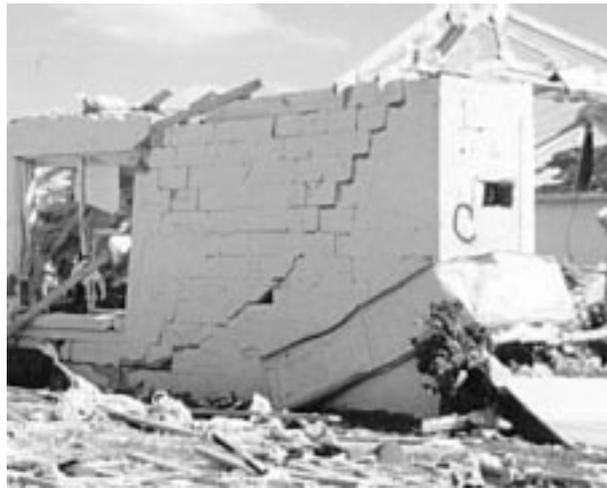
Masonry wall shear failures were also commonly observed throughout the damage area (Fig. 5). Shear failures were the result of in-plane wind pressures which the roof diaphragm transferred to the wall. The complete lack of horizontal reinforcement significantly reduced the shear capacity of the

Fig. 5 Shear failure of a masonry wall in the Lakeside Estates

masonry walls and was the primary cause of the shear failures that were observed.

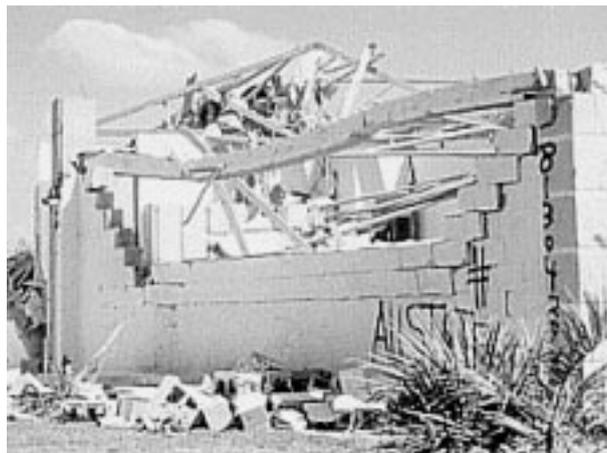
Fig. 6 Bending failure of an unreinforced masonry wall in the Lakeside Estates. Notice that the masonry wall failure caused the tie beam to sag which subsequently led to the collapse of the roof

Bending failures were the final type of masonry wall failures that were commonly observed (Fig. 6). Wind loads acting normal to the wall caused these failures. Since no vertical reinforcement was provided, the walls were very brittle and failed at relatively low wind speeds.

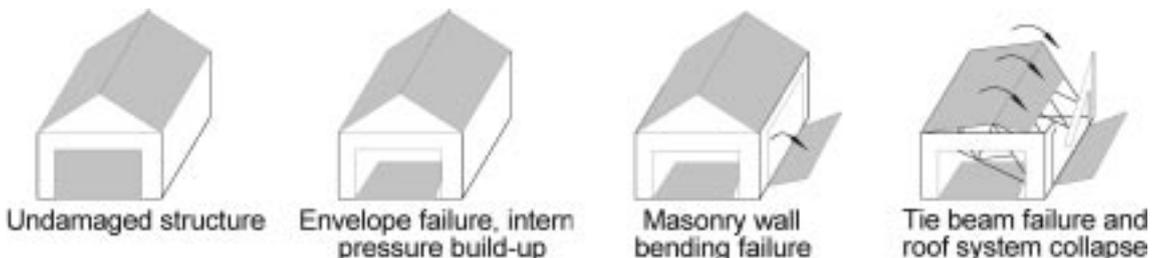
From the observations, it was evident that most of the damaged wood-roofed buildings followed one of two failure sequences. The particular sequence in any specific structure depended on several factors including the orientation of wind flow with respect to the structure, construction practices/materials used and the relative strengths of the individual structural elements. The first of the two common failure sequences was as follows (see Fig. 7):

1. Window and door (especially garage door) failures resulted in positive internal pressures.
2. Large positive internal pressures combined with negative (suction) external wind pressures caused side walls to collapse due to bending failure. This collapse removed support to the roof and reduced the capacity of the tie beam to support the roof structure.
3. Reinforced concrete tie beam sagged or failed under the increased load and the roof collapsed.

Fig. 7 First common failure sequence

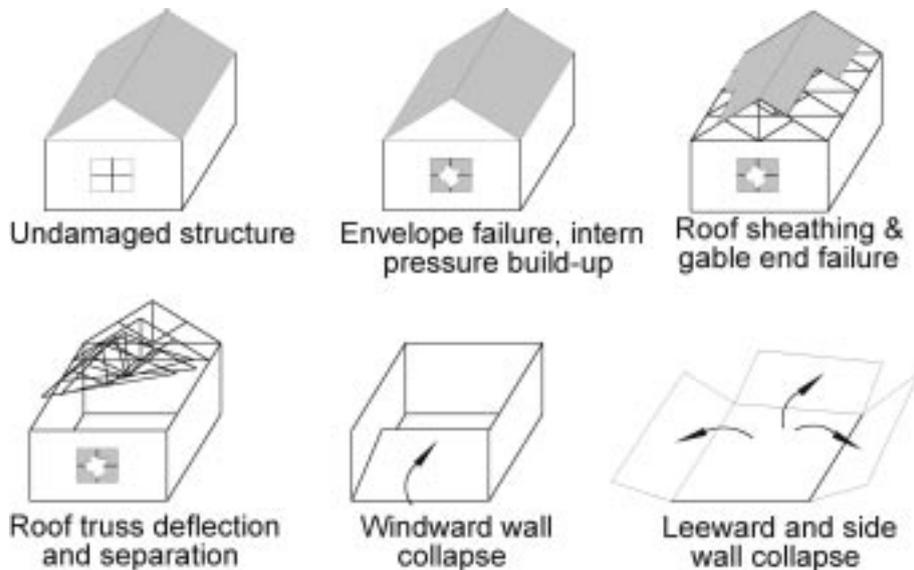
The second commonly observed failure sequence in wood-roofed structures was as follows (Fig. 8):

1. Window and door failures resulted in positive internal pressures.
2. Uplift wind pressures, combined with positive internal pressures, caused the plywood roof sheathing to separate and gable end connections to fail. These failures eliminated bracing to the roof trusses.
3. Roof trusses deflected laterally causing failure of the roof to wall connections. The trusses separated from the structure, removing roof support to the walls.
4. Loss of support from the roof system caused the windward masonry wall to act like a vertical cantilever, leading to large bending stresses at the wall to wall and wall to foundation connections. These stresses caused the connections to fail which lead to the inward collapse of the windward

Fig. 8 Second common failure sequence

wall.

5. Loss of support from windward wall caused leeward and side walls to collapse outward due to negative (suction) wind pressures.

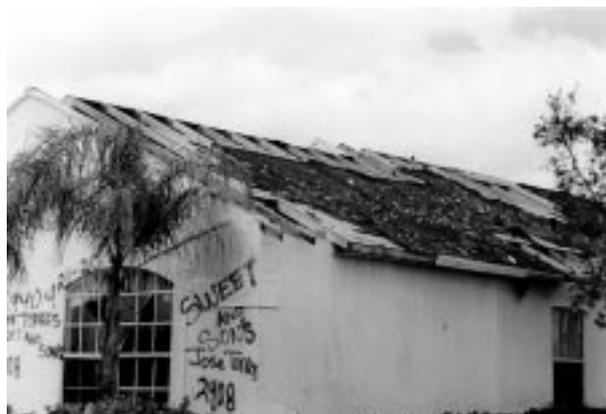
Case Study 1 suffered envelope failures. In the entire Lakeside Estates housing area, about two-thirds of the affected structures suffered similar damages. The house in question was a 116 m², single-story residence with a single car garage that was incorporated into the main structure. The tornado struck the building from the rear and caused the failure of two glazed openings on the windward wall and the separation of roof sheathing on the windward and leeward eaves as well as along the leeward ridge. Fig. 9 illustrates the extent of the failures.

Fig. 9 Rear/side (weat/south) view of Case Study 1 showing window failure and roof sheathing separation at the eaves and along the ridge

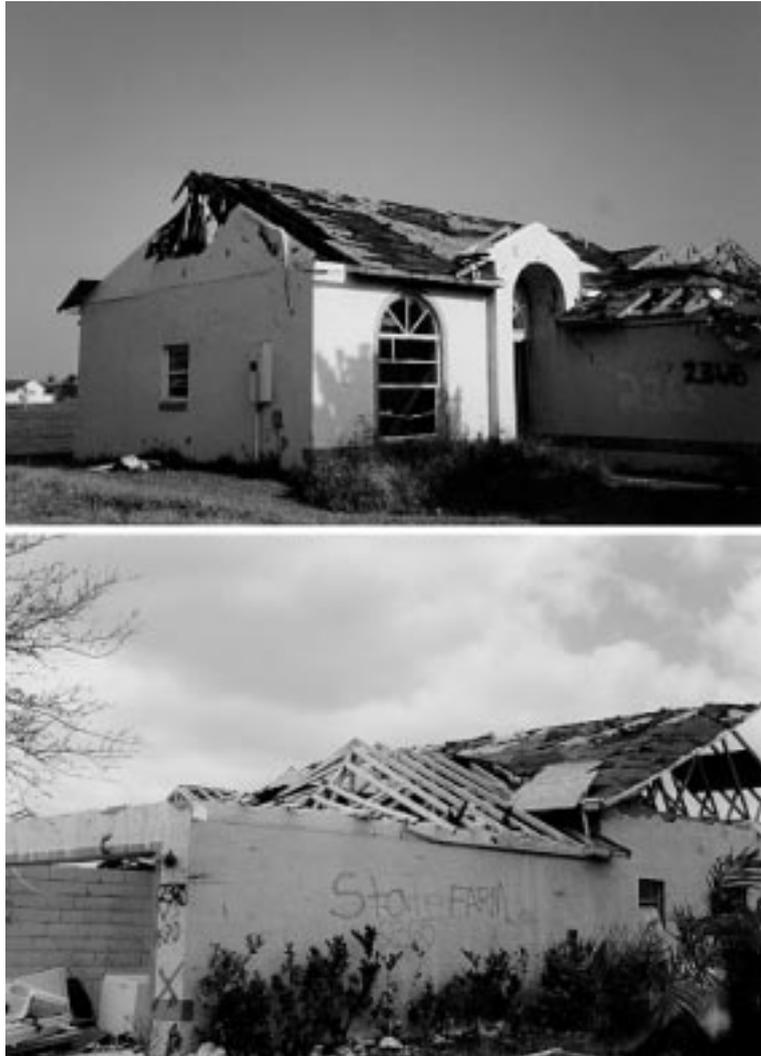
Case Study 2 was located in the subdivision that suffered the worst tornado damage in the entire Lakeside Estates area. It was a 153 m², single-story masonry residence with a two-car garage that extended out from the main structure and a roof system similar to that in Case Study 1. The tornado struck the house diagonally from the southwest and caused substantial envelope failures as well as roof structural failures. Every glazed opening (6 windows and a sliding glass door), approximately half of the roof sheathing, the garage door, the roof structure over the garage and the gable ends all failed. Additionally, the interior of the structure was completely destroyed. Fig. 10 shows two views of the building which illustrate the extent of the structural damage.

Fig. 10 Views of the south side (top) and north side (bottom) of Case Study 2 showing garage door, roof sheathing and roof structure damages

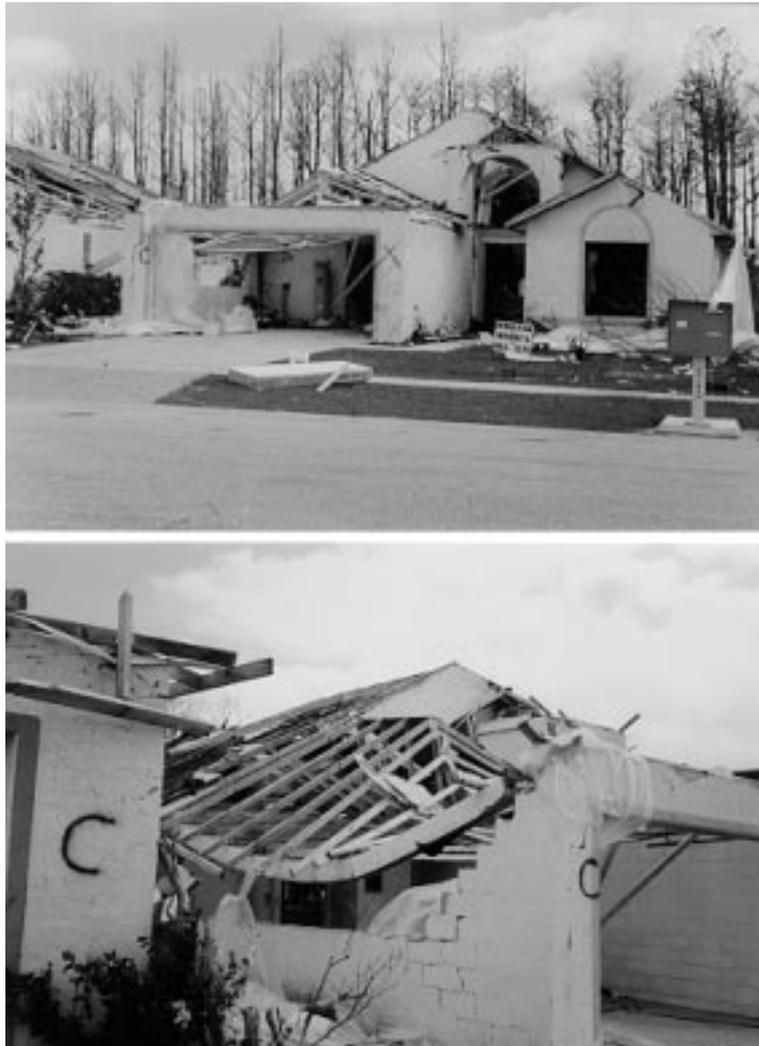
massive damage consistent with a number of completely destroyed structures in the Flamingo Lakes subdivision. The tornado struck the building from the south-west, breaching the envelope and causing both roof structure and masonry wall failures. Additionally, the contents and interior of the structure were completely destroyed. Fig. 11 shows two views of Case Study 3 which illustrate the extent of structural damages.

Fig. 11 Front view (top) and side view (bottom) of Case Study 3 showing envelope failures, roof structure failures and masonry wall collapse

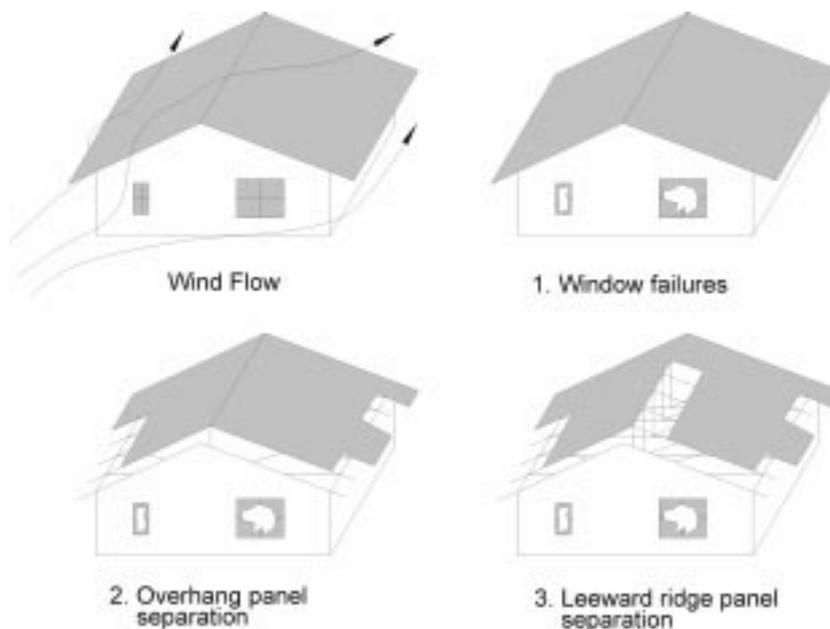
The failure sequence is shown in Fig. 12.

1. Windward glazed openings failed through missile impacts at a wind speed of about 35 m/s (75 mph) or less;
2. Overhang roof panels on both the north and south eaves separated at a wind speed of about 40 m/s (90 mph)
3. Non-overhang panels along the west eave and panels on the south side of the ridge separated at a wind speed of about 45 m/s (100 mph). The upper limit wind speed was calculated to be between 45 m/s and 55 m/s.

Fig. 12 Failure sequence, Case Study 1

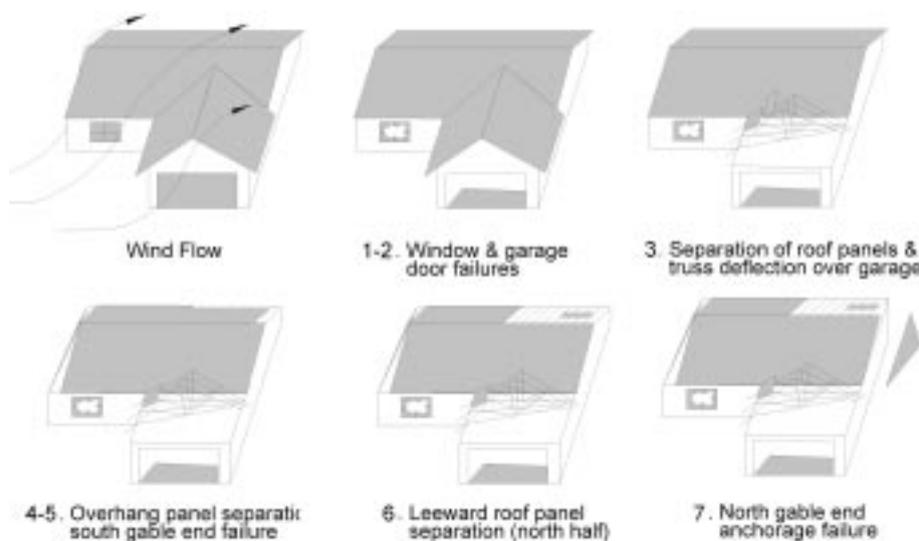
The failure sequence is shown in Fig. 13.

1. Glazed openings failed through missile impacts at a wind speed of about 35 m/s (75 mph) or less;
2. Garage door failed through withdrawal of the running track anchor bolts at a wind speed of about 35 m/s (80 mph);
3. Roof sheathing over the garage separated at a wind speed of about 40 m/s (90 mph), causing the roof trusses over the garage to deflect laterally;
4. Overhang roof sheathing along the southern, western and northern eaves separated at a wind speed of about 40 m/s (90 mph);
5. Separation of the southern eave sheathing caused the south gable end to fail due to inward acting wind pressures;
6. Roof sheathing on the northern half of the leeward roof surface separated at wind speeds between 40 m/s and 55 m/s (the upper limit wind speed was calculated to be approximately 55

Fig. 13 Failure sequence, Case Study 2

m/s.);

7. North gable end failed due to suction wind pressures at a wind speed of about 45 m/s (100 mph);

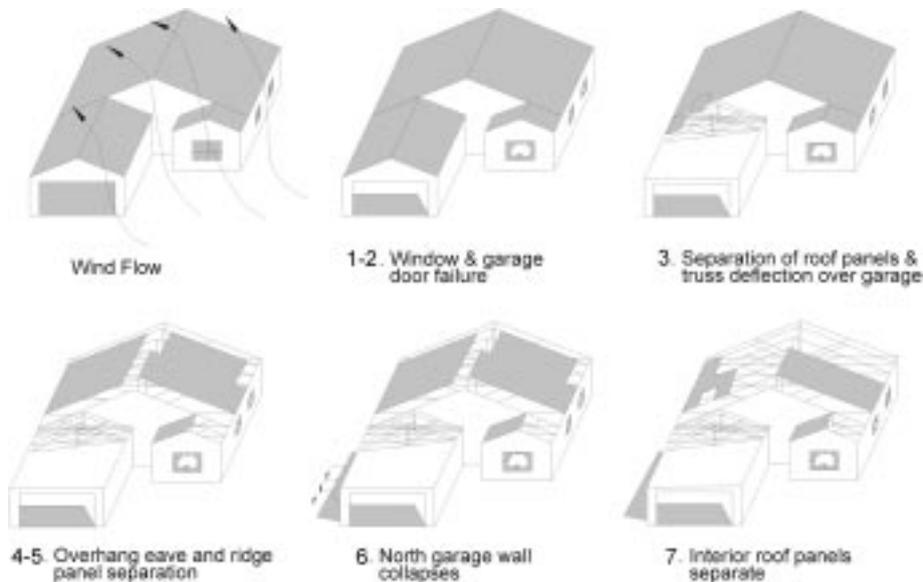
The failure sequence is shown in Fig. 14.

1. Glazed openings failed through missile impacts at a wind speed of about 35 m/s or less;
2. Garage door failed inward at a wind speed of about 35 m/s;
3. Roof sheathing over the garage separated at a wind speed of about 41 m/s, causing the roof trusses over the garage to deflect laterally;
4. Overhang roof sheathing along roof eaves separated at a wind speed of about 40 m/s;
5. Roof sheathing along the ridge separated at a wind speed of about 45 m/s;
6. North masonry garage wall collapsed at a wind speed of about 50 m/s;
7. Roof sheathing in the interior of the roof surface separated at a wind speed of about 54 m/s.

Fig. 14 Failure sequence, Case Study 3
