Smart Structures and Systems, Vol. 14, No. 3 (2014) 479-499 DOI: http://dx.doi.org/10.12989/sss.2014.14.3.479

Damages of minarets during Erciş and Edremit Earthquakes, 2011 in Turkey

Keywords: damages; reinforced concrete and masonry minarets; Van earthquakes 2011 in Turkey

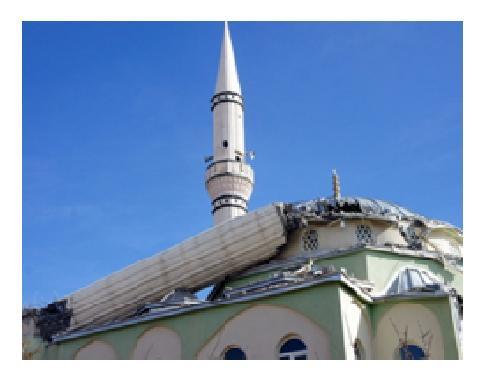
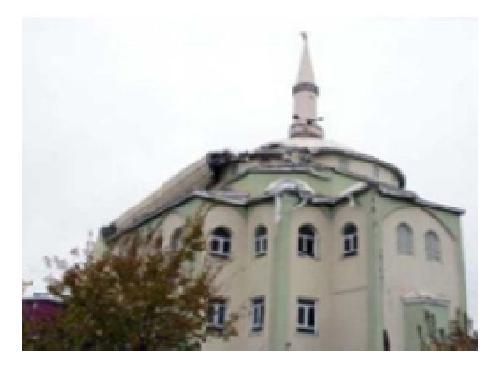
One of the most common types of the damage pattern in the reinforced concrete minarets is random horizontal cracks and concrete spalling near the bottom of the cylindrical body. There are two main reasons of this type of damage; reduction in cross section from the pulpit to cylindrical body and formation of the discontinuities in this region due to the lap spliced longitudinal steel bars (Fig. 11).

Fig. 11 Examples of failures near the bottom of the cylindrical body (URL-6, 7)

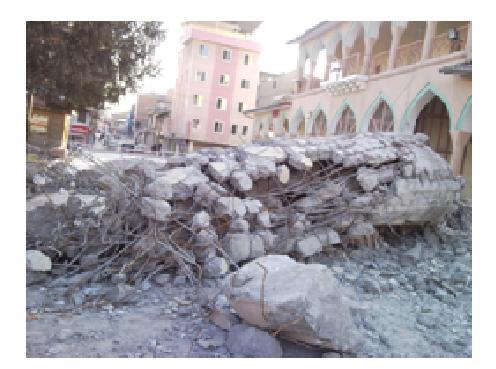
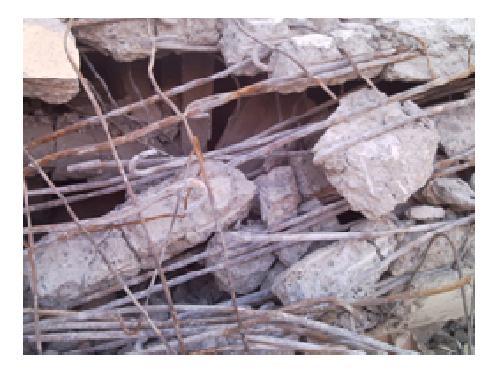
Fig. 12 Examples of the use of plain reinforcement steel

In the Turkish Earthquake Resistant Design Code, Part 3.2, it is stated that "Unribbed reinforcement steel cannot be used exempt hoops and crossties with flooring reinforcement. With the exception of elements, reinforcing steel with strength exceeding that of S420 shall not be used reinforced concrete structural elements." The use of plain reinforcement steel was observed within the cylindrical body as shown in Fig. 12. This was another source of damage that may cause to weaker bond between concrete and steel.

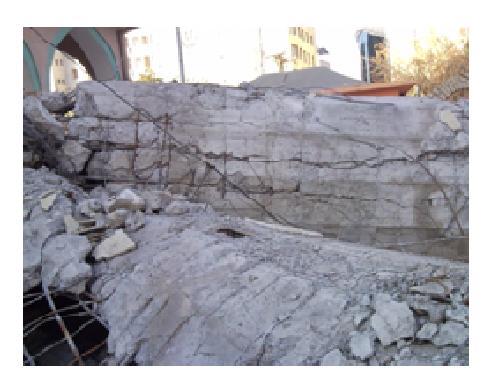
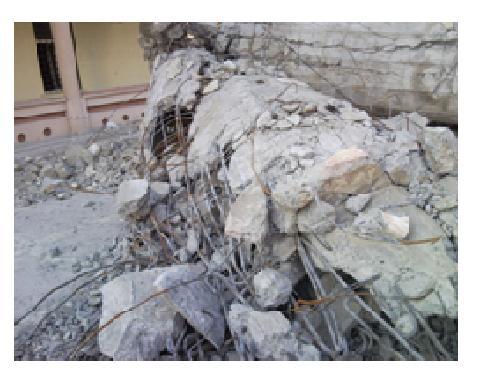
In the Turkish Earthquake Resistant Design Code, Part 3.2, it is stated that "In all buildings to be built in seismic zones, concrete with strength less than C20 (compressive strength of 20MPa) shall not be used." The use of concrete with insufficient strength was observed in the minarets as shown in Fig. 13. This was another source of damage that may decrease the structural performance during an earthquake.

Fig. 13 Examples of the use of concrete with insufficient strength

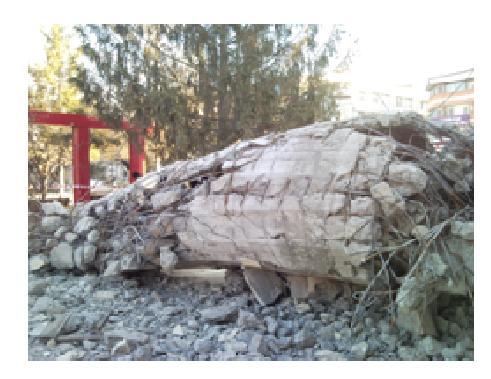
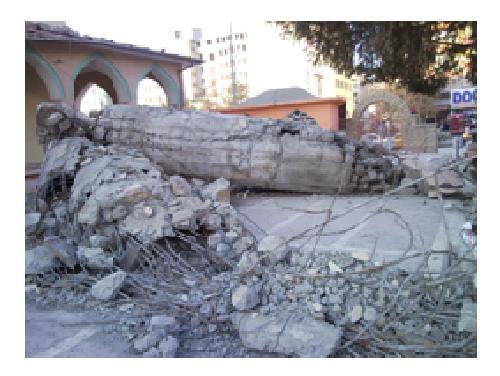
It is observed that one of the most important reasons of the damage in reinforced concrete minarets is existence of short lap splices and incorrect end hook angle. The lap splice length at the bottom of the cylindrical body was observed approximately between 60 cm and 90 cm. Also, the ends of the longitudinal reinforcement steel bars had nearly 180° end hooks. So, the combinations of plain reinforcement steel bars, inadequate lab splice length and incorrect end hook angle emerged a non-rigid and sensitive region near the bottom of the cylindrical body (Fig. 14).

Fig. 14 Examples of inadequate lab splice length and incorrect end hook angle

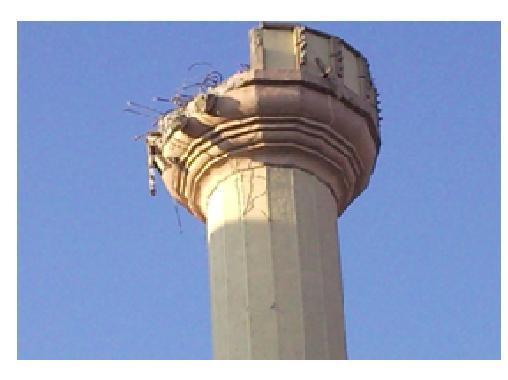
Fig. 15 An example of damage around the middle region of cylindrical body

In addition to these, the damages around the middle region of the cylindrical body have been observed in some of the reinforced concrete minarets (Fig. 15). The damages are related to some irregularities such as larger mass and stiffness concentration around these regions especially around the balconies. As seen from the Fig. 15, it is thought that longitudinal reinforcement steel bars may be lap spliced and not anchored well at this location. There is no damage at other locations. So, the lap splices creating the longitudinal reinforcements discontinuity cause of this damage.

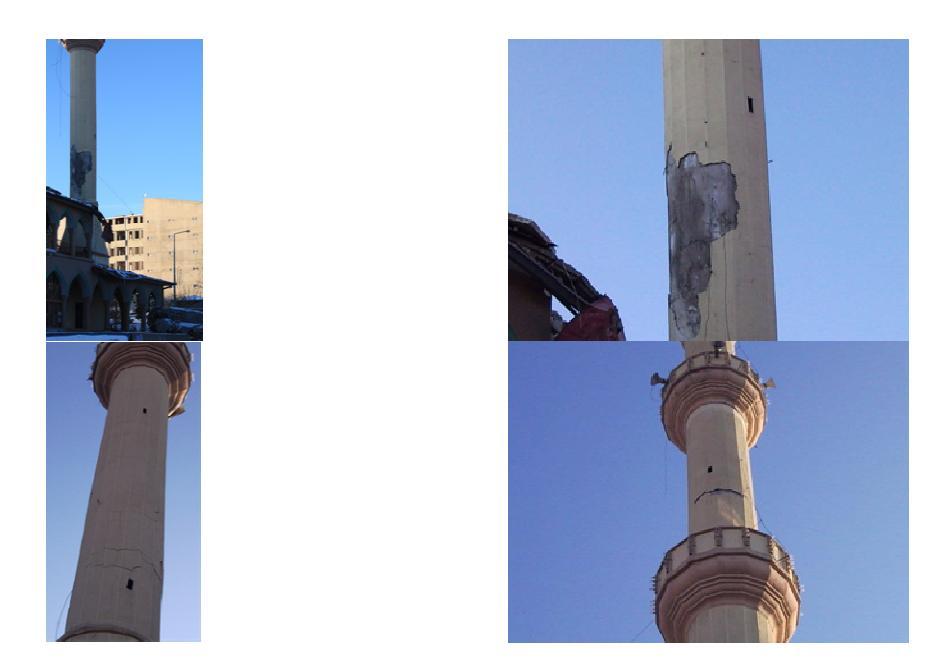
Fig. 16 Cracks occurred at the region between transition segment and cylindrical body

In addition to these, the cracks at the cylindrical body have been observed in 60-75% of the reinforced concrete minarets (Fig. 16). It is though that these minarets reflect the probable and positive behaviour. When the scientific articles related the earthquake performance of reinforced concrete minarets examined carefully, it is seen that the maximum and minimum principal stresses occurred at the region between the transition segment and the cylindrical body.

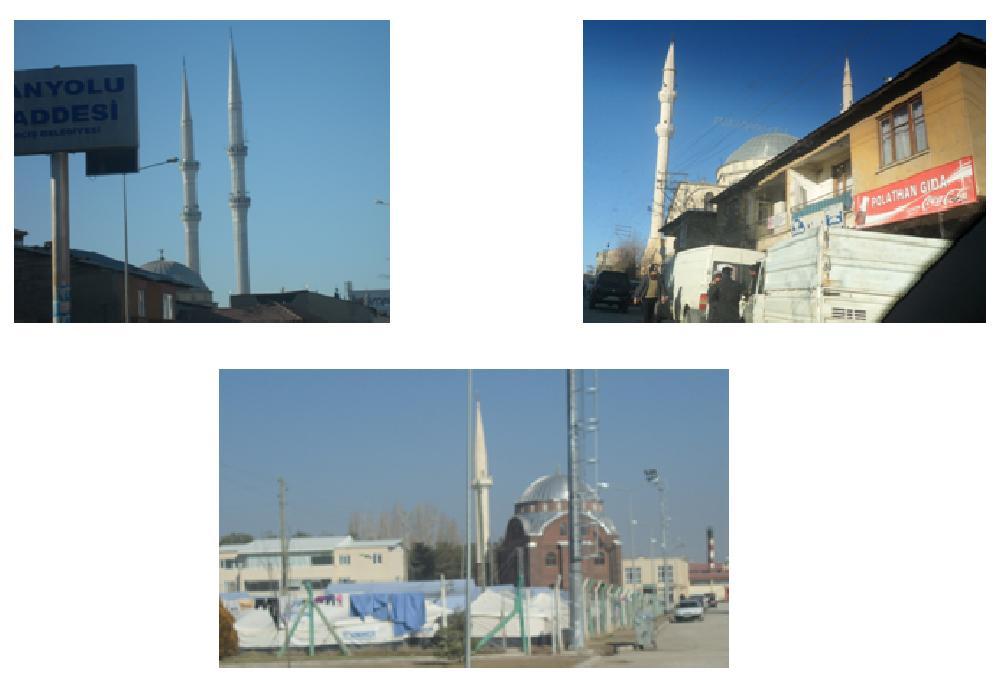
Fig. 17 Examples of undamaged reinforced concrete minarets

However, there was also some reinforced concrete minarets performed well in the affected areas. Here, only three of them are given in Fig. 17. This was mainly due to the proper care, quality of material and good workmanship during construction.

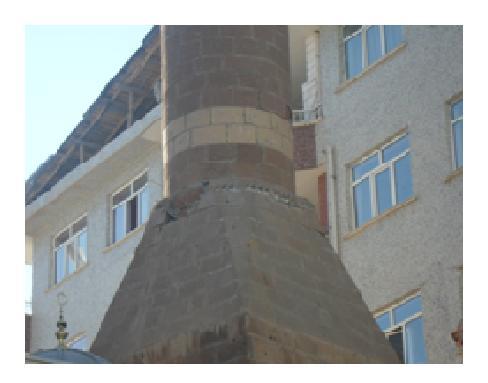
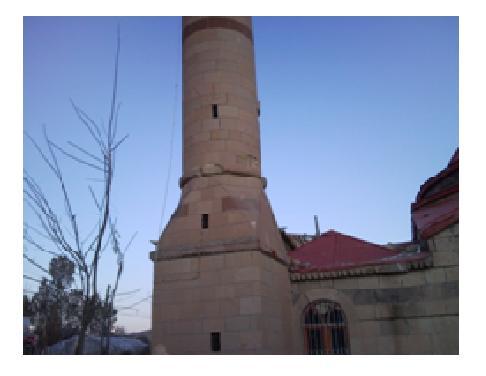
during earthquake. But transition segment, which connect the pulpit and cylindrical body, reduce the stiffness and strength of the minarets along to the height of this region. So, damages over the transition segment can be observed. Fig. 18 shows one such case where cut stones cracking and spalling was concentrated just below the cylindrical body.

Fig. 18 Examples of damages on the transition segments

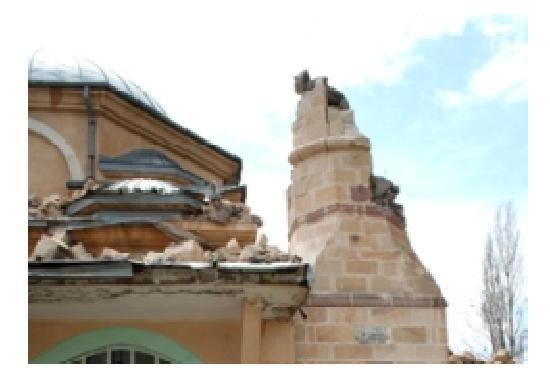
One of the most common types of the damage pattern in the masonry minarets is random cut stone cracks and spalling near the bottom of the cylindrical body. The main reason of this type of damage is reduction in the cross section from the pulpit to cylindrical body (Fig. 19).

Fig. 19 An example of failure near the bottom of the cylindrical body (URL-8)

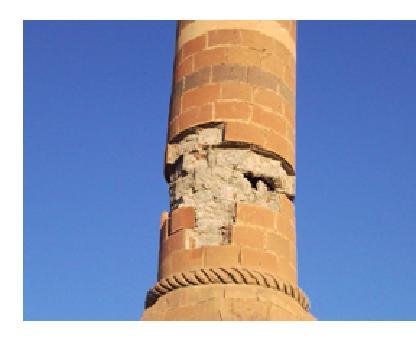
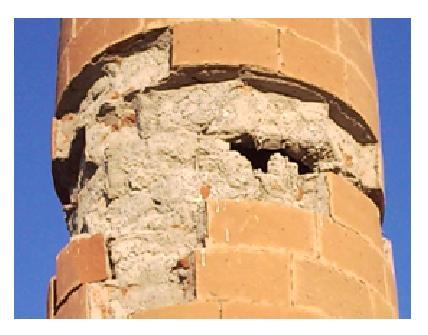
In the Turkish Earthquake Resistant Design Code, Part 5.4 (20), it is stated that "According to gross pressure area, minimum pressure strength of natural and artificial masonry units to be used in load-bearing walls shall be 5.0 MPa at least. Pressure strength of natural stones to be used in basement stories shall be 10.0MPa at least. In the case where concrete walls are constructed in basements, minimum quality of concrete to be used shall be C16 (compressive strength of 16MPa)." The use of cut stone with insufficient strength was observed in the minarets as shown in Fig. 20. This was another source of damage that may decrease the structural performance during an earthquake.

Fig. 20 Examples of the use of cut stone with insufficient strength

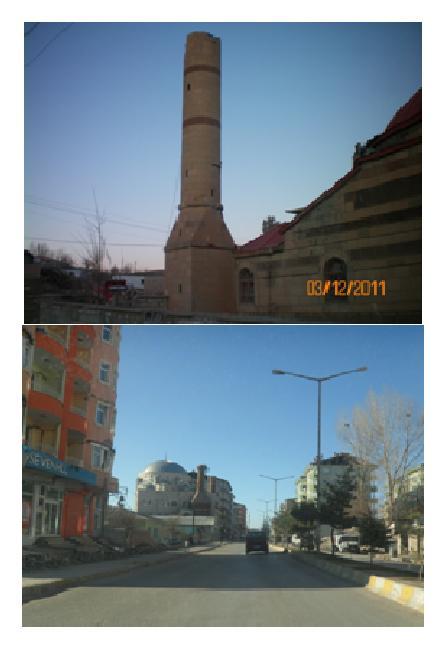
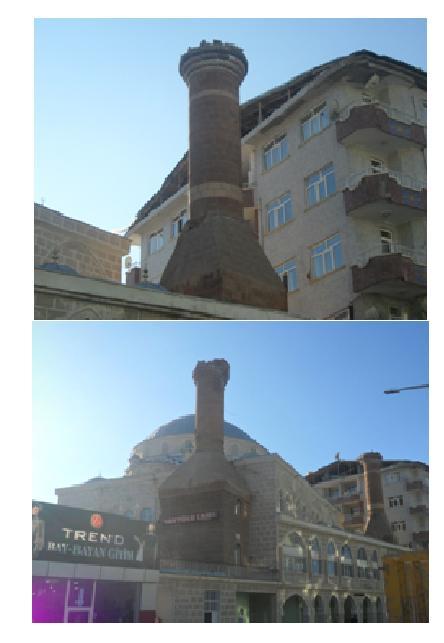
In addition to these, the damages around the middle region of cylindrical body have been observed in some of the masonry minarets (Fig. 21). The damages are related to some irregularities such as larger mass and stiffness concentration around these regions especially around the balconies.

Fig. 21 Examples of damages around the middle region of cylindrical body

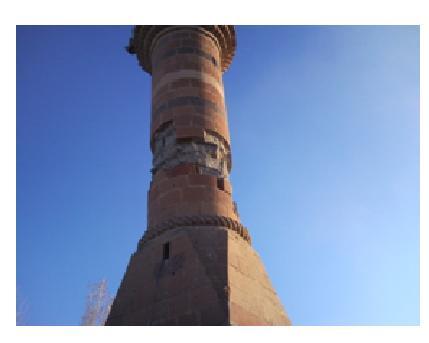
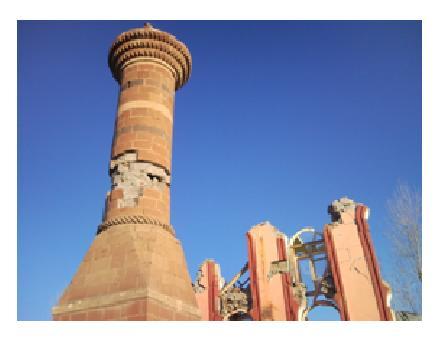
In addition to these, the failures at the cylindrical body have been observed in 60-75% of the masonry minarets (Fig. 22). It is though that these minarets reflect the probable and positive behaviour. When the scientific articles related the earthquake performance of minarets examined carefully, it is seen that the maximum and minimum principal stresses occurred at the region between the transition segment and the cylindrical body.

Fig. 22 Failures occurred at the region between transition segment and cylindrical body

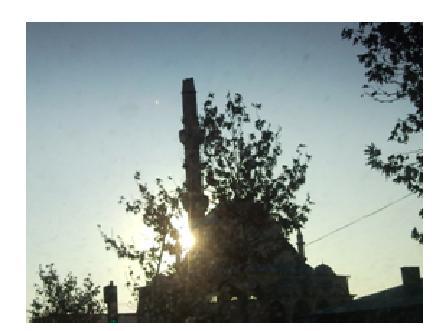
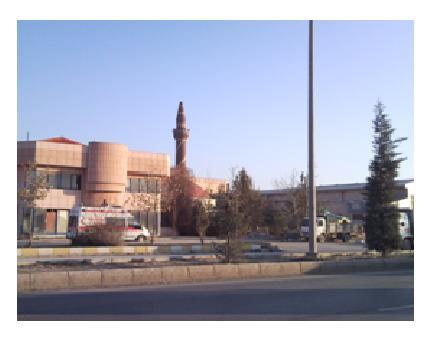
The damages and failures at the spire and end ornament have been observed in 40-60% of the the masonry minarets (Fig. 23).

Fig. 23 Example of damages and failures at the spire and end ornament

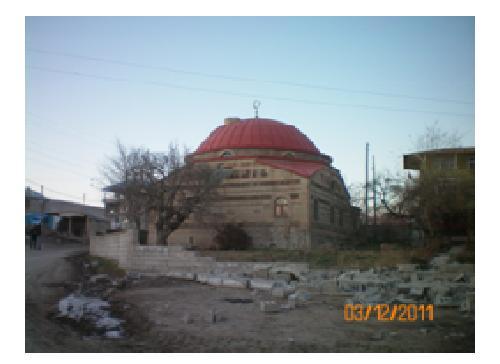
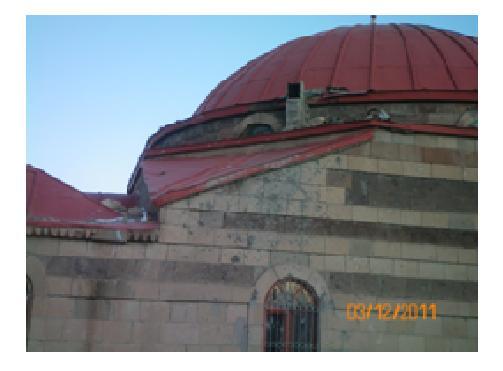
Also, some damages were observed at the connection points of mosque walls and its surroundings as shown in Fig. 24.

Fig. 24 Some damages at the connection points of mosque walls and its surroundings
