# Morphological segmentation based on edge detection-II for automatic concrete crack measurement

Tung-Ching Su<sup>1a</sup> and Ming-Der Yang<sup>\*2</sup>

**Abstract.** Crack is the most common typical feature of concrete deterioration, so routine monitoring and health assessment become essential for identifying failures and to set up an appropriate rehabilitation strategy in order to extend the service life of concrete structures. At present, image segmentation algorithms have been applied to crack analysis based on inspection images of concrete structures. The results of crack segmentation offering crack information, including length, width, and area is helpful to assist inspectors in surface inspection of concrete structures. This study proposed an algorithm of image segmentation. Several concrete pavement and building surfaces were imaged as the study materials. In addition, morphological operations followed by cross-curvature evaluation (CCE), an image segmentation technique of linear patterns, were also tested to evaluate their performance in concrete crack segmentation. The result indicates that MSED-II compared to CCE can lead to better quality of concrete crack segmenta

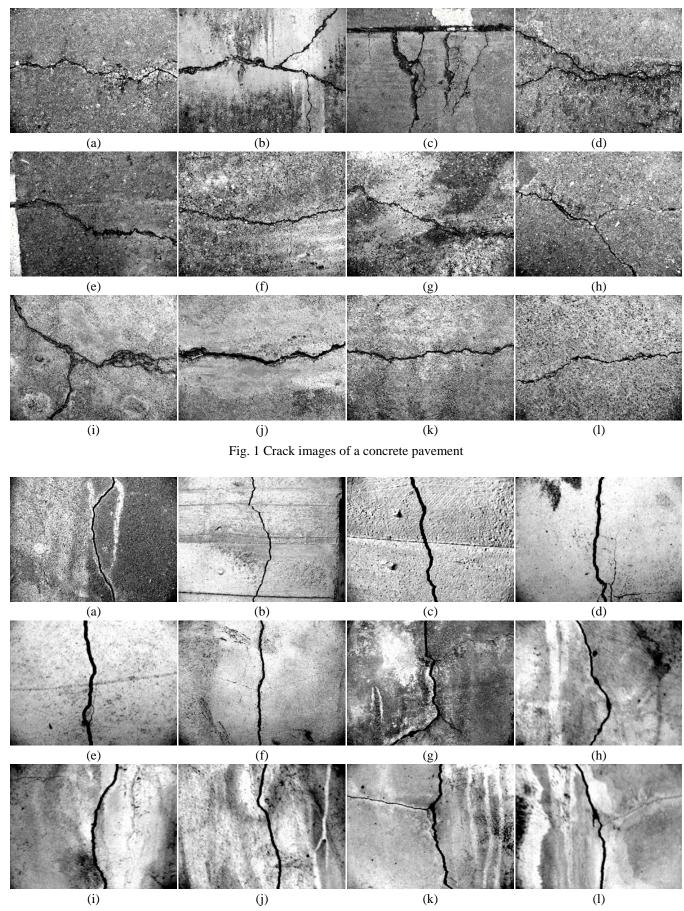
Fig. 2 Crack images of a concrete building

Cracks on concrete structure surfaces were imaged by a common digital camera, whose specifications are 3.15 M (1536×2048) pixels and adjustable focal lengths of 35 mm through 105 mm. Su (2013) considered that the characteristics of sunlight projected onto horizontal and vertical concrete surfaces are different if no accessory light is applied. Su (2013) acquired 100 inspection images of a concrete pavement as the experimental materials. Half of the 100 inspection images had a crack pattern and the other half did not, i.e., showing a clear pattern. Moreover, 33 inspection images of a concrete building were also taken as the experimental materials. Seventeen of the 33 inspection images exhibit a crack pattern and the residuals do not. The experimental result approached an optimal accuracy of 90% for crack image registration. This research furthermore selected 24 inspection images registered as crack images by Su (2013), of the concrete pavement and building surfaces, and the object distances of the inspection images are about 0.3 to 0.5 m (see Figs. 1 and 2).

where  $S_e$  represents the image segmentation result by MSED-II or CCE; and  $M_s$  expresses the image region of a true crack by manual interpretation. Figs. 4 and 5 show the manual interpretations of the true cracks for Figs. 1 and 2, respectively.

In Table 2, less than 50% of image regions of the true cracks were segmented in Images b, h, j, and l. Referring to Figs. 5 and 7, these four segmented images show that the sizes of the segmented image regions of background noises are much larger than or approximately equal to those of the true cracks. For instance, a large and strip-shaped image region, which belongs to background noise, was segmented on the right-hand side of Image b in Fig. 7 so that the Corr and Quality values were severely deteriorated. Some of the inspection images, such as Images c, e, and k, obtained higher Corr values than their corresponding Compl values. The common characteristic of the above three segmented images is that there were fewer image regions of background noises segmented. Among the 12 inspection images, Images c, d, and e obtained Quality values above 60%, and the other Quality values are also approximately between 40 and 50%. This paper demonstrated that MSED-

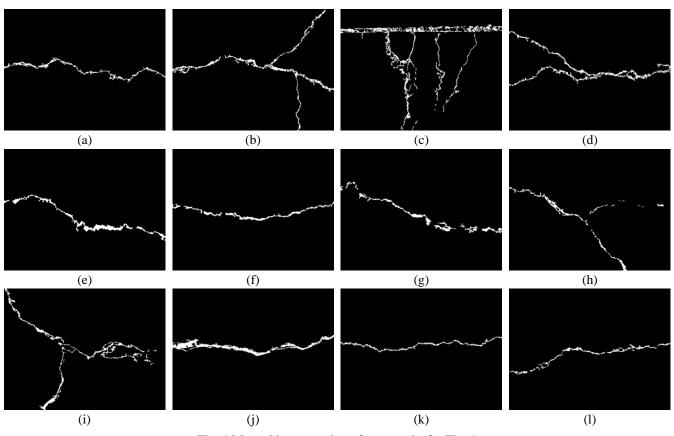
Fig. 4 Manual interpretation of true cracks for Fig. 1

In Fig. 4, Images b, c, and i display the irregular cracks, so this paper additionally applied MSED to the crack segmentation and compared the performances of MSED with MSED-II. Nevertheless, the obtained *Quality* values by MSED are between 15% and 20%, much less 45% obtained by MSED-II. The inferior crack segmentation result of MSED majorly results from many background noise (non-crack) segmentations. Thus, this experiment demonstrates the necessity of developing MSED-II.

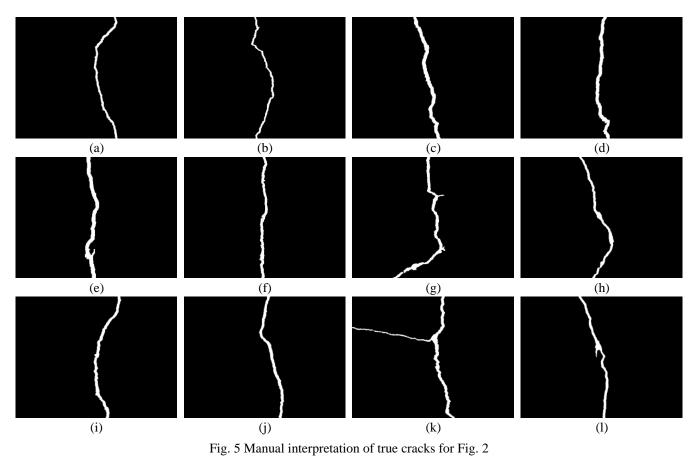
The crack segmentation results using MSED-II are shown in Figs. 6 and 7. The segmented image regions are depicted in red polylines. The performances of MSED-II in the segmentations of the concrete pavement and building cracks are evaluated as Tables 1 and 2, respectively. Tables 1 and 2 present that the *Compl* values are usually higher than the *Corr* values. This result means that most image regions belonging to true cracks can be segmented by MSED-II. However, some image regions of background noises were also segmented and reserved after the postprocessing.

In Table 1, Images a, e, g, h, k, and l exhibit that less

than 50% of image regions of the true cracks were segmented. In other words, more than 50% of image regions segmented in the above binary images belong to background noises. Referring to Figs. 4 and 6, one can find that the segmented image regions of background noises have tones as deep as the true cracks. Unfortunately, the morphological features of the segmented image regions of background noises match the post-processing's threshold, so that the non-crack patterns were also reserved. Among the 12 inspection images, Images j and g obviously obtained the highest and lowest *Quality* values, respectively, and the other *Quality* values are approximately between 40% and 50%.

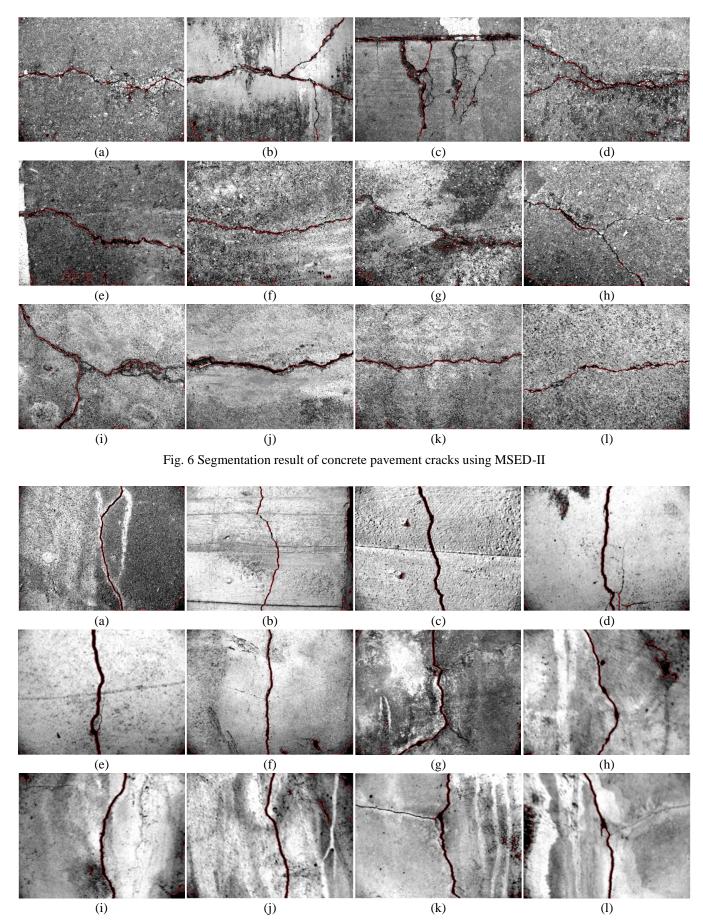
Fig. 7 Segmentation result of concrete building cracks using MSED-II

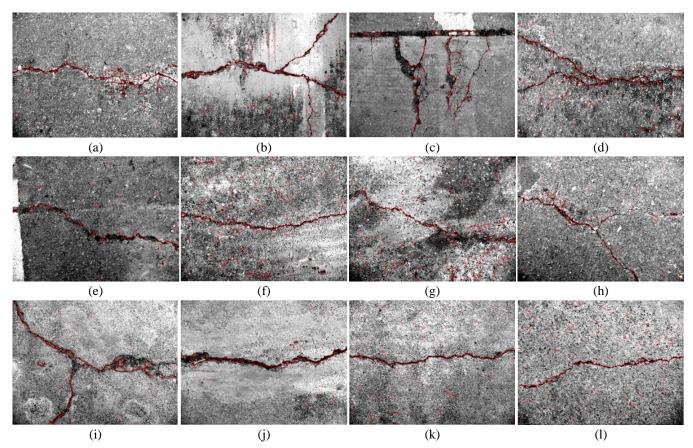
Fig. 8 Segmentation result of concrete pavement cracks using CCE

The crack segmentation results using CCE are shown in Figs. 8 and 9. Tables 3 and 4 list the performance evaluations of CCE in segmenting the concrete pavement and building cracks, respectively. In Table 3, most of the binary images also have higher *Compl* values than *Corr* values, and half the *Compl* values are above 60%. Images c and g have the lowest *Compl* and *Corr* values, respectively. Only the 23.28% of true cracks in Image c were segmented, and about 80% of the segmented image regions in Image g belong to background noises. Thus, Images c and g both obtained lower *Quality* values than the other binary images. Conclusively, the obtained *Quality* values of applying CCE to concrete pavement crack segmentation are between 20 and 40%.

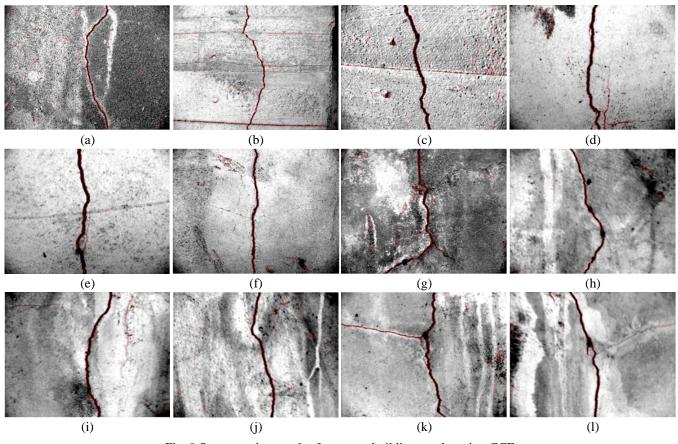
Fig. 9 Segmentation result of concrete building cracks using CCE

In Table 4, most of the binary images have higher *Corr* value than *Compl* values, running contrary to the

segmentation performance shown as Table 3. Over half the binary images have *Corr* values above 60%. Even the *Corr* value of Image e reaches 90.45%. Images j and l obtained higher *Compl* values as well as *Corr* values approximating to 70%. Thus, the above two binary images have higher *Quality* values than the others. Table 4 also shows that the lowest *Corr* value of 28.33% was evaluated for Image b, because the lateral and deep stripe of wood moldboard was segmented by CCE (see Fig. 9(b)). The segmented stripe greatly deteriorates the segmentation correctness of the true crack, but this result demonstrates that CCE is sensitive to a line-like pattern so as to be useful in thin crack segmentation.
