Seismic assessment and retrofitting measures of a historic stone masonry bridge

Abstract. The 750 m long “De Bosset” bridge in the Cephalonia Island of Western Greece, being the area with the highest seismicity in Europe, was constructed in 1830 by successive stone arches and stiff block-type piers. The bridge suffered extensive damages during past earthquakes, such as the strong M7.2 earthquake of 1953, followed by poorly-designed reconstruction schemes with reinforced concrete. In 2005, a multidisciplinary project for the seismic assessment and restoration of the “De Bosset” bridge was undertaken under the auspices of the Greek Ministry of Culture. The proposed retrofitting scheme combining soil improvement, structural strengthening and reconstruction of the deteriorated masonry sections was recently applied on site. Design of the rehabilitation measures and assessment of the pre- and post-interventions seismic response of the bridge were based on detailed in-situ and laboratory tests, providing foundation soil and structural material properties. In-situ inspection of the rehabilitated bridge following the strong M6.1 and M6.0 Cephalonia earthquakes of January 26th and February

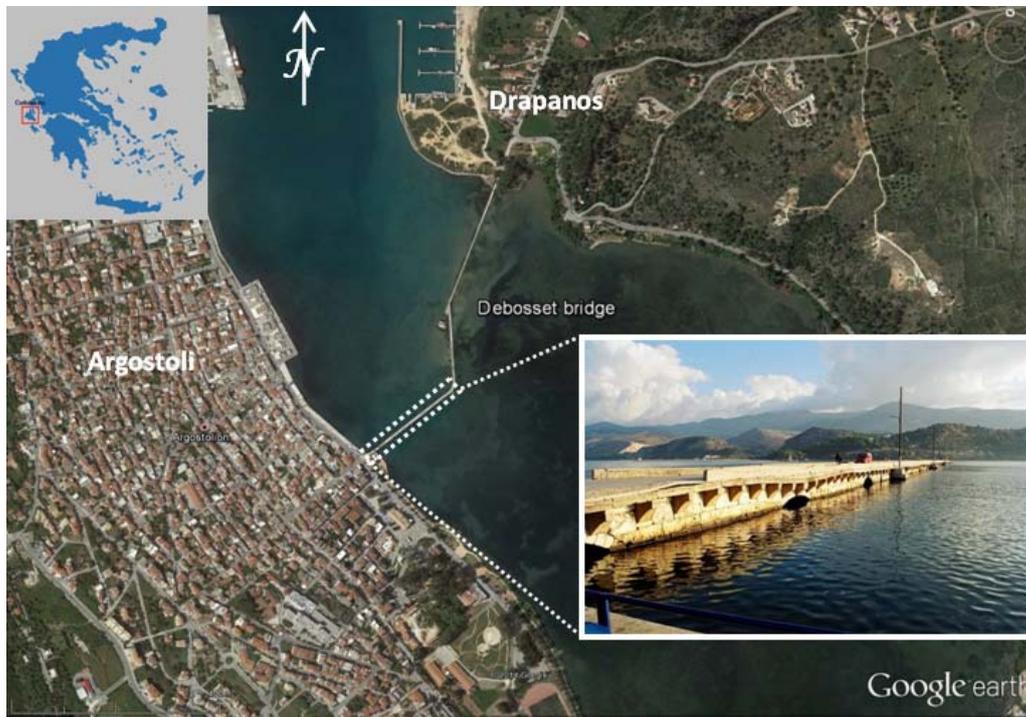
Fig. 1 Overview of the old stone masonry 750 m long “De Bosset” bridge in Cephalonia island connecting the city of Argostoli with the opposite shoreline (Drapanos) (Google earth image)

Originally constructed in 1830 by successive stone arches founded on stiff block-type stone piers, the historic multi-span stone masonry “De Bosset” bridge connects the shorelines of Argostoli and Drapano at the southern side of the Argostoli bay (Fig. 1). The bridge has a total length of 750 m and its height varies between 2 to 4 m along its longitudinal axis. The foundation area of the bridge piers is approximately equal to 10 m long and 5 m wide. The severe M_s7.2 earthquake of 1953 (Papazachos 1997) induced extensive deformations of the deck and differential settlement of the piers (Fig. 2(a)). The characteristic failure mechanism of old stone bridges related to out-of-plane collapse of the arch walls and filling material (Griffith *et al.* 2003) is evident in Fig. 2(b). Major parts of the bridge were totally reconstructed during the period of 1960 to 1970. The original stone sections and the filling material of the bridge were removed (Fig. 2(c)). A new

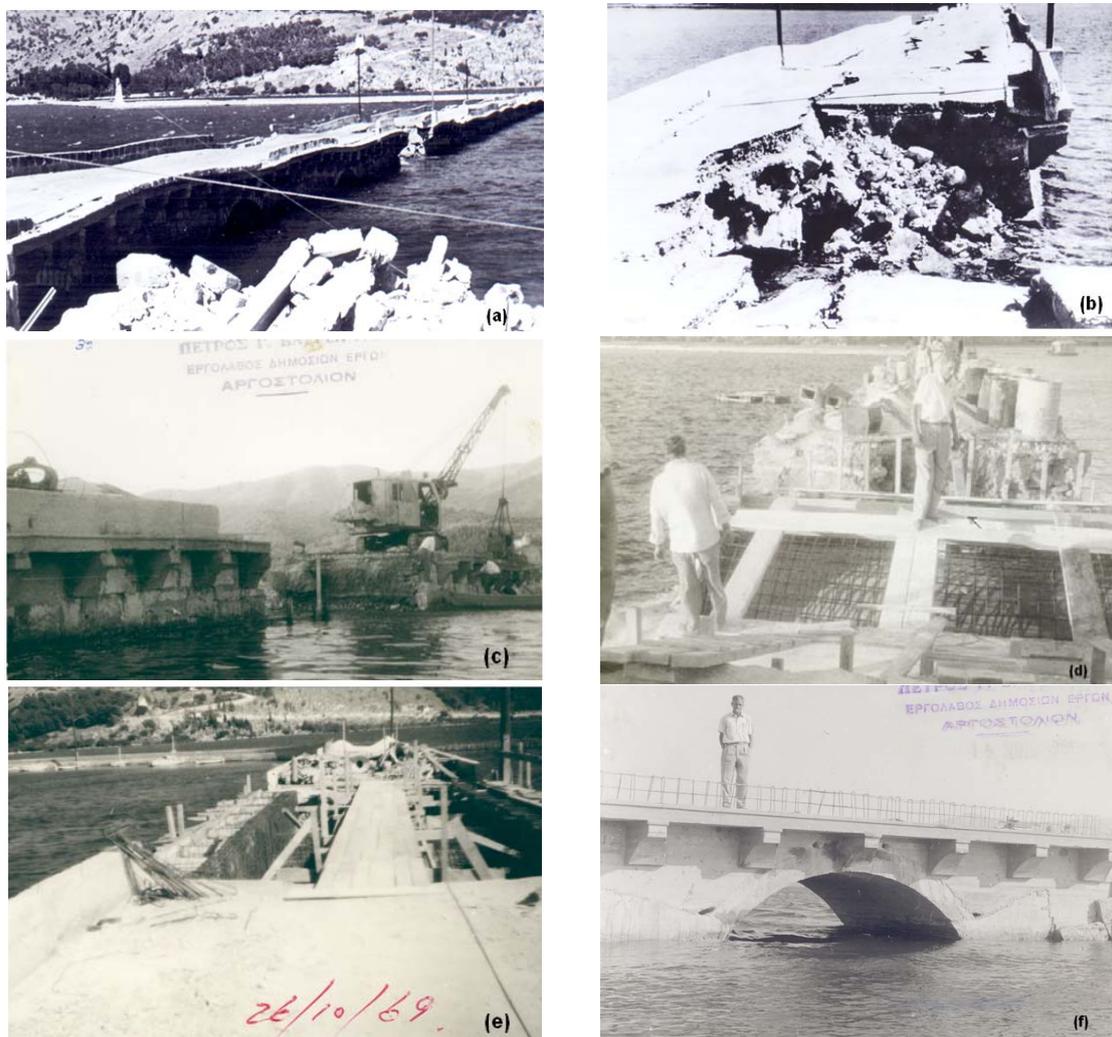
Fig. 2 (a), (b) Extensive damages to the “De Bosset” bridge due to the severe $M_s 7.2$ earthquake of 1953, including lateral deformations and differential settlement of the deck and out-of-plane collapse of the arch walls and filling material; (c)-(f) partial reconstruction of the bridge with reinforced concrete during the period 1960-1970; (c) removal of the original stone sections and the filling material; (d), (e) placement of the reinforcement forming the original shape of the bridge arches (f) a typical arch of the bridge reconstructed with reinforced concrete

reinforcement mesh was installed to form the arch-shaped sections of the bridge (Fig. 2(d)) and two new concrete spandrel walls of approximately 40 cm width were cast in place (Fig. 2(e)). In this manner, the original architectural pattern of the bridge was reproduced by reinforced concrete (Fig. 2(f)) while modifying substantially the material homogeneity and structural stiffness of the bridge. However, the extent of the above interventions along the longitudinal axis of the bridge is unknown since the authentic dry stone material was preserved in some sections of bridge including the first two arches close to the city of Argostoli. The latter is illustrated in the photogrammetric mapping of a part of the western façade of the bridge shown in Fig. 3.

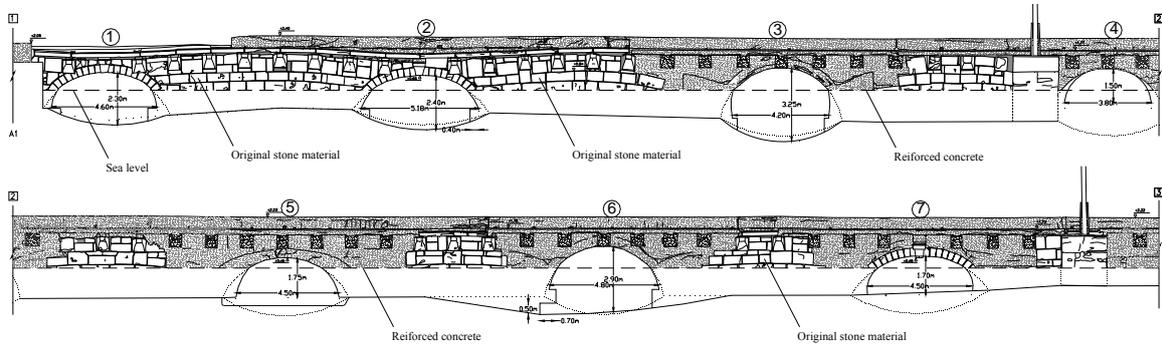
Fig. 3 Western façade of the bridge along the first seven arches close to Argostoli city based on photogrammetric mapping (The photogrammetric study was conducted in 2002 by the Photogrammetry Lab of the School of Rural and Surveying Engineering of the National Technical University of Athens)

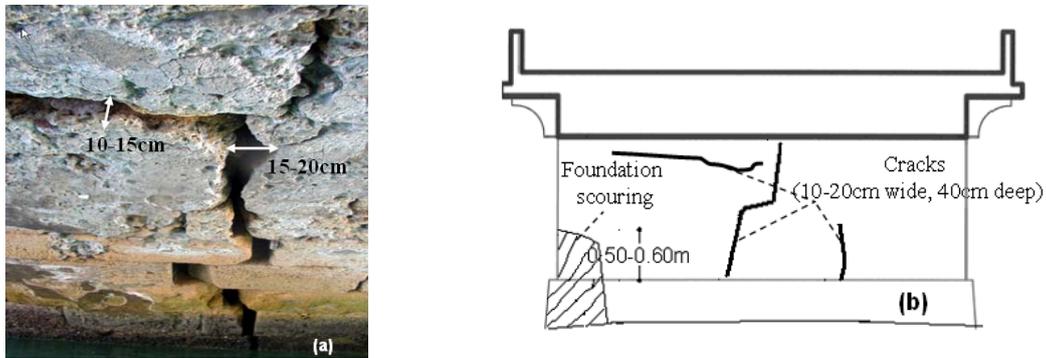
Fig. 4 Typical findings during the in-situ inspection of the bridge pathology in 2005: (a) Extensive longitudinal and transverse cracks in the tensile zones under the arches and (b) foundation scouring of the piers base

In 2005, a multidisciplinary research project for the seismic assessment and restoration of the “De Bosset” bridge was undertaken by the Laboratory of Soil Mechanics, Foundation and Geotechnical Earthquake Engineering (LSMFGEE) of the Aristotle University of Thessaloniki (Pitilakis 2006) and supervised by the Directorate for the Restoration of Byzantine and Post-byzantine Monuments of the Greek Ministry of Culture. A series of in-situ inspections and laboratory tests on concrete and stone specimens was performed to obtain a detailed knowledge of the bridge pathology and strength. With reference to structural defects, extensive cracks up to 20 cm wide and 40 cm deep were recorded in the tensile zones under the arches (Fig. 4(a)). An underwater inspection revealed large foundation scouring up to 1m deep in most of the bridge

piers (Fig. 4(b)), due to strong sea currents within the Argostoli bay. The original stone masonry material was highly deteriorated by deep corrosion, loss of mass and poor condition of joint mortars. Delamination and detachment of covering was observed for the concrete sections. Laboratory tests on concrete specimens revealed a substantially low compressive strength corresponding to concrete category C8/10, whereas the effective cross section of the reinforcement bars was reduced to almost one half of the original section area. Mean values for the static modulus of elasticity were measured at 10 GPa. Further details on the above experimental data may be found in Papayianni *et al.* (2007).

Mention has already been made to the extensive longitudinal and transversal cracks that were observed under the stone arches, indicating poor structural stability. The fracture line method reported in Erdogmus and Boothby, 2004 was employed to evaluate the transverse strength of the bridge under seismic loading. The above method is originated from the yield line theory that has been adopted in code provisions (British Standards 1992) for unreinforced masonry design. In this case, the spandrel wall is considered as a retaining wall of the material fill volume above the arch, inducing active-state pressures as applied loads. In fracture line analysis, the yield lines on a surface, representing axes of rotation, are the equivalent of hinges on a beam that occur when the plastic bending moment is reached (Erdogmus and Boothby 2004). The bending moment producing rupture is assigned to all points along a hinge line. The selected fracture line pattern representing the failure mechanism, depends on the boundary conditions, geometry and material properties of the problem at hand. In the case of the “De Bosset” bridge, the assumed fracture line pattern is shown in Fig. 9, resembling the out-of-plane collapse of the spandrel walls caused by the 1953 earthquake (Figs. 2(a) and 2(b)). According to the above method, the maximum allowable pressure q_{max} , referring to the transverse strength of the wall, may be estimated from the equivalence of external and internal work

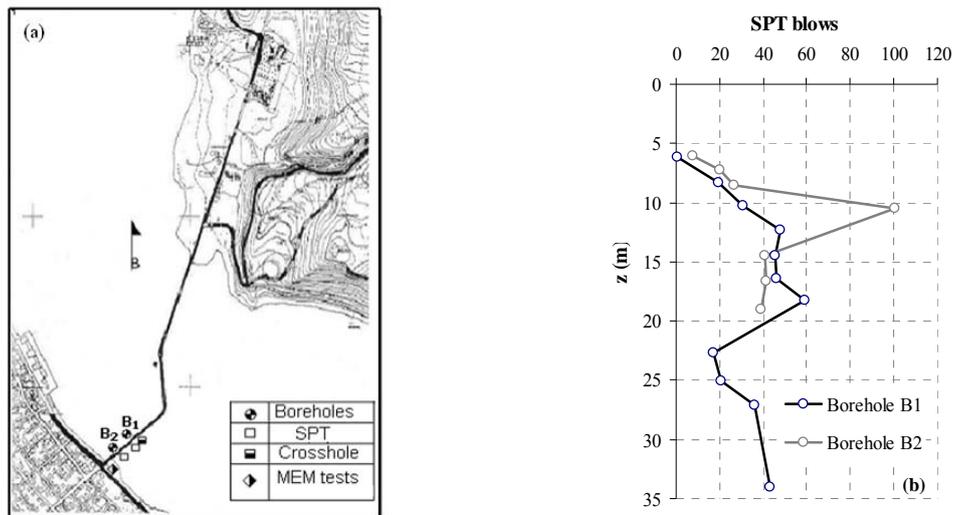
Fig. 5 (a) Geotechnical and geophysical tests performed along the “De Bosset” bridge in 2005, (b) SPT test results obtained at B1 and B2 boreholes location

The geotechnical and geophysical field campaign comprised of geotechnical borings, Standard Penetration Testing (SPT), Cross-Hole Seismic (CH) and Microtremor Array Measurements (MAM) at selected locations along the bridge shown in Fig. 5(a). SPT profiles at boreholes B1 and B2 are plotted in Fig. 5(b). The field surveys were complemented with laboratory tests to provide the mechanical and the dynamic properties of the foundation soil. The geotechnical cross section of the bridge site obtained from the in-situ surveys is illustrated in Fig. 6. The local sandstone, which can be considered as the seismic bedrock with shear wave propagation velocity (V_s) larger than 1000 m/s, is found at a depth of about 35 m. It is overlaid by a soft silty clay layer of low shear strength with V_s varying between 140 and 170 m/s. The measured angle of friction (ϕ_u) and cohesion (c_u) of the surficial layer under undrained loading conditions are 3° and 26.1 KPa, respectively, while the average plasticity index (PI) is 30%. Considering the above characteristics, the foundation soil of the bridge should be classified as soil type D (i.e., soft clays of high plasticity index and thickness higher than 10 m) according to the Greek Seismic Code (EAK2000). Resonant column tests provided shear modulus (G) degradation and hysteretic damping ratio (D) curves of the soil layers with increasing shear strain (γ). The latter were adopted in equivalent linear soil response analyses, presented in the ensuing.

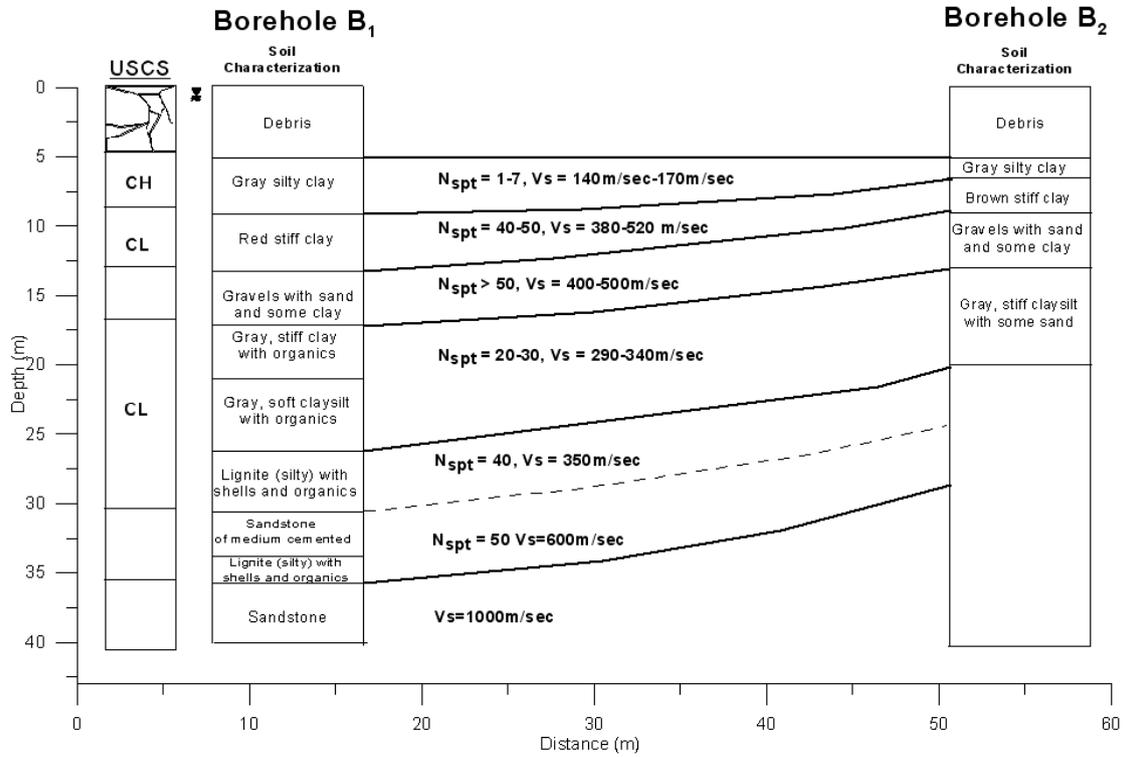
Fig. 6 Geotechnical cross section of the bridge foundation soil along the line B1-B2 shown in Fig. 5(a)

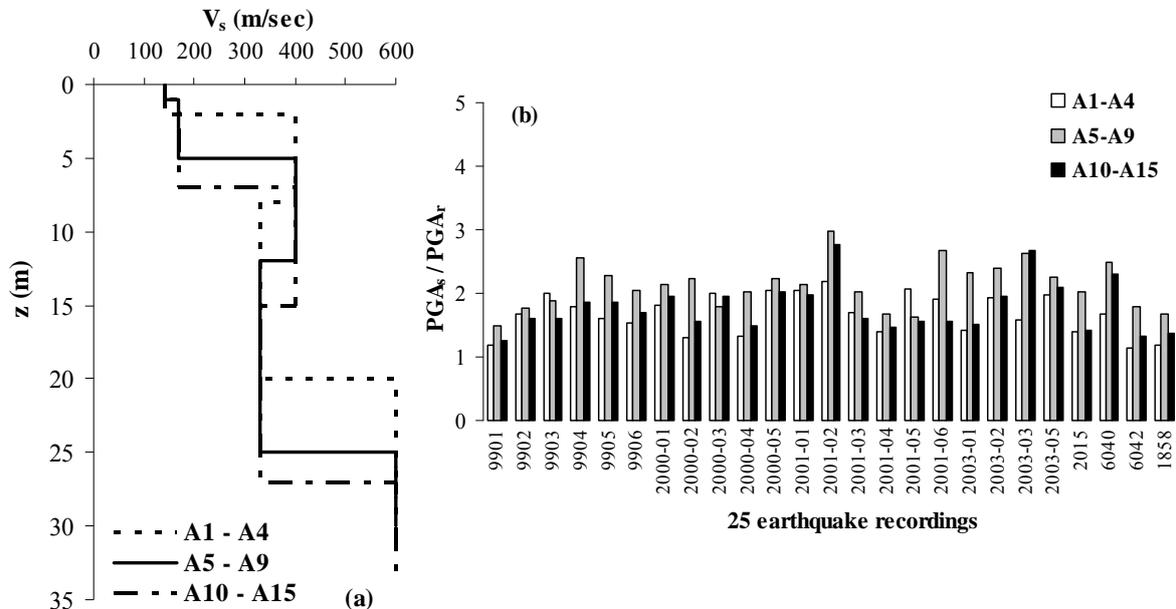
Fig. 7 (a) Shear wave propagation velocity (V_s) profiles to account for variation of V_s along the bridge longitudinal axis. (b) Surface-to-bedrock peak acceleration ratios (PGA_s / PGA_r) at the bridge site for each one of the 25 selected earthquake recordings

The corresponding surface-to-bedrock peak acceleration ratios (PGA_s/PGA_r) are plotted in Fig. 7(b). Each code name in the abscissa of the graph refers to a selected earthquake event. A mean PGA_s/PGA_r ratio at 1.7 was revealed, corresponding to a mean peak horizontal acceleration of 0.6 g at the ground surface of the bridge soil profile. It is noted that, stronger amplification of the seismic motion from bedrock to ground surface was observed for the deeper soil models “A5-A9” and “A10-A15”. Figs. 8(a) and 8(b) shows the normalized acceleration response spectra computed at the bedrock and the ground surface, respectively, referring to the “A1-A4” shear wave velocity model. The high frequency content of the computed earthquake motions is reflected in the mean response spectrum compared with the elastic design spectrum of EAK2000 and EC8 (CEN 2002) for soil category D and C, respectively. Surface-to-rock outcrop transfer functions obtained from the equivalent linear analyses are compared in Fig. 8(c). The analytical solution reported in Roesset (1976) for a multi-layer damped ($d=10\%$) soil is also plotted, denoting a fundamental frequency (f_0) of the bridge soil deposit at 4 Hz under linear viscoelastic considerations. Evidently, the degradation of soil stiffness and damping increase with increasing shear strains γ shifted f_0 to lower frequencies in the range of 2.5 to 3.5 Hz, depending on the frequency characteristics of the input motion.

the soil profile at the CH station. Acceleration time histories computed at the bedrock level are plotted in Figs. 18(a) and 18(b), having peak values at 0.174 g and 0.146 g for the earthquake events of 01/26/2014 and 02/03/2014, respectively. The deconvoluted rock motions were then specified at the base of the bridge soil profile to compute the seismic response at the ground surface of the bridge site by means of equivalent linear soil response analysis (Modaresi and Foerster 2000). Figs. 18(c) and 18(d) show the computed acceleration time histories at the ground surface of the bridge site with peak values equal to 0.371 g and 0.251 g for the first and the second earthquake, respectively. The corresponding surface-to-bedrock peak ground acceleration ratio is close to two, in agreement with the mean amplification ratio obtained during the design of the rehabilitation measures (Fig. 7(b)).

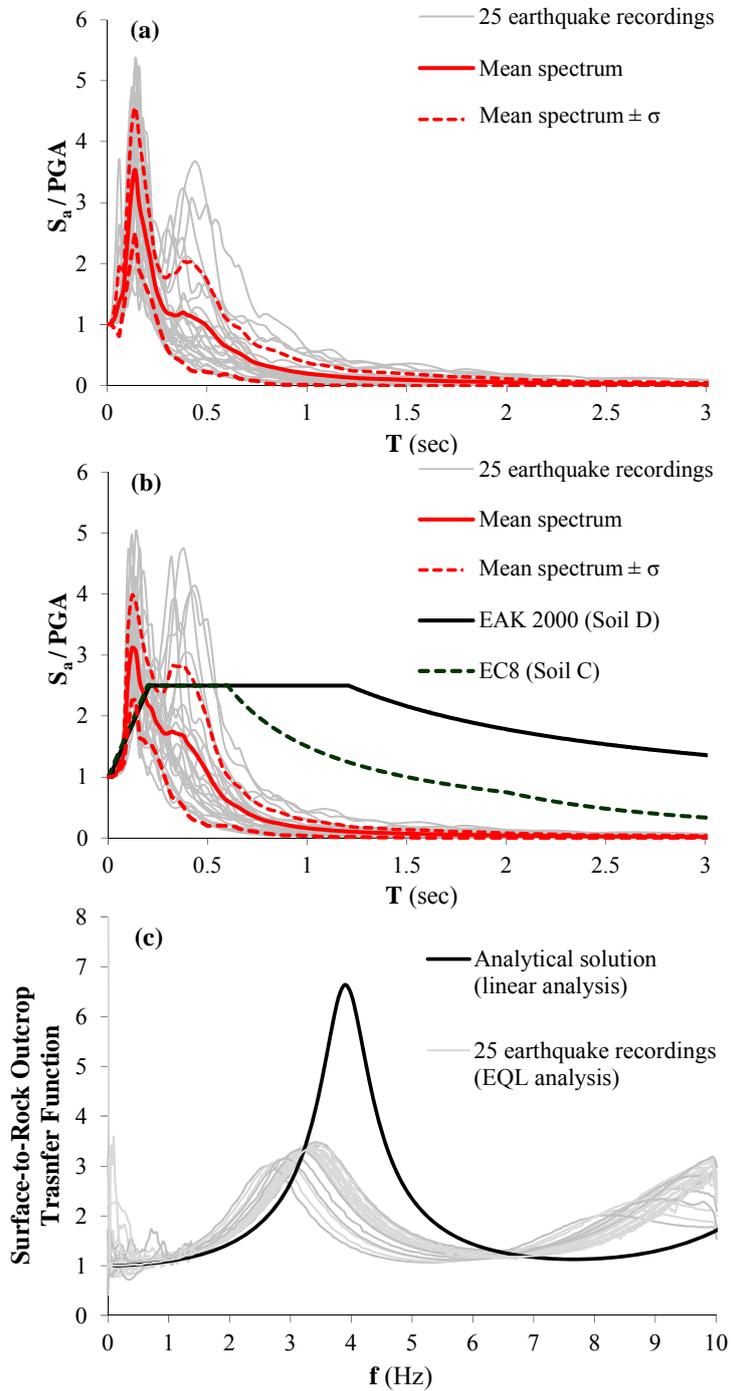
Fig. 8 Normalized acceleration response spectra at (a) bedrock level and (b) ground surface of the bridge soil profile computed from equivalent linear soil response analysis. EAK2000 and EC8 normalized elastic spectrum corresponding to soil category D and C, respectively, are also plotted. (c) Comparison of surface-to-rock outcrop transfer functions between damped ($d=10\%$) linear elastic solution (Roesset 1977) and equivalent linear analyses. The graphs refer to the “A1-A4” V_s model

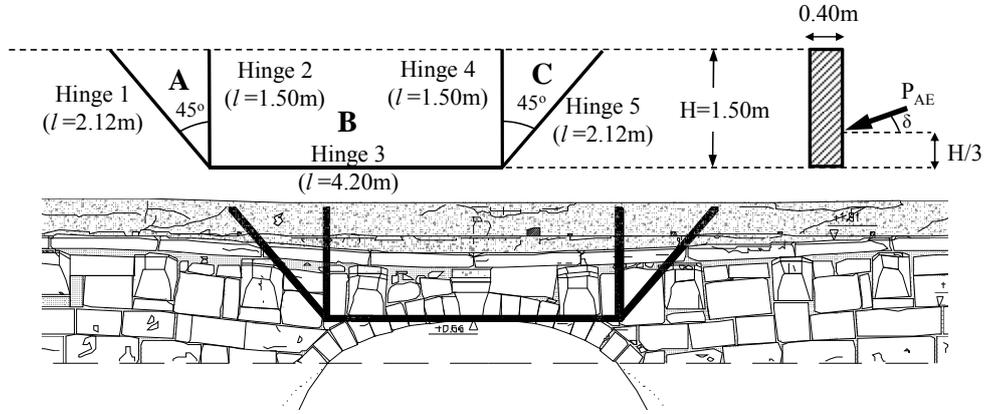
Fig. 9 Assumed fracture line pattern of a typical bridge arch for estimating transverse load effects by means of the fracture line method reported in Erdogmus and Boothby (2004). The adopted fracture line pattern resembles that of the out-of-plane collapse pattern of the “De Bosset” induced by the 1953 earthquake

With reference to the external seismic loading imposed on the bridge spandrel wall, the resultant lateral active thrust P_{AE} (Fig. 9) is estimated by implementing the Mononobe-Okabe approach (Okabe 1924, Mononobe and Matsuo 1929). For this reason, the coefficient of horizontal acceleration (k_h/g) of the backfill was set at 0.6, taking into account the abovementioned mean peak horizontal acceleration computed at the ground surface of the bridge soil profile, whereas the coefficient of vertical acceleration (k_v/g) was set at $0.42k_h$.

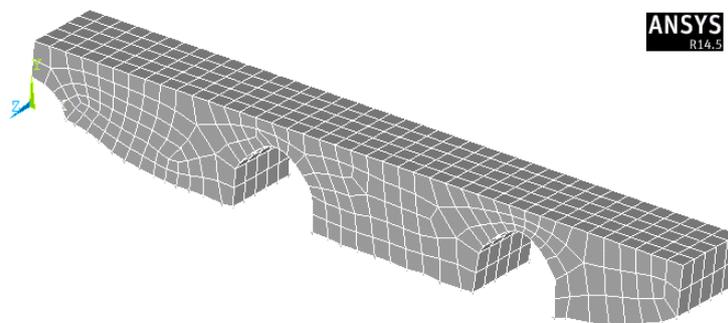
Fig. 10 Three-dimensional finite-element model of a representative part of the “De Bosset” bridge adopted for the stress-based analysis of the bridge seismic response

Within a second, more rigorous analysis stage of the bridge seismic response, a three-dimensional finite element model was analyzed in the frequency domain by implementing the finite-element code ANSYS (ANSYS 2001). In order to reduce computational cost, a representative part of the bridge (Fig. 10) was modelled with proper boundary conditions to obtain equivalent modal characteristics with the whole bridge (Rovithis *et al.* 2006, Rovithis and Pitilakis 2011). Cubic elements were employed to reproduce the actual geometry of the bridge by assuming perfect bonding between the elements in the framework of a stress-based analysis. The mean value of the elastic modulus of elasticity (E_s) obtained from laboratory tests at 10 GPa was adopted as a modelling approximation of the cracked and heterogeneous material of the bridge (OPCM 3274, 2005). Both fixed- and flexible-base models were analyzed to investigate soil-structure interaction

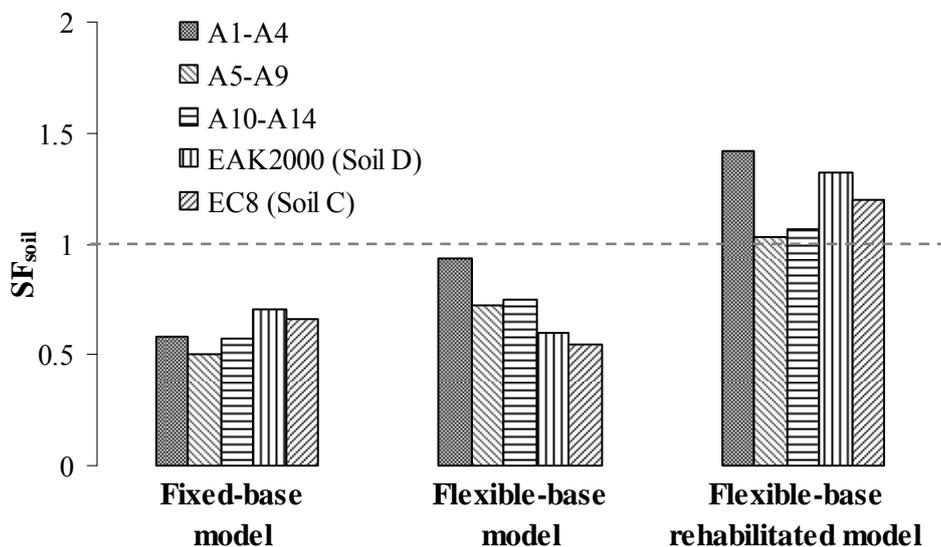
Fig. 11 Safety factor against bearing capacity of the bridge foundation soil; fixed-base model, flexible-base bridge model before the rehabilitation measures and flexible-base model after the rehabilitation measures. Each bar refers to a different spectrum loading derived from soil response analysis (A1-A4, A5-A9 and A10-A14 soil profiles) and code regulations (EAK2000 elastic spectrum for soil category D and EC8 elastic spectrum for soil category C)

Having identified the vibrational characteristics of the bridge, a series of response spectrum analyses were performed to estimate the vertical stress field under the bridge piers. The mean acceleration response spectra specified at the base of the bridge models were those computed from the free-field ground response analyses. Code-defined elastic spectra were also implemented as a conservative loading in the transverse direction (Rota *et al.* 2005). The mean vertical stress developed under the foundation area of a typical pier was compared with the bearing capacity of the foundation soil which in turn was computed from the available geotechnical data. The corresponding safety factor (SF_{soil}), referring to the ratio of the bearing capacity of the bridge foundation soil over the mean vertical stress developed under the bridge piers, is plotted in Fig. 11, for fixed- and flexible-base conditions, respectively. Each bar in the graph refers to a different loading spectrum obtained from soil response analysis (“A1-A4”, “A5-A9” and “A10-A14” soil profiles) and code regulations (EAK2000 elastic spectrum for soil category D and EC8 elastic spectrum for soil category C). The deviation between fixed- and flexible-base model reflects the effect of soil-structure interaction on the vibrational characteristics of the structure and consequently on the imposed seismic loading. With reference to the pre-rehabilitated bridge, the safety factor related to the bearing capacity of the bridge foundation soil is below unity for both fixed- and flexible-base cases.

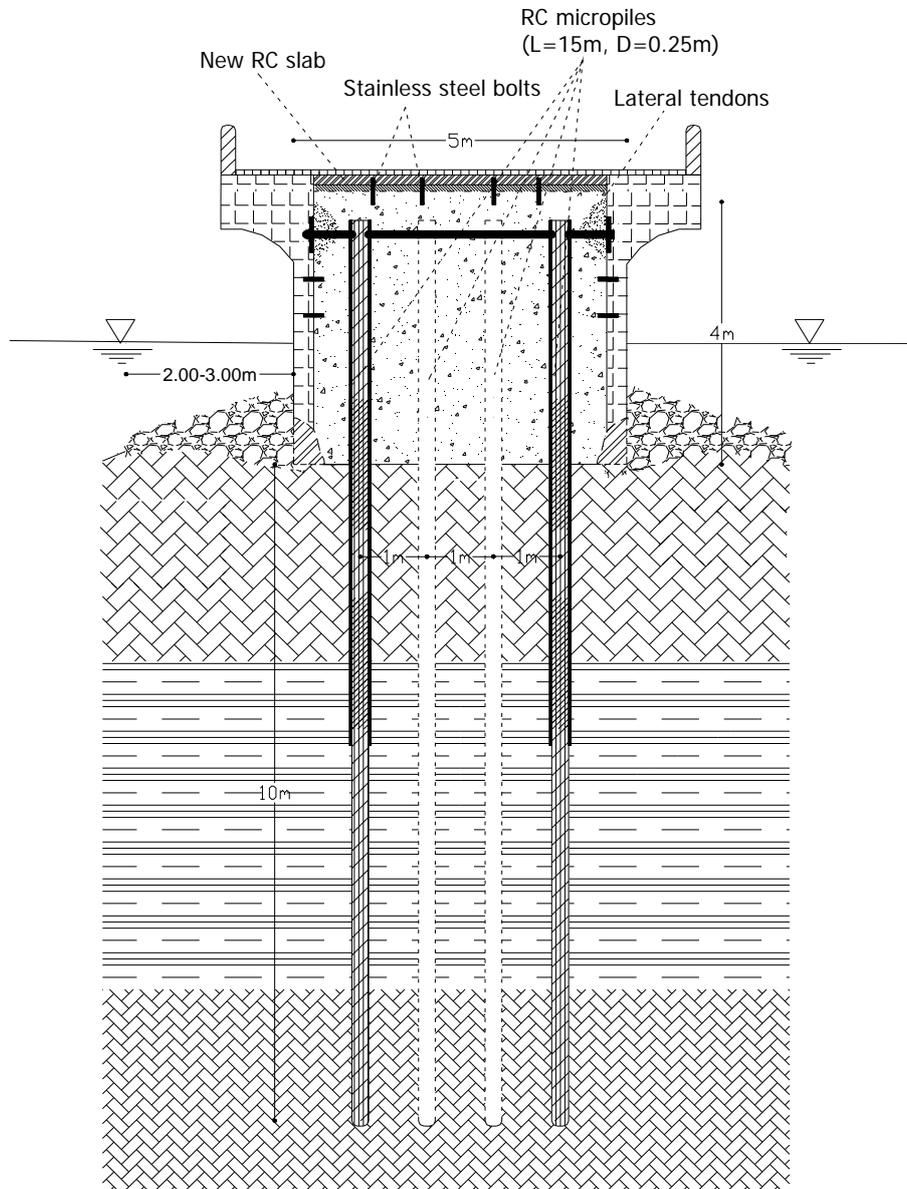
Fig. 12 Typical cross-section of the rehabilitated “De Bosset” bridge showing the proposed intervention measures

In this regard, the adopted rehabilitation scheme shown in Fig. 12 was based on the following design concepts: (a) maintenance of the monumental features of the bridge by partial or total

restoration of the detached stones and the concrete facades with local stones being compatible with the authentic material, (b) increase of the bridge transverse strength with highly-resistant mortar to connect the new stone elements and closely spaced stainless steel lateral tendons to confine the bridge spandrel walls along the longitudinal direction, (c) improvement of the foundation soil by a group of micropiles, designed as a complementary load-transfer mechanism, while increasing the bearing capacity of the foundation soil and (d) protection of the piers base against future scouring with stone-gravel material.

With reference to the foundation soil improvement, the final design of the rehabilitation measures (Pitilakis 2006) yielded for each bridge pier a group of twenty-two micropiles, drilled from the bridge deck until the stiff gravel-sand layer found at -10 m (Fig. 6). The pile diameter (D), the normalized pile spacing (S/D) and the pile length to pile diameter ratio (L/D) were set at 0.25 m, 8 and 60, respectively. The axial load capacity of each pile is 340 kN and 270 kN, referring to pile shaft friction and pile tip resistance, respectively, whereas the design axial load for each pile was computed at 300 kN for combined gravity and seismic loads. Given that shaft friction is considered as the main resisting mechanism of the micropiles, within the context of the proposed soil strengthening intervention, the above pile group configuration provides safe transmission of the bridge loads, by increasing the overall bearing capacity of the soil-micropiles group system. Piles longitudinal reinforcement detailing is composed of 12 steel bars of 16 mm diameter whereas piles transverse reinforcement is formed by 8 mm diameter spiral stirrups placed every 10 cm along the pile shaft. More densely-spaced stirrups were designed for the piles transverse reinforcement at the level of the bridge base and the interface between soil layers with different stiffness. Regarding strengthening of the bridge monolithic behaviour in the transverse direction, the design of the rehabilitation measures resulted in a series of 20 mm diameter stainless

steel lateral tendons placed every 1.5 m along the longitudinal axis of the bridge and a new lightly-reinforced concrete slab of 15 cm thickness connected to the original bridge structure through a mesh of stainless steel bolts, allowing for light traffic on the bridge deck. The connection between the new reinforced concrete slab and the piles was deliberately avoided to ensure low bending moments at the piles heads.

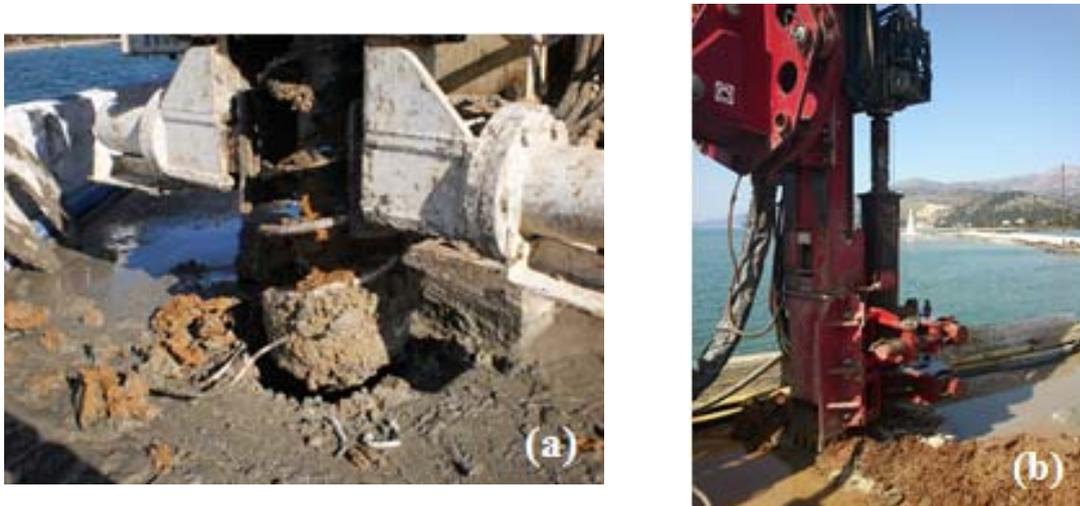
Fig. 13 (a) Filling material of the bridge composed of soil, sparse steel bars and debris that was revealed during restoration works (b) Steel tubes embedded consecutively to prevent debris fall inside the borehole during the drilling of the micropiles

applied at the bridge site. During implementation of the rehabilitation measures, a number of unfavourable site conditions were revealed. More specifically, it was found that the filling material between the longitudinal spandrel walls was extremely heterogeneous composed of soil, sparse steel bars and debris (Fig. 13(a)), making the drilling and the construction of the micropiles particularly difficult. In order to stabilise the sidewalls of the boreholes, steel tubes of 30 cm diameter were employed to prevent debris fall inside the borehole (Fig. 13(b)). Piles reinforcement was introduced through PVC tubes placed within the steel tubes.

The PVC tubes were not removed after casting the micropiles to protect them from strong sea currents. The above technical solution allowed drilling of the micropiles group based on the original design (Fig. 14(a)). For the old stone sections of the bridge, the stainless steel lateral tendons were anchored to new stone walls constructed in the inner side of the stone facades (Fig. 14(b)). With reference to the architectural interventions, the original stone facades of the bridge

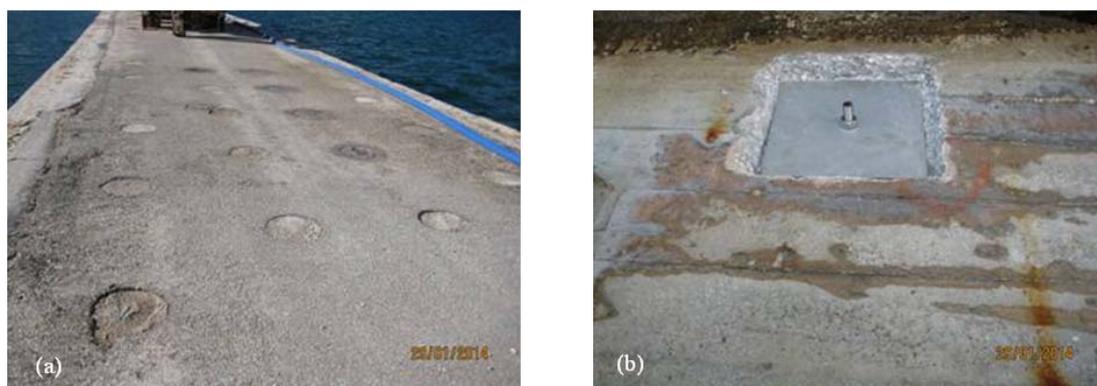
Fig. 14 (a) Group of micropiles drilled from the bridge deck (b) Steel plate embedded in the lateral façades of the bridge for anchoring the stainless steel tendons

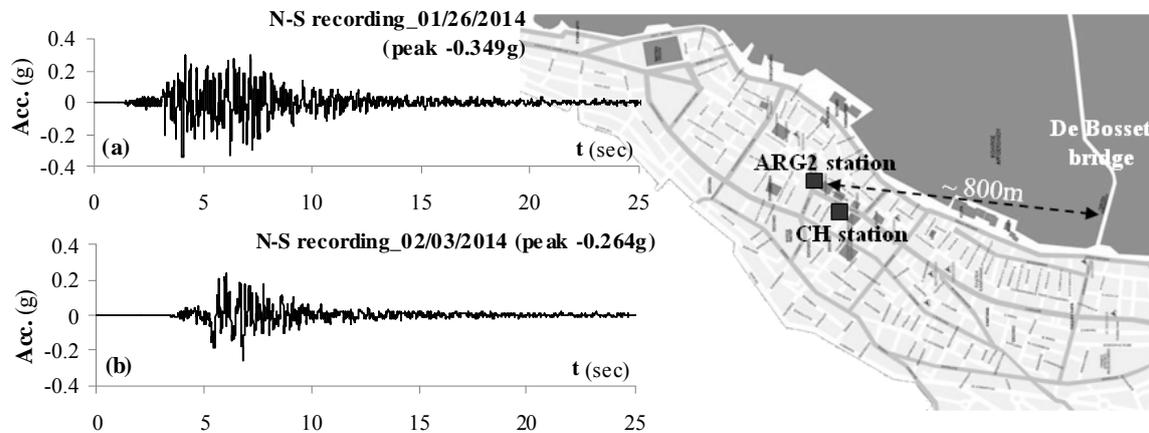
Fig. 15 Acceleration time histories (N-S component) recorded at Argostoli (ARG2) station for (a) the mainshock of 01/26/2014 (13:55GMT) and (b) the mainshock of 02/03/2014 (03:08GMT) (EPPO-ITSAK reports 2014a, 2014b)

Given the comparable geological setting between ARG2 and CH accelerometric station sites, the recorded motions at ARG2 station were deconvoluted to the bedrock level by implementing

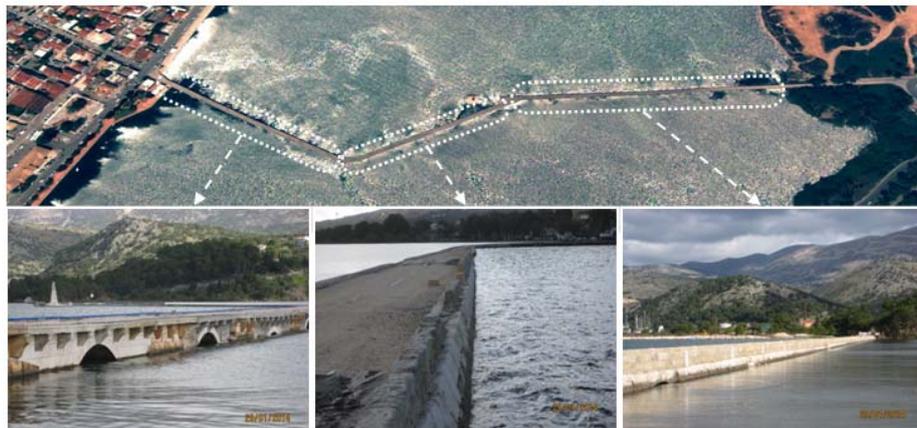
Fig. 16 In-situ inspection of the rehabilitated “De Bosset” bridge after the two major Cephalonia earthquakes of 01/26/2014 and 02/03/2014, revealing no damage or visible defects at the bridge structure

The rehabilitated bridge was inspected soon after the main earthquake events (Rovithis *et al.* 2014). The inspection revealed no damage or visible defects at the bridge structure (Fig. 16) indicating an overall satisfactory seismic performance, despite the large ground accelerations experienced in this site. On the contrary, the quay wall adjacent to the “De Bosset” bridge founded on the same soil conditions suffered permanent horizontal displacement of 10cm towards the shoreline with an approximate backfill settlement of 15 cm after the first earthquake event of 01/26/2014. The observed lateral movement of the quay wall and the settlement of the backfill were further increased, almost doubled at some locations, after the second earthquake of 02/03/2014 (Fig. 17).

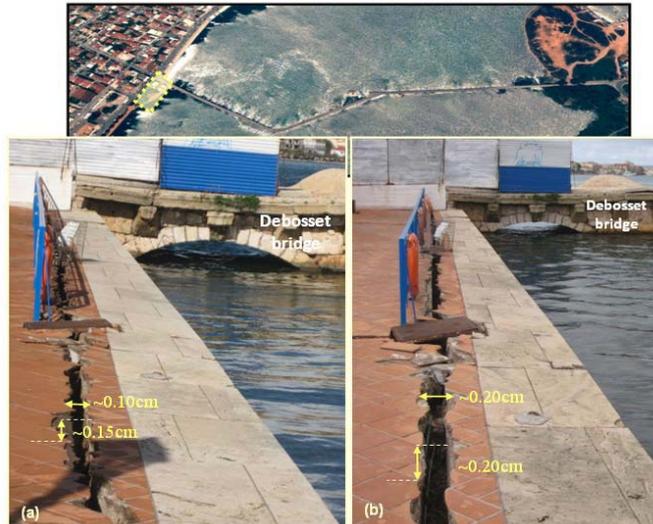
Fig. 17 Recorded failures adjacent to the “De Bosset” bridge; permanent lateral displacement of the quay wall and settlement of the backfill induced by (a) the first M6.1 earthquake event of 26/01/2014 (13:55GMT) and (b) the second M6.0 earthquake event of 03/02/2014(03:08GMT)

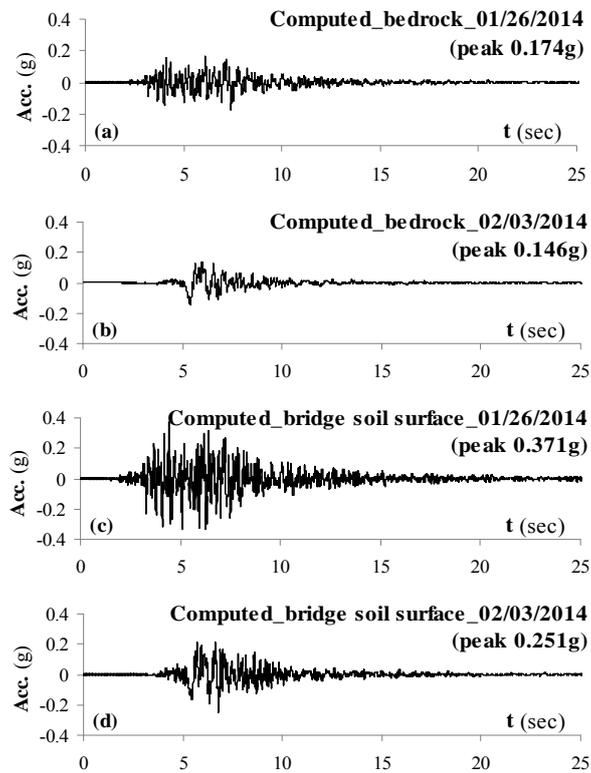
Fig. 18 (a, b) Acceleration time histories computed at the bedrock of the CH station soil profile for the two earthquake events of (a) 01/26/2014 and (b) 02/03/2014. (c, d) Acceleration time histories computed at the surface of the bridge soil profile for the two earthquake events of (c) 01/26/2014 and (d) 02/03/2014

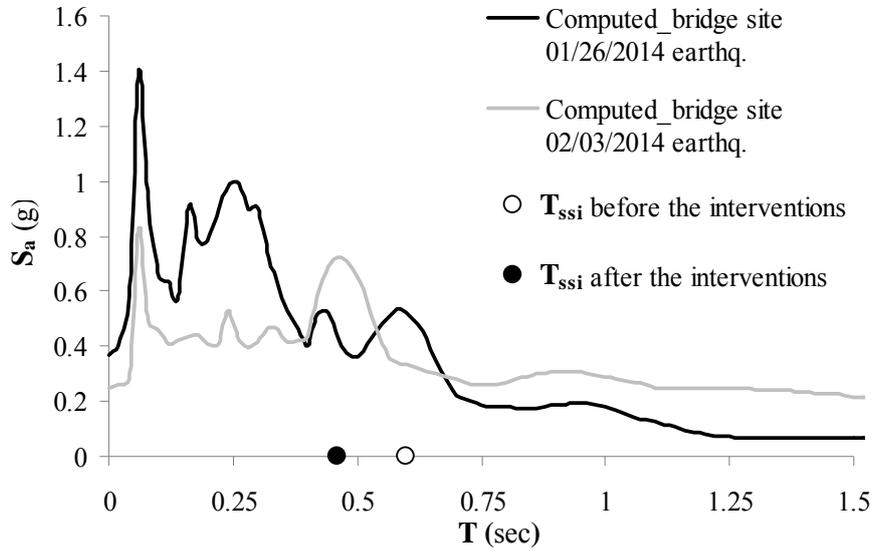
Fig 19. Acceleration response spectra of the two earthquake motions computed at the foundation level of the bridge; the effective natural period (T_{ssi}) of the flexible-base bridge model before and after the intervention measures is also shown

implementing the 3D numerical model of the bridge. The corresponding acceleration response spectra specified at the base of the bridge model are compared in Fig. 19. The effective natural periods (T_{ssi}) of the pre- and post-rehabilitated bridge model under flexible-base conditions are also noted in the graph, referring to the fundamental vibrational mode (Table 2). It is observed that

the rehabilitated bridge sustained larger seismic loading under the second earthquake of 03/02/2014, due to the decrease of the effective natural period after the intervention measures. The above is reflected in the safety factor against bearing capacity of the foundation soil (SF_{soil}) computed for the second earthquake (Fig. 20), which is lower than the SF_{soil} obtained for the first earthquake. However, for both earthquake events, SF_{soil} is increased above unity with respect to the pre-rehabilitation model response, indicating the capacity of the bridge foundation system after the interventions to withstand safely the imposed seismic loading.

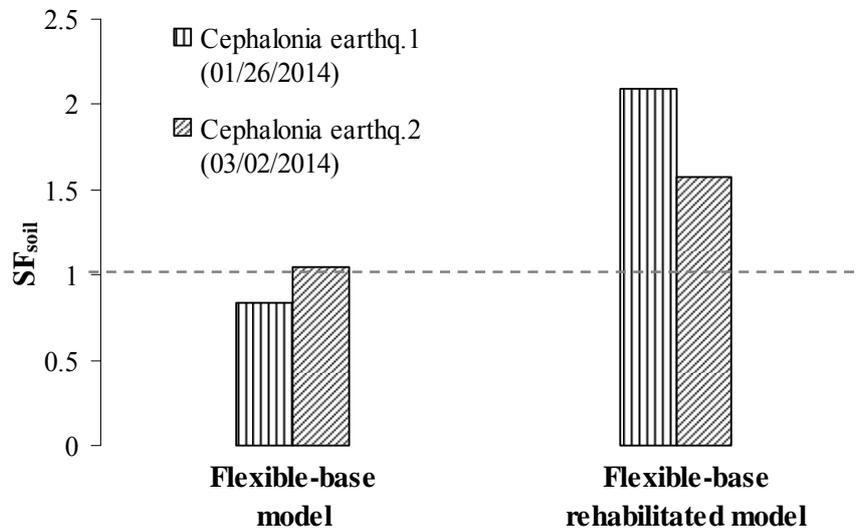
Fig. 20 Effect of rehabilitation measures on the bridge safety factor against bearing capacity of the foundation soil under the computed seismic loading induced by the two earthquakes of 01/26/2014 and 02/03/2014
