Influence of modified intended use on the seismic behavior of historical himis structures

Keywords: himis structures; the modification of intended usage; seismic analyses; Finite Element Method (FEM)

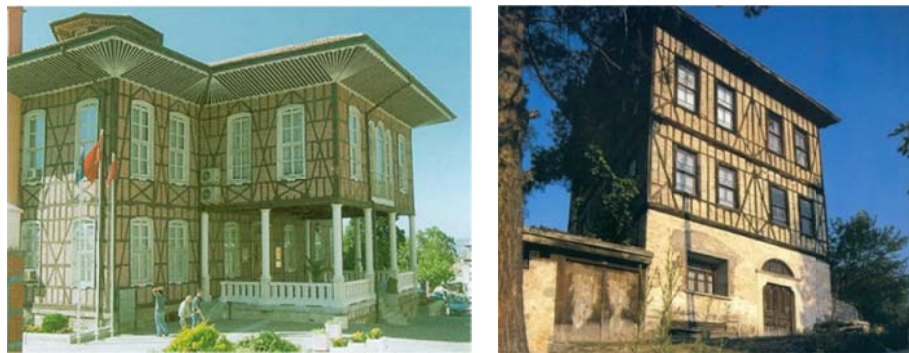
Fig. 1 Traditional himis structures in Turkey (Doğangün *et al.* 2006)

The protection of historical structures by the appropriate and convenient techniques is one of the most important challenges of today. Most of historical structures are damaged because of the natural disasters, time dependent deformations, and bad usage or conscious damage to the structure and thereby are exposed to the destruction. Several structures have different structural system properties in Turkey, where the historical structures are widespread. Especially, traditional buildings are characterized according to their historical structural properties. Moreover, they are treated to be the earliest examples of the historical heritage because of the use of natural materials and the primitive construction techniques. One of those structures is called as ‘himis structure’. Himis construction is simply described as a timber frame with masonry infill such as bricks, adobes, or stones (Fig. 1). This type of construction is a variation on a shared construction

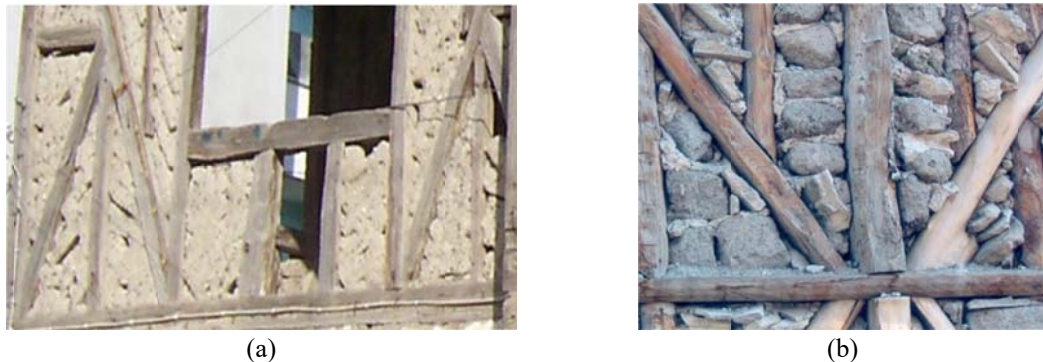
Fig. 2 The use of smooth surfaced (a) moulded and (b) unmoulded adobe (Doğangün *et al.* 2004)

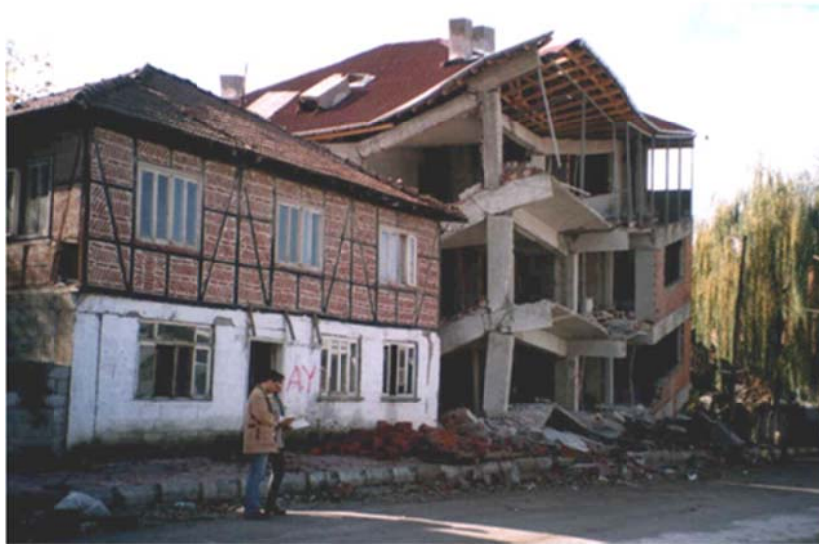
Fig. 3 View of traditional himis and reinforced concrete building after the 1999 Izmit earthquake in Turkey

Himis structures are predominant among the historical structural systems in central Anatolia. In himis technique, main timber posts are placed at the corners. Then, the diagonal bracing elements are used to support the structural integrity of timber frames. Finally, the spaces of the timber supporting system are filled by the adobe elements in these structures. The examples of the adobe fills are applied to the examined zones in Turkey, which are shown on Fig. 2(a) and 2(b). Since Turkey is an earthquake country, the destructive earthquakes have damaged too many structures. In the most destructive earthquake that took place in the last century in Turkey, himis structures have shown better performance compared to the concrete structures (Fig. 3).

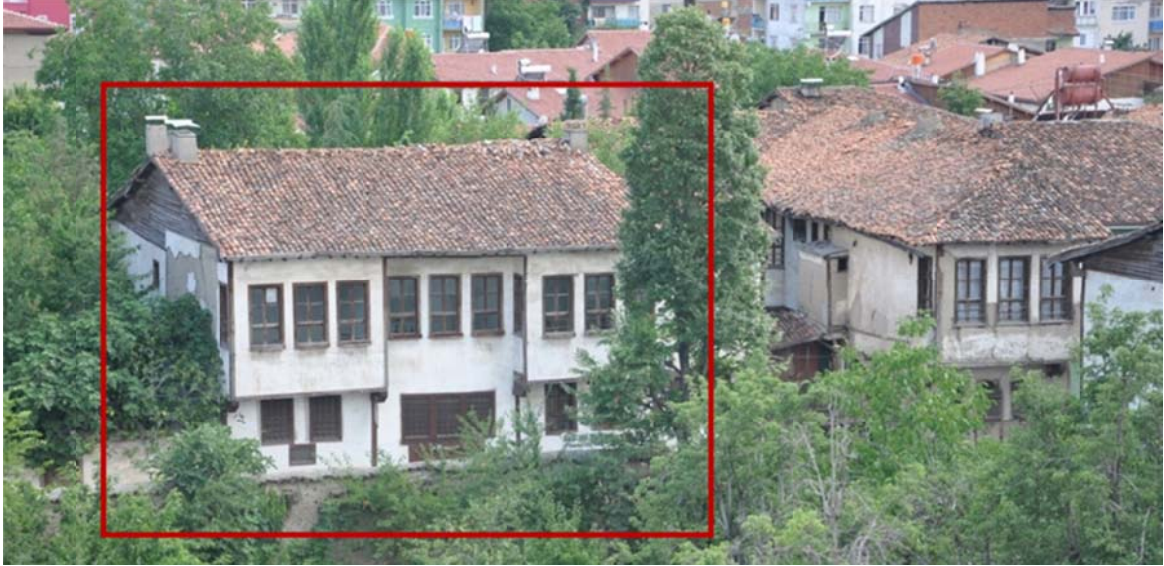
Fig. 6 Overview of Teknecioğlu Mansion (Photographs by Elif Yaprak)

The examined structure has gained its present appearance, which is composed of timber mainframe, adobe filled himis and fully plaster. Teknecioglu Mansion is currently in the abandoned state and therefore, the owner of the structure has planned to change its intended usage. In this scope, an in-situ investigation was carried out by the authors in Teknecioglu Mansion in order to detect deterioration in traditional himis structures (Figs. 6-8). The investigation mainly aimed to better understand the structural behaviour and deformation capacity of the structure. The visible signs of deterioration in the structure were visually examined in the light of the structural features and architectural characteristics. The majority of deteriorations in Teknecioglu Mansion have been mainly caused by the damage on the structural elements and the decay of the structural materials. The main problems on the structure are the damage on the structural elements, the loss

of material, and the decrease in the structural strength. One of the facades of the structure has been partly demolished on the timber frame and many irregular micro cracks have been observed on the plaster of timber-framed walls. In addition, during the structure's service life, construction materials have deteriorated and lost their qualities due to the environmental conditions, spalling or flaking. Potential failures because of material degradations should not be neglected because these degradations cause irreversible effects on the structure in a negative manner. Moreover, the drainage excavations on the side prove that the foundation soil was in good condition (Good Soil) and there is no significant damage on the structure.

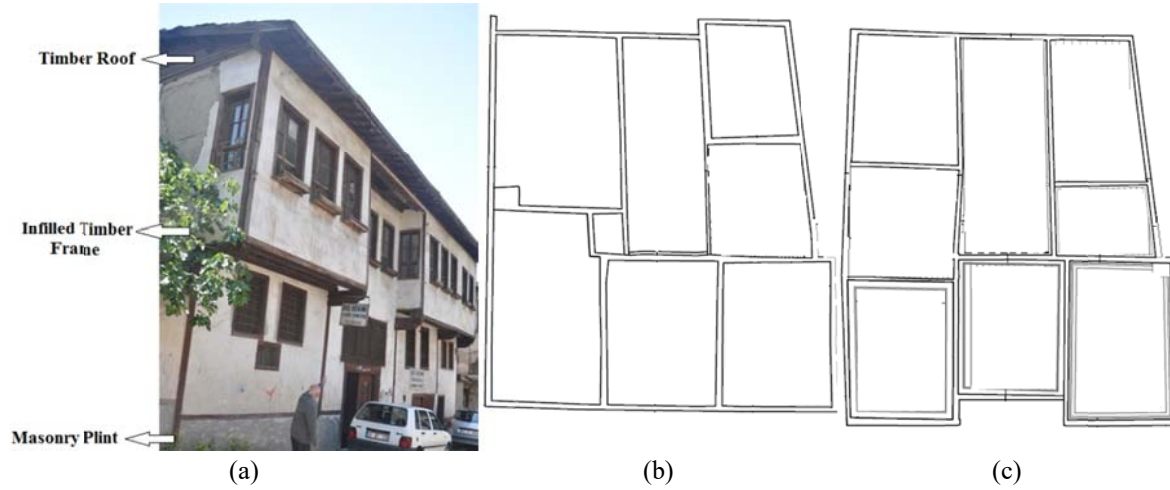
Fig. 9 (a) The original shape of the Teknecioğlu Mansion, (b) Ground Floor, (c) First Floor

Teknecioğlu Mansion consists of three major parts. The first part is the masonry plint, the second part is the infilled timber frame, and the third part is the timber roof. The floors between stories consist of timber elements. Timber materials are easy to use and may be obtained from natural environmental and sustainable sources. Furthermore, timbers resist to tensile and compression forces. Therefore, it has been used as a horizontal bearing member to the structure. The mansion has differences in plan on ground and first floors. Additionally, the mansion rises towards front facade on the upper floor (Fig. 9). In the scope of the study, Hayati Teknecioğlu Mansion is firstly modelled as a current shape (mansion), after that, it is modelled as hotel and restaurant (the other two construction purposes) and it has gained new functions with those two models. The earthquake effects of the structure are examined by the dynamic analysis on the three models created. The appropriate analysis of the proprietary historical structures' and their reinforcement and maintenance are very important in order for the delivery of those to the future.

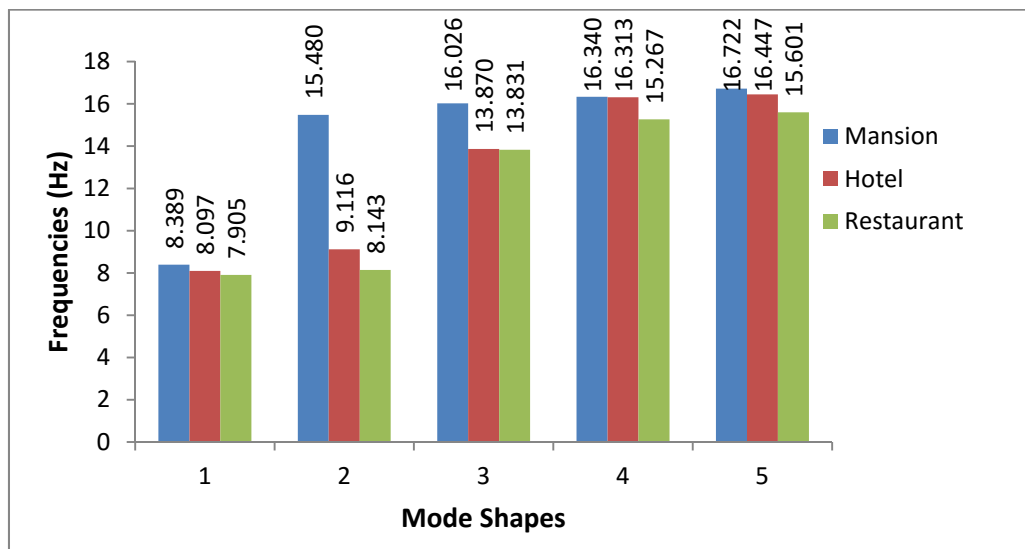
Fig. 15 Frequencies values for first five mode shapes

The modal analysis is primarily used for the dynamic analysis of the investigated structure. Sufficient numbers of vibration modes are determined considering TEC. With respect to TEC, sufficient number of vibration modes should be taken into consideration for the fact that the sum of effective mass participating ratios should be greater than 90% of the total mass of the building for each direction. The modal analyses are considered for the first 30 modes and the first five modes that have higher contributions to effective mass participating ratios. The first five mode shapes for the structures are presented in Fig. 15 and Fig. 16. As shown on the Fig. 16, the frequencies values of the mode shapes differ according to the modification in the usage and the most significant difference is observed on 2nd mode.

The period values generated through the evaluation of the analyses prove that the first condition of the structure is quite rigid. However, it is observed that the period values get higher and the structure's rigidity decreases due to structural system and loads after the transformation of the structure from the mansion into a hotel and restaurant.

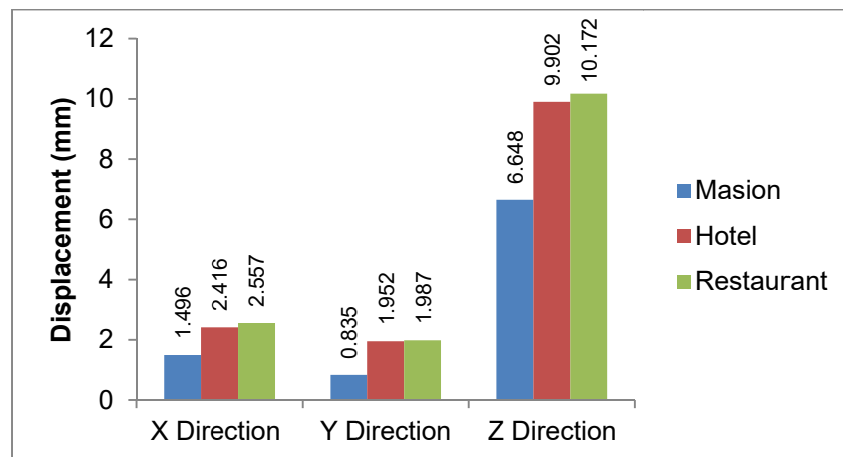
Fig. 21 Maximum displacements on X, Y and Z directions

The analyses of the displacements show that the maximum displacement in the X direction with G+Q+Ex+0.3Ey load combination, the maximum displacement in Y direction with G+Q+Ey+0.3Ex and the maximum displacement in the Z direction with 1.4G+1.6Q load combination are generated. The evaluation of the displacements generated through the structure because of the modified usage show that the least displacement is generated in the mansion form while the highest displacement is generated in the restaurant form among the three models analyzed. Additionally, the comparison between the mansion and restaurant form reflect that there are 70.9% change in the X direction, 137.8% change in the Y direction and 53% change in the Z direction in terms of displacements.

where h_i is the story height, and R is the behavior factor related to the ductility of structure. If this requirement is applied to the Teknecioğlu Mansion ($h_i=8$ m, $R=3$), the corresponding maximum allowable top displacement is 0.05 m. The dynamic displacements achieved are lower than the values generated through the formula. In this respect, it is seen that the maximum displacement values are within the allowable limits.
