Seismic response and retrofitting proposals of the St. Titus Church, Heraklion, Crete, Greece

Abstract. The purpose of this work is to investigate the seismic behavior of St. Titus Church in Heraklion, Crete, Greece as well as the need of its seismic retrofitting. A numerical model of the Church is constructed using shell finite elements and it is then seismically examined using response spectrum and linear time-history analyses. Effects of soil-structure interaction have been also taken into account. The Church without retrofit is expected to exhibit extensive tensile failures and many compressive ones. Aiming to maintain the architectural character of the structure as well as to increase its seismic resistance, a retrofitting procedure involving injection of cement grout in conjunction with reinforced concrete jacketing to the internal side of the masonry walls is proposed. A numerical implementation of the proposed seismic retrofitting is performed and its effect is evaluated by response spectrum and linear time-history analyses. From the results of these analyses, it is shown that compressive failures are eliminated while only few tensile failures of local character take place

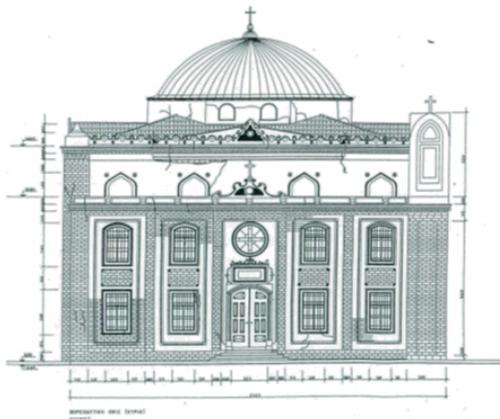
Fig. 6 Cracks at the external side of St. Titus Church

Damages in the form of cracks have been exhibited due to both the frequent occurrence of weak-to-moderate earthquakes and to the oxidization of the anchored parts of the steel tie rods at the external walls. These cracks have been imprinted in detail at the beginnings of 1970 and are indicatively, shown in Figs. 6-8.

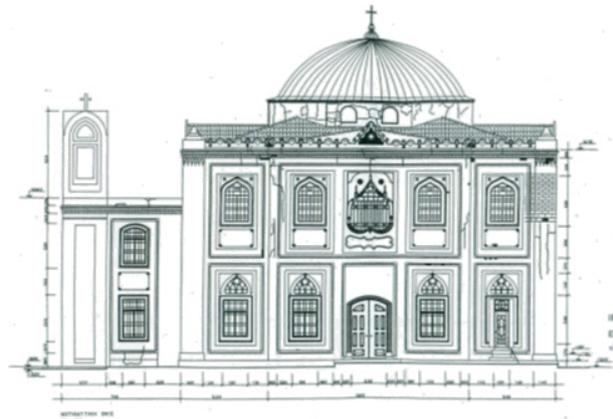
Fig. 7 Cracks at the external side of St. Titus Church

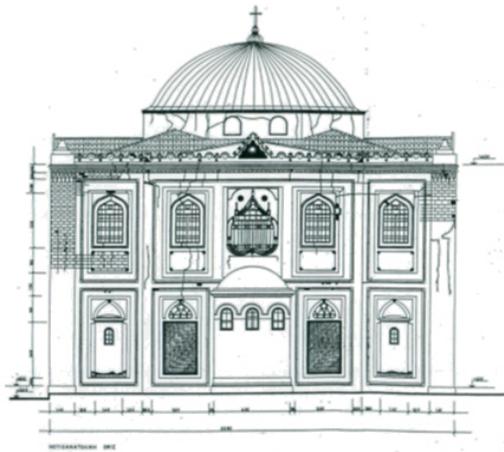
Fig. 8 Cracks at the external side of St. Titus Church

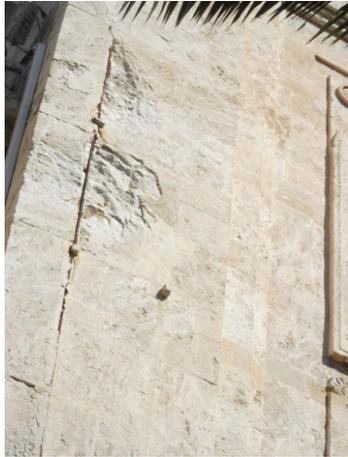
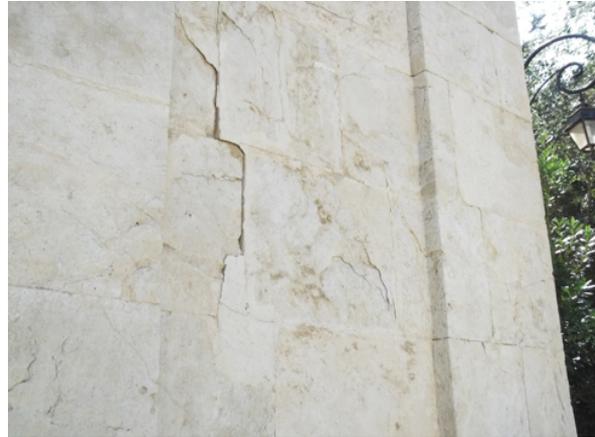
Fig. 9 Current status, oxidization at south-east side Fig. 10 Current status, oxidization at south-west side

external sides of masonry as well as severe oxidization of the anchored parts. Similar cracks were identified by the authors of the present paper during their visits at the Church between 2010-2013 and are indicatively shown in Figs. 9 and 10. The internal part of the structure is in good condition and no visible cracks exist. Soil settlements have not been observed.

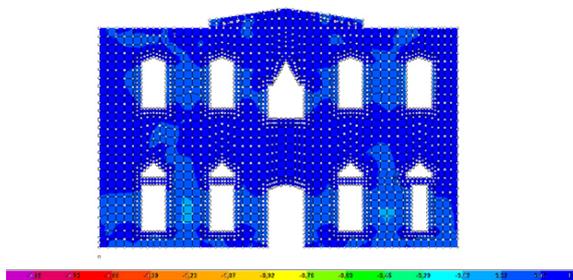
Fig. 15 Horizontal tensile normal stresses (in MPa) at the front view of the fixed-base Church

From the results of Figs. 15-20, it is concluded that the seismic combinations mandated by Eurocode 8 (2009) may lead to extensive tensile failures at all sides of the structure, while compressive failures also take place around the central openings at the north, south and east sides of the Church, using as orientation the sides of Fig. 4. These failures are in accordance with the damage observed to the external sides of the Church before its restoration in the decade 1970-1980 (described in section 2.3) as well as with the present damage state of the external sides.

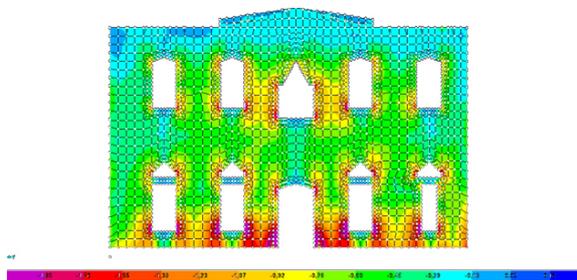
Fig. 16 Vertical compressive normal stresses (in MPa) at the front view of the fixed-base Church

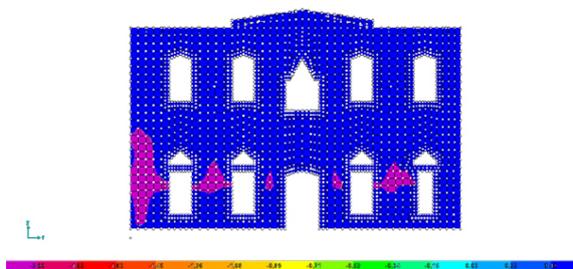
Fig. 17 Vertical tensile normal stresses (in MPa) at the front view of the fixed-base Church

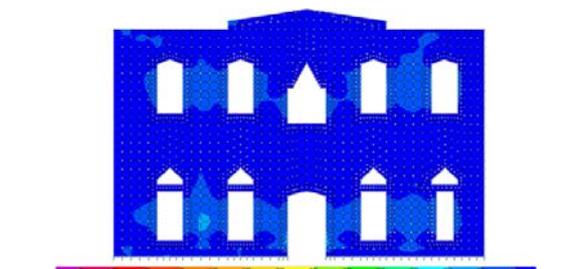
Fig. 18 Horizontal tensile normal stresses (in MPa) at the front view of the Church considering SSI effects

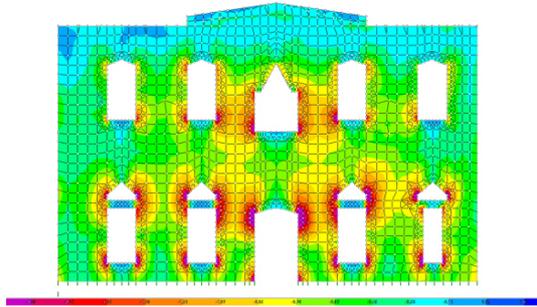
Fig. 19 Vertical compressive normal stresses (in MPa) at the front view of the Church considering SSI effects

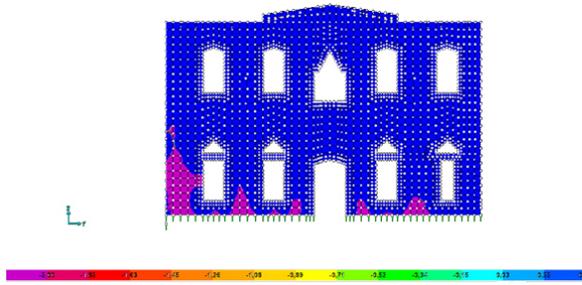
Fig. 20 Vertical tensile normal stresses (in MPa) at the front view of the Church considering SSI effects

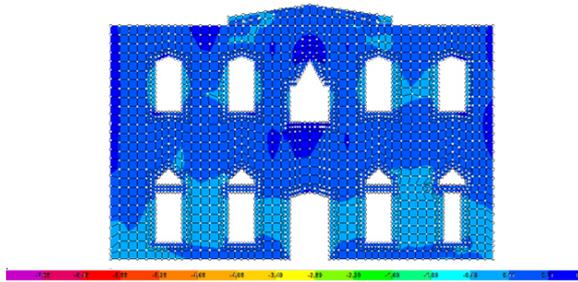
Fig. 21 Tensile normal stresses (in MPa) at the front view of the fixed-base Church

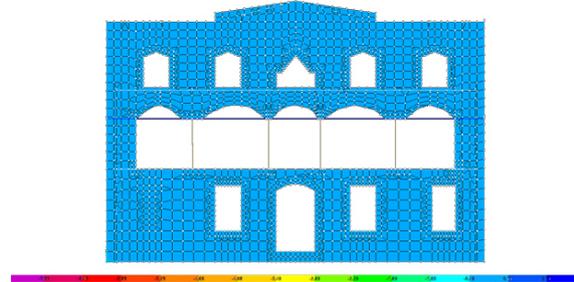
Fig. 22 Tensile normal stresses (in MPa) at the wall between the main temple and the vestibule of the fixed-base Church

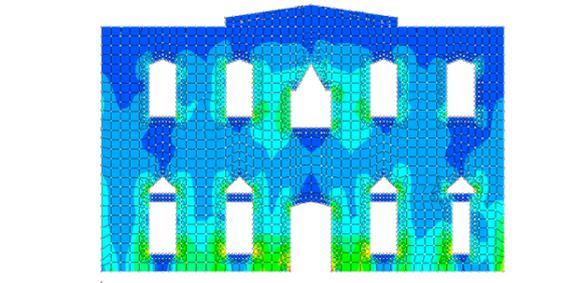
Fig. 23 Compressive normal stresses (in MPa) at the front view of the retrofitted fixed-base Church

Figs. 23 and 24 display the compressive and tensile normal stresses at the front view of the retrofitted Church considering it to be fixed-base. It has been found that the maximum compressive and tensile stresses are -5.60 MPa and 2.70 MPa, respectively. The maximum compressive stress is much less than that of a typical reinforced concrete having a strength of 20 MPa. The maximum tensile stress has to be explicitly delivered by steel reinforcement. Simple calculation per meter length and for a thickness of 10 cm of the jacket, leads to steel reinforcement $\Phi 12/12.5$ cm, where the strength of steel is 400 MPa. Figs. 25 and 26 show the minimum and maximum, respectively, shear stresses along the interface between the masonry wall and the jacket, in order to estimate the diameter of the anchors needed. It was found that the minimum and maximum compressive and shear stresses are -0.80 MPa and 0.80 MPa, respectively. Simple calculations lead to $\Phi 18/12.5$ cm anchors placed in grid.

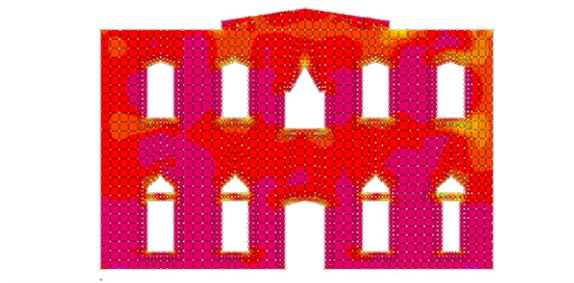
Fig. 24 Tensile normal stresses (in MPa) at the front view of the retrofitted fixed-base Church

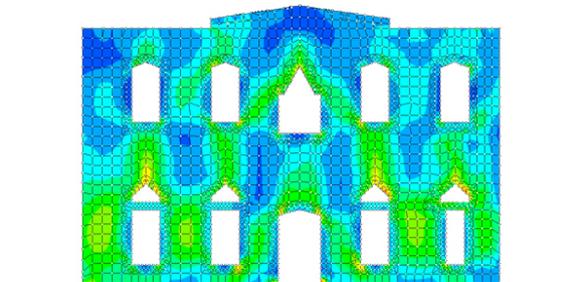
Fig. 25 Minimum shear stresses (in MPa) at the front view of the retrofitted fixed-base Church

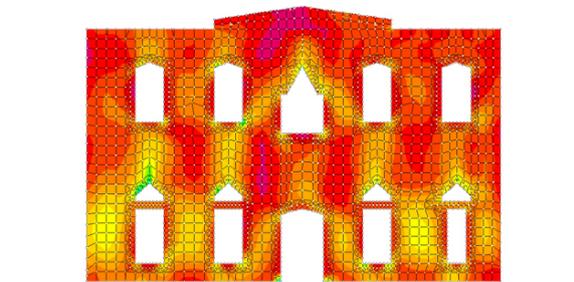
Fig. 26 Maximum shear stresses (in MPa) at the front view of the retrofitted fixed-base Church

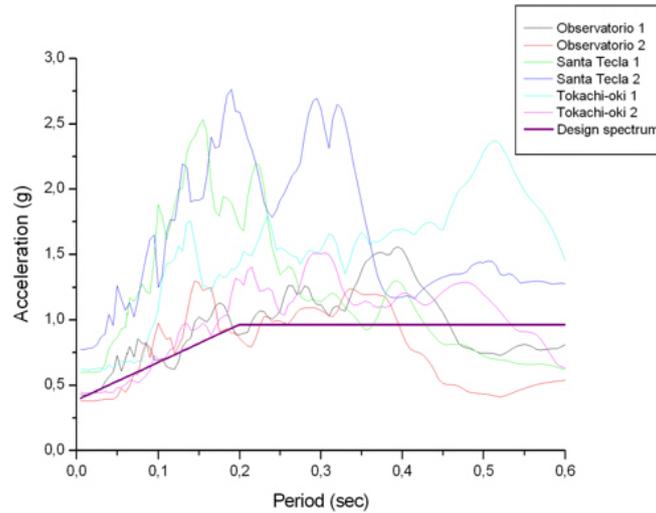
Fig. 27 Response spectra of the accelerograms used

the broader area. The three accelerograms which were eventually selected are a) the Observatorio and Santa Tecla recordings from the 13/1/2001 San Salvador earthquake and b) the HKD092 recording from the 25/9/2003 Tokachi-Oki, Japan earthquake. These accelerograms have been downloaded from COSMOS (1999). The response spectra of the two horizontal components for each one of the aforementioned three accelerograms and for the period range of 0.005 to 0.6 sec are given in Fig. 27. In the same figure, the reference design spectrum is also given.

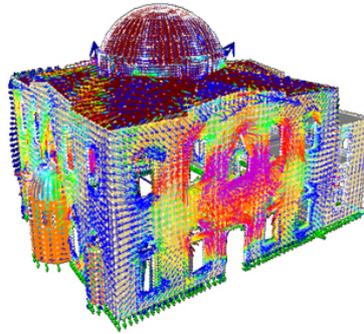
Fig. 32 Direction of stresses for the case of the fixed-base Church subjected to Observatorio strong ground motion accelerogram

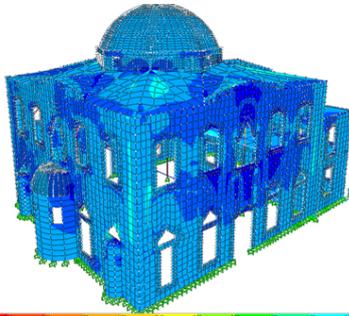
Fig. 39 Horizontal normal stresses (in MPa) for the retrofitted Church by applying mass impregnation, subjected to Observatorio strong ground motion accelerogram

The effect of application of only mass impregnation is depicted first. Considering again the case of modulus of elasticity equal to 7.08 GPa and damping ratio equal to 4%, Figs. 39 and 40 show the distribution of horizontal and vertical normal stresses, respectively, for the case of the Obesrvatorio strong ground motion accelerogram. The retrofitted fixed-based structure does not exhibit any compressive failures, however, some tensile failures due to horizontal stresses occur. Similar results are obtained for the cases of the other two accelerograms as well as for all cases when SSI effects are taken into account. As modulus of elasticity increases to 13.67 GPa, tensile failures become less but they are not eliminated.

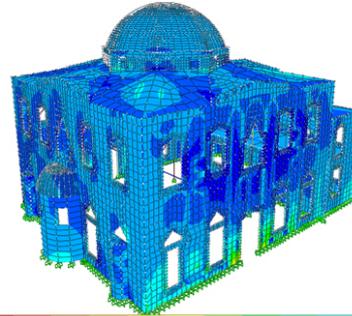
Fig. 40 Vertical normal stresses (in MPa) for the retrofitted Church by applying mass impregnation, subjected to Observatorio strong ground motion accelerogram

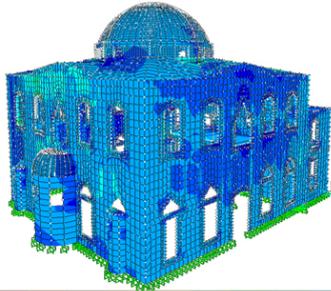
Fig. 41 Horizontal normal stresses (in MPa) for the retrofitted Church by applying mass impregnation, subjected to Santa Tecla strong ground motion accelerogram

damping ratio equal to 4%, Figs. 41 and 42 show a favorable distribution for both horizontal and vertical normal stresses of the retrofitted fixed-based Church. Tensile failures are localized at the external sides of peripheral walls. To get an idea of the direction of total stresses, Fig. 43 is provided for interpretation purposes of the stress results of Figs. 41 and 42. Similar results can be obtained for all cases when taking into account SSI effects.

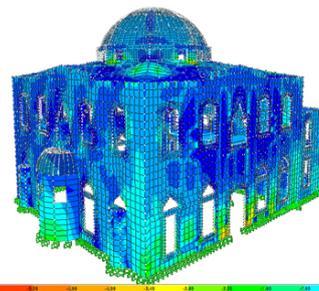
Fig. 42 Vertical normal stresses (in MPa) for the retrofitted Church by applying mass impregnation, subjected to Santa Tecla strong ground motion accelerogram

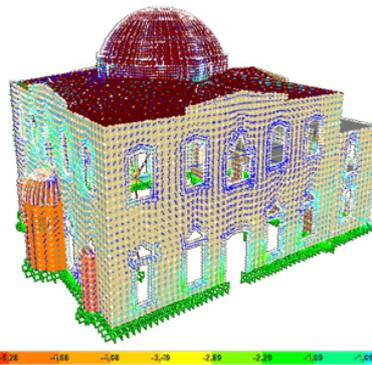
Fig. 43 Direction of stresses for the case of the fixed-base Church subjected to Observatorio strong ground motion accelerogram

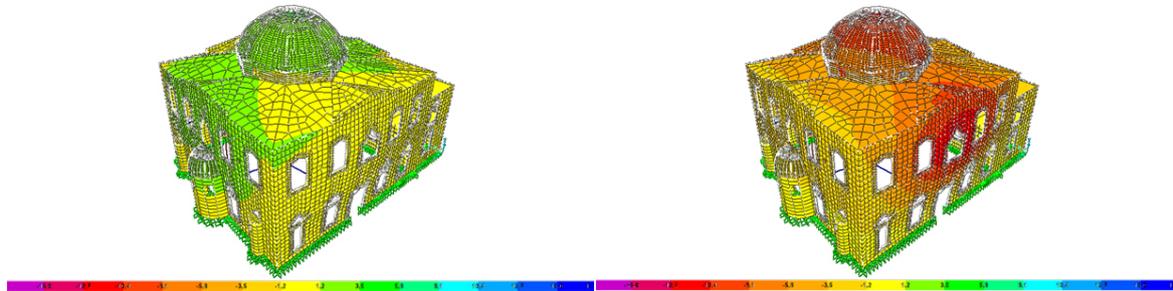
Fig. 44 Horizontal displacements along the X direction of the retrofitted Church by applying mass impregnation and jacketing, subjected to Santa Tecla strong ground motion accelerogram

Fig. 45 Horizontal displacements along the Y direction of the retrofitted Church by applying mass impregnation and jacketing, subjected to Santa Tecla strong ground motion accelerogram
