Experimental study on seismic performance of reinforced concrete frames retrofitted with eccentric buckling-restrained braces (BRBs)

Abstract. As a new type of energy dissipation component with excellent mechanical performance, the Buckling-Retrained Braces (BRBs) were gradually applied in retrofitting and improving seismic performance of reinforced concrete structures in China. In order to investigate the seismic performance of reinforced concrete structures retrofitted with BRBs, quasi-static test of two single-bay and 3-story reinforced concrete frames specimens was conducted and introduced in this paper. Two 1/2 scaled specimens were designed to reflect real prototype structure. For comparison, one control specimen was designed without BRBs, and the other specimen was retrofitted with BRBs. And particularly, for the specimen retrofitted with BRBs, the BRBs were eccentric layout instead of usually concentric or x-shaped layout, aiming to be more suitable for large-span frames. In the test, the failure mode, carrying capacity, deformability, ductility and energy dissipation ability of both two specimens were investigated. Based on the test results of the measured hysterical curv

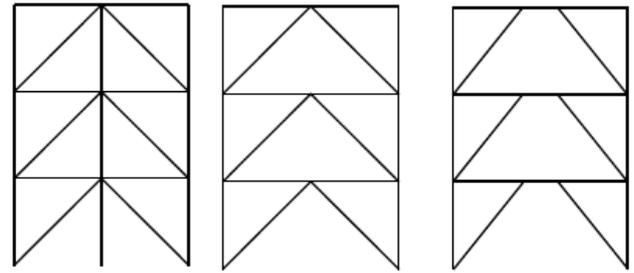
Fig. 1 Three layout types of BRBs

As illustrated in Fig. 1(c), for the eccentric braces layout, the beam was divided into three parts instead of two parts in the centric layout. In this case, if the middle part of the beam is designed as 3 meters, then the inclination angle of braces could be adjusted to 45 degree to well meet the requirement of the current Chinese code. A new problem

(a) x-shaped layout (b) concentric layout (c) eccentric layout

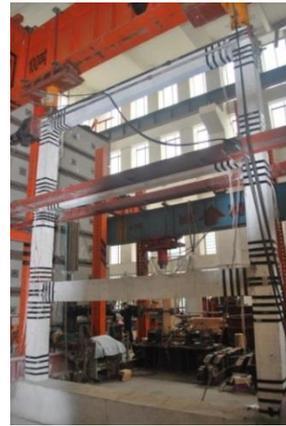
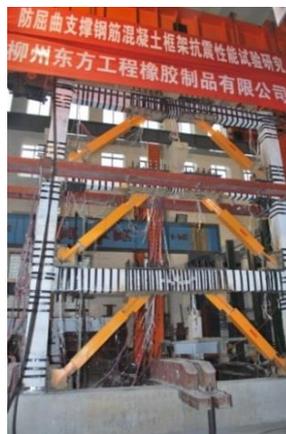
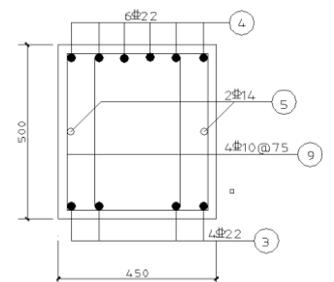
Fig. 2 photos and details of the cross section of the specimens

(a) Photo of specimen RCF1

(c) Cross section detail of columns of 1st floor

(d) Cross section detail of columns of 2nd and 3rd floor

(b) Photo of specimen RCF2

(e) Cross section detail of all the beams

(f) Cross section detail of base beams

(c) Photo of brace core

(g) Connections for braces

As mentioned above, two reinforced frame structure specimens were tested. The first specimen was labeled as RCF1 here and was the control specimen that without BRBs, the second specimen was labeled as RCF2 and was retrofitted with eccentric BRBs. The RC frame was designed based on the prototype of one reinforced concrete frame school building, which was 6 stories and 8 bays, and the height of stories and the length of span were 3 meters and 7.2 meters, respectively. The specimens was modeled in the scale of 1/2 and designed with only 3 stories due to the limitation of experimental conditions. Both two specimen were designed as 3-story and one-bay reinforced concrete frames, the height of each story was 1500 mm, the span

length was 3600 mm, the total height of the specimens was 5000 mm, and total width of the specimens was 4500 mm. The sizes of cross section, materials used as well as the layout of reinforcement bars in the beams and columns are the same for specimen RCF1 and RCF2. All the configurations of specimens and the details of reinforcement are listed in Table 1 and Table 2, and also demonstrated in Fig. 2. The amount of longitude rebar was same in beams, while for columns, the bottom columns was placed more reinforcing bars as well as stirrups to sustain more loading. Besides, stirrups were placed with space of 150 mm in most of parts, but in the region where higher shear force would occur, such as beam end, column end, smaller space of 75 mm was adopted. In the tests, considering the force caused by brace would have harmful effect on the framing components and in order to avoid the shear failure of the beam-ends and column-ends of specimens, some external steel strips were added on some areas of the specimens to improve the shear capacities of the link beams and columns and also confine the deformation. The section of inner core of BRB is $10 \times 70 \text{ mm}^2$, and in order to ensure local stability, some stiffeners were attached to the end of brace, forming the cross section, and besides, gusset plates and bolts were used to connect braces to frame, which indicated that brace would be welded to gusset plate first and then gusset plate would connect to framing components by bolts. Besides, eccentrically braced frame might cause additional shear force and sometimes axial force on the link beam, so the demand for link beam design was more stringent. In the specimen, stirrups with smaller space and more steel strips were used to make sure that link beam would not damage seriously and could remain good condition before brace yielded.

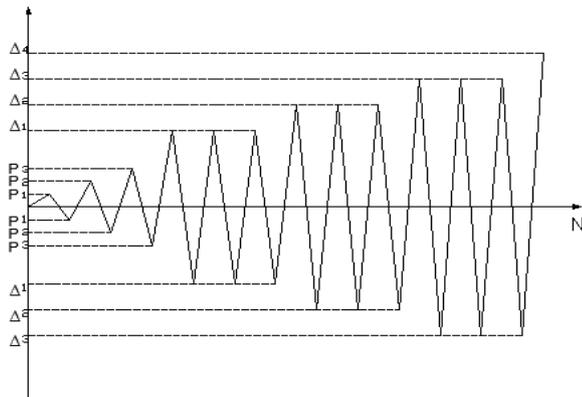
Fig. 3 Loading protocol of the test

was controlled to certain force values according to planned force loading steps and reversely loaded one cycle for each loading step, as illustrated in Fig. 3. And after cracking, the MTS actuator was controlled to certain displacement according to designed displacement loading steps. The displacement control was reversely loaded and repeated 3 cycles for each loading steps, which were enlarged with the increment of 5 mm. It was not until the horizontal load decreased to less than 85% of the peak load that the experiments ended.

The vertical load was loaded to 400 kN on the top of column, equivalent to the experimental axial compression ratio of 0.248, which was calculated from the real loads of prototype. The horizontal load was single-point loaded on the center axis of the top beam. The loading protocol was designed and controlled by both force and displacement, that is, at the elastic stage or before cracking, the MTS actuators

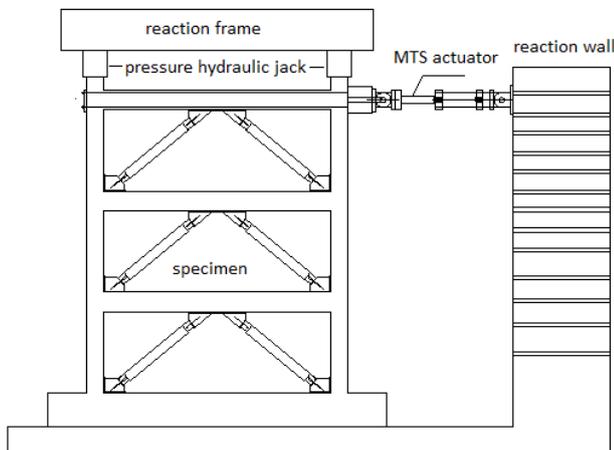
Fig. 4 Schematic diagram of test set-up

The loading setup of this experiment was illustrated in Fig. 4. The arrangements of the test measuring instruments

aimed to record the strains of different elements such as concrete and reinforcement bars, the displacement or drifts of every story and so on. Consequently, displacement transducer was positioned at all beams end including the base beam. Besides that, in order to measure the axial deformation of braces, displacement transducers were fixed on both ends of BRBs, and the strains of the core steel of brace (the midpoint) were also measured as well. The strain gages were located in the bars of expected plastic hinge areas, such as the beam-ends and column-ends, the joint core areas.

specimens were vertically loaded by stable pressure hydraulic jack and horizontally loaded by MTS electro-displacement hysteresis curves could be directly measured, and the seismic performance such as the bearing capacity, deformation capacity, the stiffness as well as the restoring force features and so on could also be obtained.

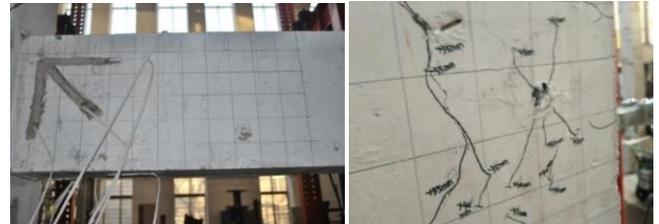
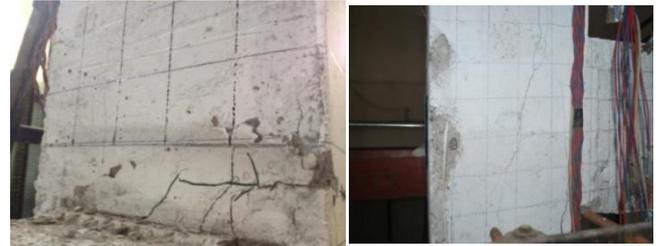
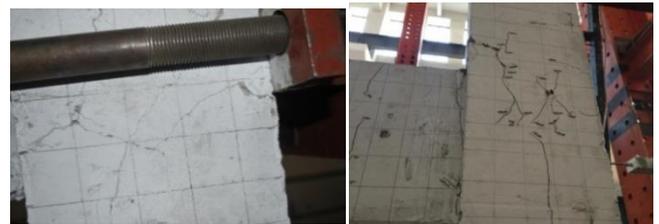
Fig. 5 Failure mode and cracks of specimen RCF1

Before the horizontal load reached 30 kN, almost no obvious changes, except that little drift and few cracks of structure were observed. When the load reached 30 kN, some tiny cracks occurred at the end of beam in story 3, the width of cracks was small and few cracks were found. With the experiment going on, the cracks extended and more and more cracks emerged in different parts, most in beams, some in columns or even in joint area and the reinforcement of beams yielded. When the top displacement reached 55 mm, the concrete of beam end wrecked due to the broad

(a) Left end of 1st story beam (b) Joint core area of 1st story

(c) Bottom end of column of 1st story (d) Left end of 2nd story beam

(e) Top end of 2nd story column (f) Bottom end of 2nd story column

crack and the load peaked. During the whole process, cracks in beam end of the 2nd story were most severely. The final failure mode and details of cracks were shown in Fig. 5.

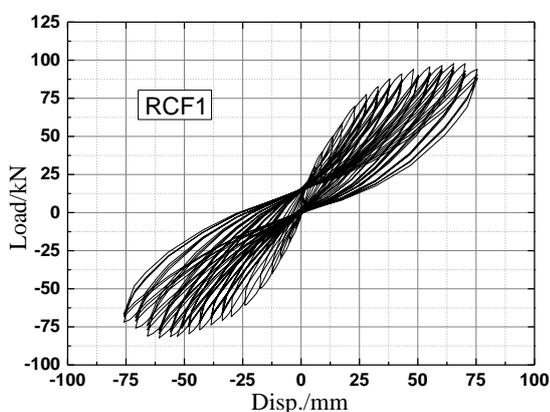
(a) specimen RCF1

(1) From curve of specimen RCF1, as illustrated in Fig. 7(a), it could be indicated that some slippages between concrete and reinforcement in the members occurred during test, especially in beam-ends, which resulted in a slight "pinching effect", of specimen led to the cracking occurring

at early stage. The pinching effect was mostly caused by the concrete cracking, the slip of bars and the imperfection

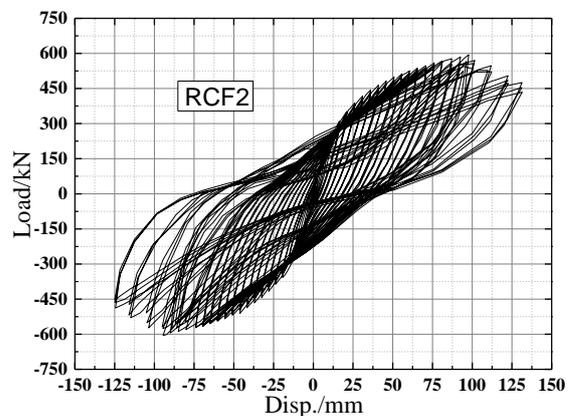
(b) specimen RCF2

(2) From curve of specimen RCF2, as illustrated in Fig. 7(b), the area of the curve of RCF2 was much larger than that of specimen RCF1, with higher bearing capacity of 620 kN against 98 kN of RCF1, this was also analogous to other results of other researches, which indicated that buckling-restrained braces can significantly improve the bearing capacity (Liu 2005).

(3) The specimen RCF2 had larger initial elastic stiffness, and came into plastic stage a little later than that of specimen RCF1, which was owing to the large stiffness provided by BRBs. When the BRBs yielded, an obvious turning point in the curve occurred. The whole structure presented a favorable yielding mechanism, in which the BRBs yielded under small inter-story drift ratio before the link beams yielded, and then finally followed by the plastic hinge formed at beam-ends and column-ends. Besides, the partial retrofit with steel strips also provided benefit for link beam.

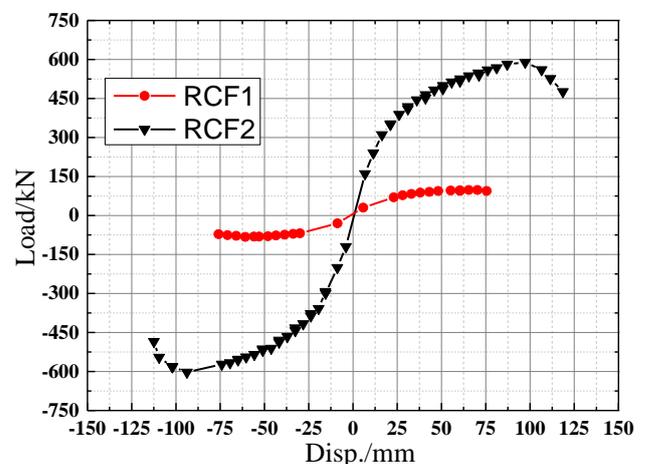
Fig. 8 Skeleton curve of specimens

As the structural performance index, skeleton curve plays an important role in the analysis of inelastic response for structure. The skeleton curves of two specimens were shown in the same pictures, as illustrated in Fig. 8.

From Fig. 8, it could be found that the relationship between load and displacement changed from elasticity to plasticity, the bearing capacity of RCF2 was much higher than that of RCF1, and the ultimate displacement of RCF2 was largely improved. All those conclusions were the same with conclusions drawn from the hysteretic curve of load vs. displacement, but the skeleton curve reflected them more explicitly. And it again indicated that with BRB, both the stiffness and capacity would be improved to a great extent. It could be also found that the curve was a little asymmetric. The reason for this could be explained as follows, the buckling of BRBs under compression has been confined to a great degree by the external confining systems, but when the inner core element was highly compressed, due to the friction action and the contact action between the inner core element and the external confining systems, the bearing capacity of compression was always higher than that under tension condition, and then resulted in some asymmetric, which was also commonly found in other researches, saying that the compression capacity was about 10% higher than tension capacity.

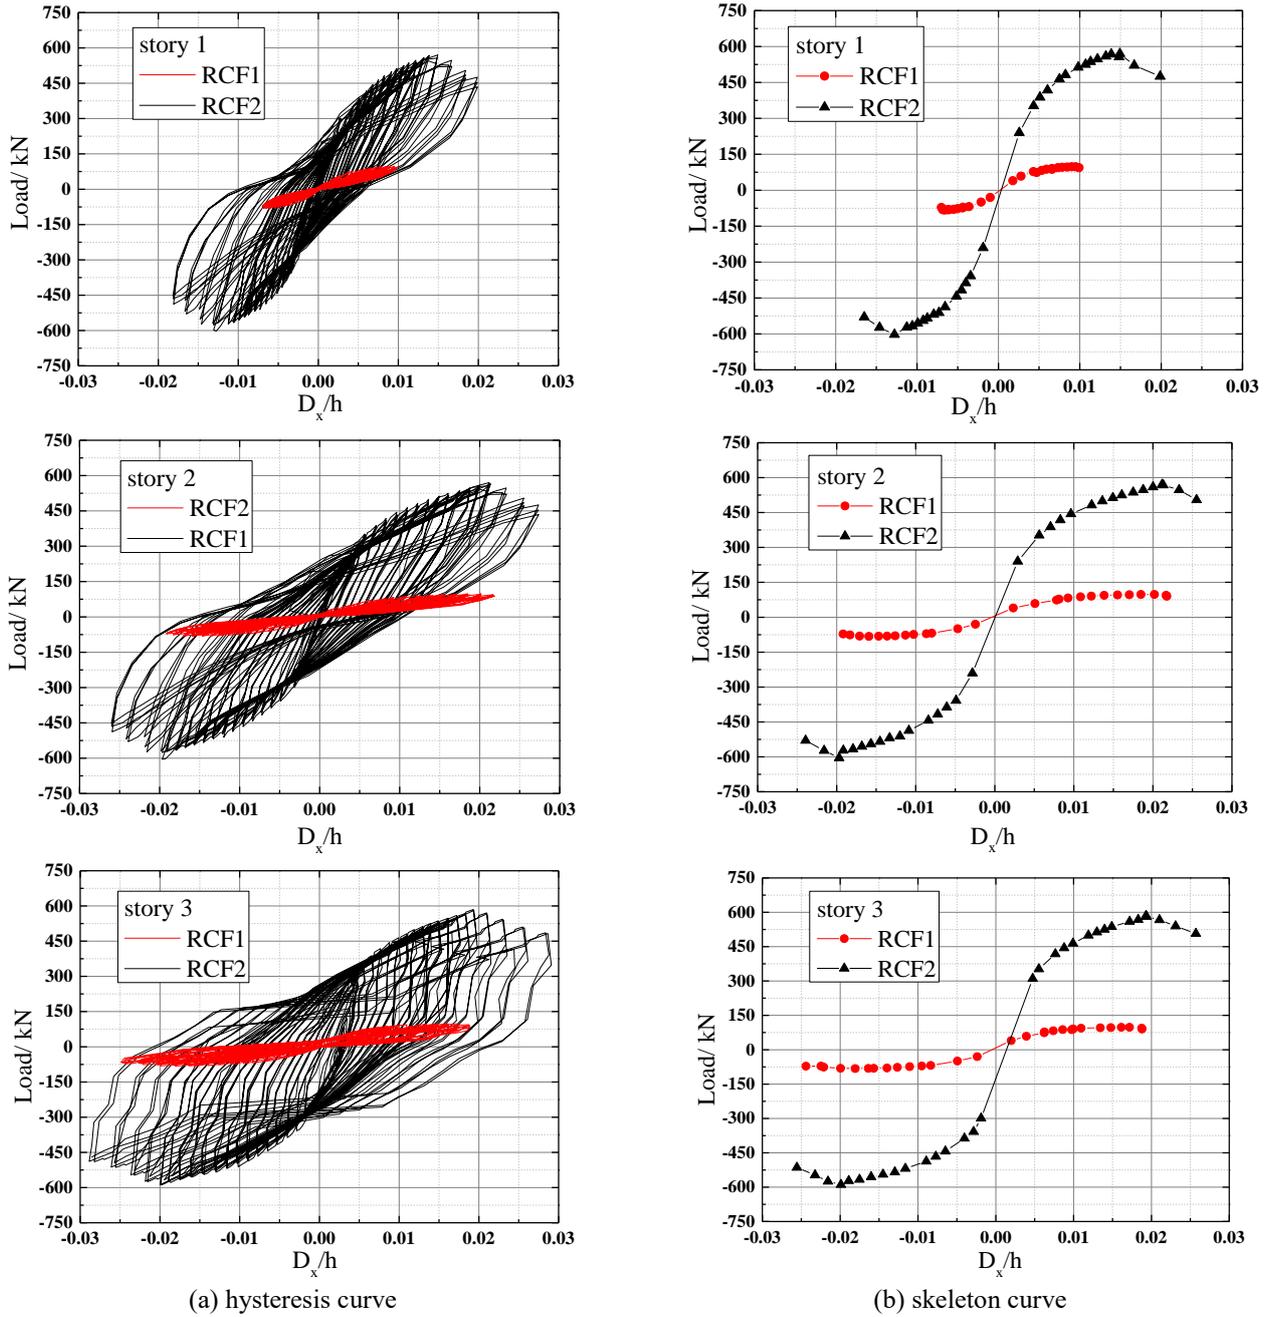
Fig. 9 Curve of shear force vs. inter-story drift

(1) The shapes of curves of every individual were similar to that of the whole specimen. The behavior for different story was analogous.

(2) When the specimens were pushed or loaded positively, the largest inter-story drift was found at the 2nd story. And when the specimens were pulled or loaded negatively, the largest inter-story drift was found at the 3rd story. It was probably due to the fact of some boundary conditions. For story 1, there was a rigid ground beam connected to columns and the ground beam was also connected to ground, which enlarged the stiffness for the story 1. And for story 3, due to the loading set-up, the beam was constrained by the loading rod and it also made the beam more rigid. However, to the end of experiment, the concrete of 3rd story damage seriously, especially on the top column because of the direct vertical load of the column, the structure became weaker and the drift became larger.

(3) The asymmetry of hysteretic curves of shear force vs. inter-story drift of each story was also found. For Specimen RCF1, the asymmetry of hysteretic curves of the 1st story was more obvious than that of the 2nd and the 3rd story, while the asymmetry of curves of each story for Specimen RCF2 were small and similar. The asymmetry was mainly due to that there was still difference in compression and tension of BRB, and compressive capacity was a little higher than tension capacity. Besides, the openings and closures was another reason.

(4) Both in specimen RCF1 and RCF2, there were a sharp change at the hysteretic curve of the 3rd story, which was caused by the local crush of top-ends of the column where loaded both vertically and horizontally.

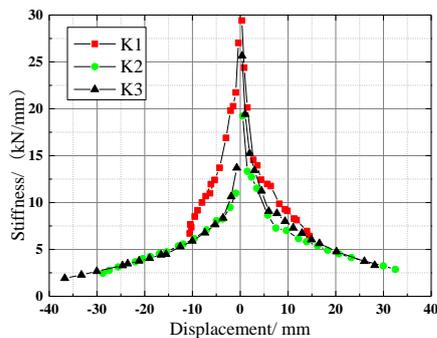
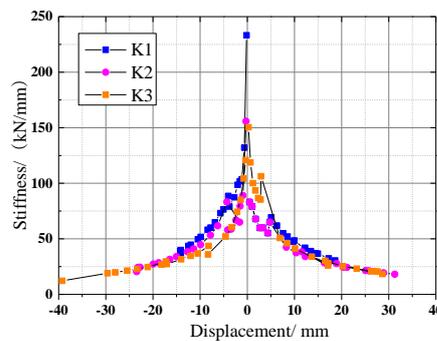
Fig. 10 Degradation of lateral stiffness of specimens

As for specimen RCF1, the lateral stiffness was mainly contributed by the lateral stiffness of beam and column members, which were relatively limited. On the contrary, the lateral stiffness of specimen RCF2 was mostly contributed by the BRBs. The stiffness of different story of two specimens was calculated and listed in Table 4 and Table 5.

RCF1 was much smaller than that of specimen RCF2, and same situation for the shear force. However, the increasing range did not fluctuate as sharply as the increase of inter-story drift. And the inter-story drift ratio of the two specimens ranged from 4 to 8. The law of degradation of stiffness was also different, just as shown in Fig. 10. At first, the slope of the curve is very sharp, but in the later period, after all the cracks developed completely and the structure seriously damaged, with the increase of inter-story drift, the load or shear force increased very slowly.

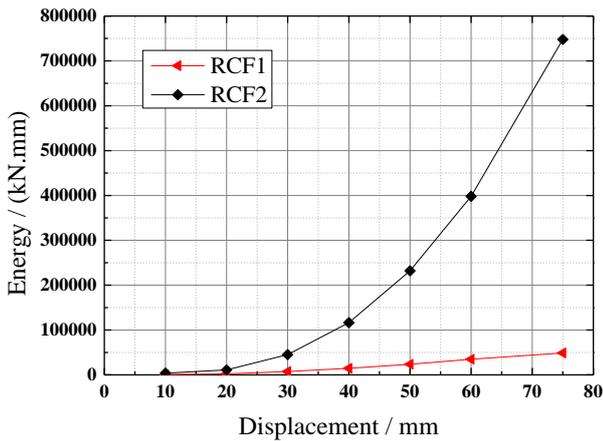
Fig. 11 Energy-dissipation capacity of specimens

From the hysteretic curve, the energy dissipation capacities of two specimens were calculated and demonstrated in Fig. 11.

It can be seen that the ability of dissipating energy of specimen RCF2 was much larger than that of specimen RCF1, which showed that the ability of dissipating energy of BRBs was much larger, because the BRBs could absorb

quite a large amount of input energy. With the drift increasing, the dissipating-energy of BRBs accumulated significantly with the increasing of its plastic deformation. Consequently, the BRBs could be considered as the first protect lines for structure to dissipate amounts of input energy and protect the frame structure from damaging and collapsing. The total energy dissipated by specimen RCF2 was up to 2011676 kN·mm while the dissipated energy of specimen RCF1 was only 48438 kN·mm, which probably indicated that BRBs greatly improved the ability of energy-dissipation and could ensure the structure to maintain safe when suffered severe earthquake. And this outcome was also verified by Wu *et al.* (2013) that the buckling-restrained could almost dissipate more than 60% of the input energy, especially when the inter-story drift achieved 1/40, the energy dissipated by BRBs accounted for nearly 80% of the energy dissipated by whole structure. This could also be seen from Fig. 11, with the displacement increasing, the dissipated energy grew faster.

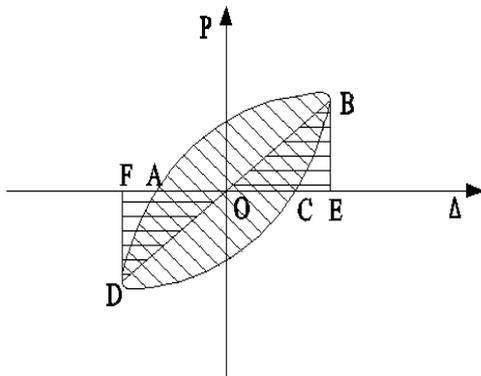
Fig. 12 Schematic diagram of equivalent viscous damping calculation

Damping can significantly reduce the response of vibration and was always used to measure the energy for vibration reduction, which must be taken into consideration in seismic performance investigation and response analysis. For convenience, the damping ratio was used to consider the effect of damping of BRBs. Moreover, in order to incorporate various energy-dissipating systems, the damping ratio often consists two parts: the damping ratio of RC frame ζ_f and the additional equivalent viscous damping ratio provided by BRBs. For simplicity, the method of energy-equivalent could also be used to calculate the whole structural equivalent viscous damping ratio. The formula is written as follows

$$\zeta_{eq} = \frac{E_p}{2\pi E_e} = \frac{A_{ABC} + A_{ADC}}{2\pi(A_{OBE} + A_{ODF})} \quad (1)$$

In formula (2), E_p and E_e represent the dissipating energy and the total energy under certain target displacement, respectively. And E_p refers to the whole dissipating energy for every cycle, which could be obtained by calculating the area of the shadow in the Fig. 12, While E_e refers to the strain energy reserve of the whole structure (namely potential energy), which could be obtained by calculating the area of triangle in the Fig. 12 by the formula of $E_e = \frac{1}{2} \sum F_{\max} U_{\max}$.
