# Pullout resistance of treadmats for reinforced soil structures

Keun-Soo Kim<sup>1</sup>, Yeo-Won Yoon<sup>\*1,2</sup> and Ki-II Song<sup>2</sup>

**Abstract.** A series of pullout tests were carried out on waste tire treadmats of various weave arrangements, with confining stresses ranging from 9 to 59 kPa approximately, in order to investigate the pullout behavior and to apply the results to the design of treadmat reinforced soil structures. A treadmat reinforcement can be considered as belonging to the extensible type thus progressive failure would develop in every tread. The pullout capacity of a treadmat was found to be generally equal to the sum of capacities of the longitudinal treads, with minor enhancement realized due to the presence of transverse treads. Pullout failures occurred in treadmats under light surcharge and with treadmats with higher material presence per unit area, while breakage failures occurred in treadmats under heavier surcharge and with treadmats with higher ratio of opening. The pullout capacity of a treadmat increased with increasing surcharge height and treadmat stiffness. A pullout test on a commercially available geogrid was also carried out for c

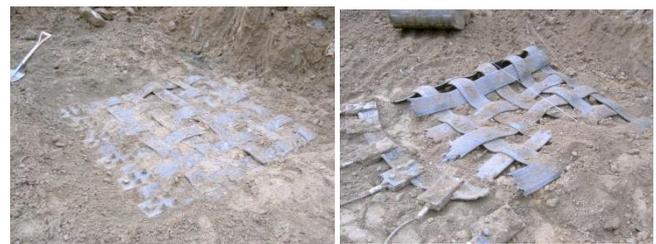
(a) 6×6 treadmat failed by pullout (b) 6×6 treadmat failed by breakage

Fig. 6 Deformed shape of the treadmats after the pullout test

Although the treadmats which failed by pullout were only slightly deformed, as shown in Fig. 6(a), the treadmats which failed by breakage were torn, as shown in Fig. 6(b). The distribution of the tensile force in the treadmats is the highest in the frontal part, because they can be considered as a type of extensible reinforcement materials. However, the largest extension occurred between the first and the second row, because the steel plates were attached at the first row of the treadmats. The breakage mainly occurred in direction perpendicular to the pullout direction between the first and the second row.

Typical deformed shape and pullout behavior of treadmats which failed by breakage are given in Fig. 6(b) and Fig. 9, respectively. Table 7 summarizes the pullout behavior of a 4×4 treadmat which failed by breakage. Its initial behavior shown in Fig. 9 was similar to that of the treadmats which failed by pullout. In other words, frontal movement was mobilized; however, rear movement did not develop at this point. The middle displacement of the 4×4 treadmat was measured at a pullout force of 137 kN, and the strain for corresponding frontal displacement,  $\epsilon_{\text{front}}$ , was 8.2%. Because the pullout force and deformation of the tread are related to the stiffness of the treadmats or the number of treads, despite the fact that the pullout force of the 4×4 treadmat is smaller than that of the 6×6 (F) treadmat, its strain is larger. The last displacement was not measured at the pullout capacity of 157 kN because the pullout force was not transferred to the last row due to breakage of the tread. The pullout force rapidly decreased after the peak value.

Based on the experimental test results, transverse members are very flexible and breakage failures were only observed in longitudinal members (Fig. 6(b)). And, if cross area between longitudinal and transverse member takes as longitudinal member, surface areas of transverse member of 3×3 and 6×6 are 4% and 2.4% of longitudinal member area, respectively. Bergado *et al.* (1993) reported that the pullout capacity of geogrids without transverse members was about 90-100% of that of the grids with transverse members. Also the difference in pullout resistance between geogrid and treadmats is from the tensile strength difference.

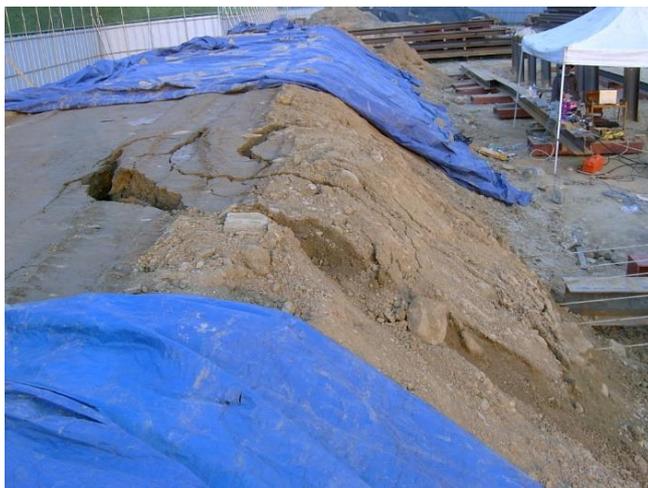
Fig. 7 Tension crack occurred in test embankment during the pullout test

Long (1993), O'Shaughnessy and Garga (2000a), Gerscovich *et al.* (2001) and Kim *et al.* (2011), reported that progressive failure was clearly observed in three-dimensional tire reinforcements. Typically, as working the pullout force, the first row of the tire reinforcements is extended in the direction of the pullout force. The first row is entirely mobilized, and the force is then transferred to the next row. Finally, the last row is elongated after full mobilization of the previous row. After failure of the last row, the tire reinforcement begins to slide along the lower surface of the tire reinforcement and to carry the soil mass above it as well, as shown in Fig. 7.
