## Ultimate strength of long-span buildings with P.E.B (Pre-Engineered Building) system

**Abstract.** With the improvement of the quality of construction materials and the development of construction technologies, large-scale long-span steel frame buildings have been built recently. The P.E.B system using tapered members is being employed as an economically-efficient long-span structure owing to its advantage of being able to distribute stress appropriately depending on the size of sectional areas of members. However, in December 2005 and in February 2014, P.E.B buildings collapsed due to sudden loads such as snow loads and wind gusts. In this study, the design and construction of the P.E.B system in Korea were analyzed and its structural safety was evaluated using the finite element analysis program to suggest how to improve the P.E.B system in order to promote the efficient and rational application of the system.

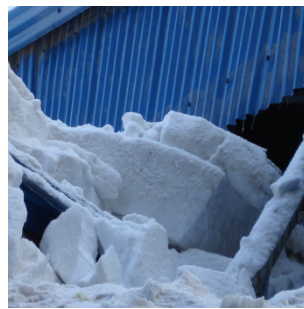
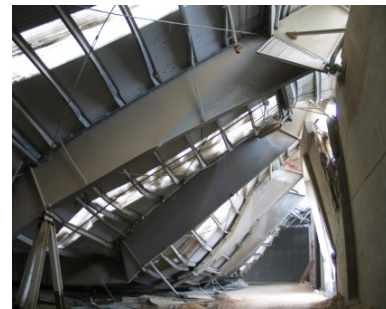
Fig. 1 Building A in K City

(a) Collapse of roof

(b) Snowfall of roof

(c) Deformation of rafter

was seriously damaged by heavy snow load and a sudden gust of wind. Also, in February 2014, gymnasium of M Resort in G City was collapsed and 10 people was died and more than 100 people was injured. Although the buildings were destroyed and damaged by a snow load three times stronger than the permissible snow load, the failure mode was brittle fracture caused by the local buckling at the web under compressive force and lateral torsional buckling at the flange below the rafter as shown in Figs. 1 to 3.

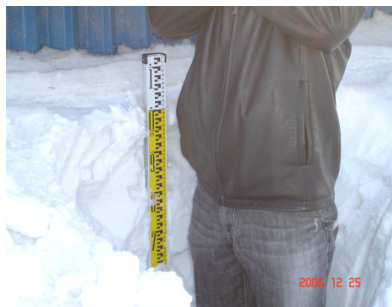
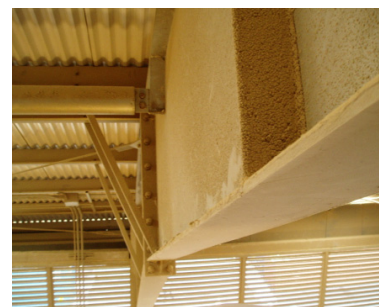
Fig. 2 Building B in K City

(a) Snowfall of roof

(b) Lateral torsional buckling

(c) Web of rafter

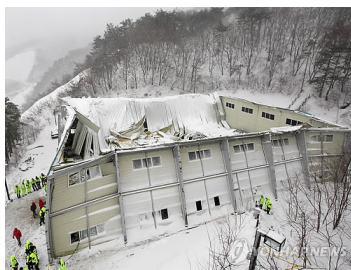
Fig. 3 Gymnasium of G City

(a) Collapse of roof

(b) Snawfall of roof

(C) Deformation of rafter

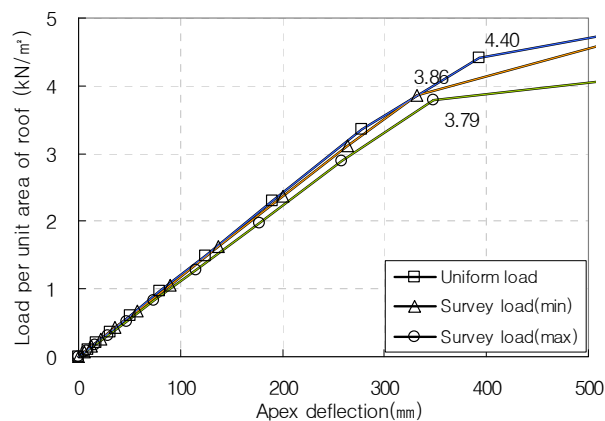
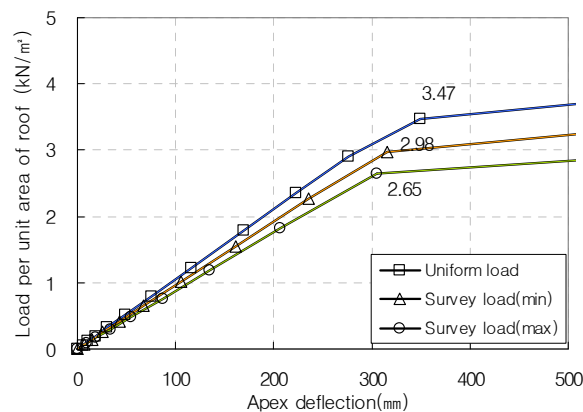
Fig. 8 Results of non-linear analysis

rate. Fig. 8 shows the relationship between load per unit area and Apex deflection compared between survey loads and uniform load. Building A yielded under the uniform load of  $4.4 \text{ kN/m}^2$ . However, while stiffness under survey loads was similar to that under uniform load, it yielded under the load of  $3.79\text{--}3.86 \text{ kN/m}^2$ . Building B yielded under the uniform load of  $3.47 \text{ kN/m}^2$  and under the survey loads of  $2.65\text{--}2.98 \text{ kN/m}^2$ .

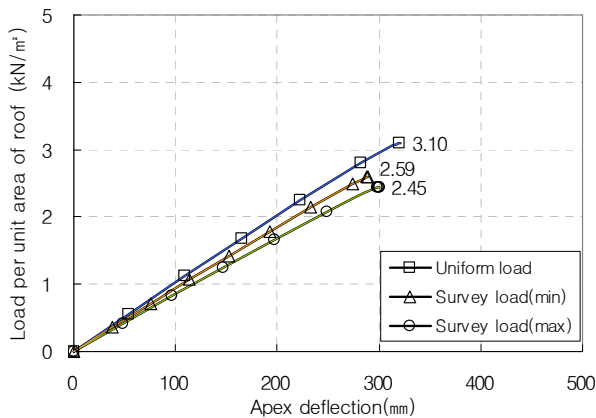
Fig. 9 Results of lateral torsional buckling analysis

During post-buckling analysis, survey loads were increased at a constant rate. As shown in Fig. 9, lateral buckling was observed under 2.70-2.94 kN/m<sup>2</sup> in Building A and under 2.45- 2.59 kN/m<sup>2</sup> in Building B at where web local buckling was observed previously.

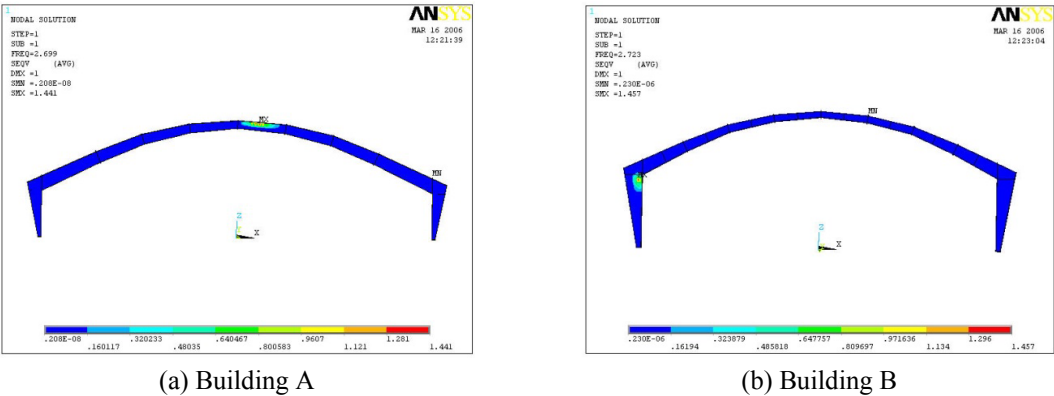
Fig. 10 Local buckling under uniform load

the ANSYS 9.0 (ANSYS 2005) Web local buckling was initially observed at the center of span in Building A and at the columns in Building B.

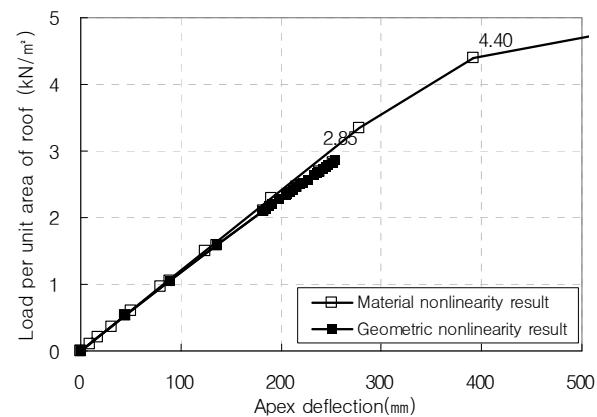
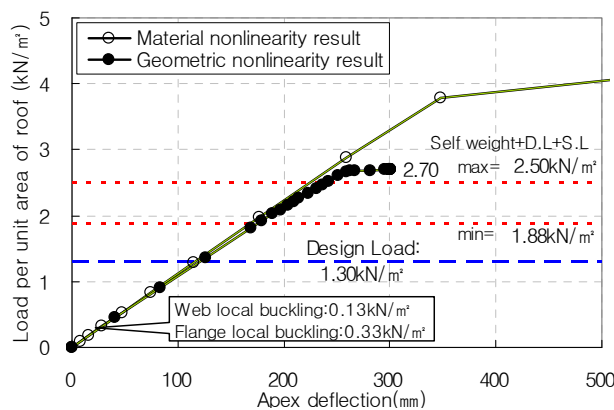
Fig. 12 Results of non-linear analysis for Building A

Under uniform load, web local buckling was initially observed and followed by flange local buckling and lateral torsional buckling in Building A and web local buckling was initially observed and followed by lateral torsional buckling and flange local buckling in Building B. However, under survey loads, lateral torsional buckling was initially observed in Building A due

to uneven load distribution and followed by web local buckling and flange local buckling in Building A and flange local buckling was initially observed and followed by web local buckling and lateral torsional buckling in Building B. Therefore, it is deduced that the ultimate load capacity and collapse mode of P.E.B buildings vary significantly depending on load direction and reinforcement type such as flange braces and stiffeners.

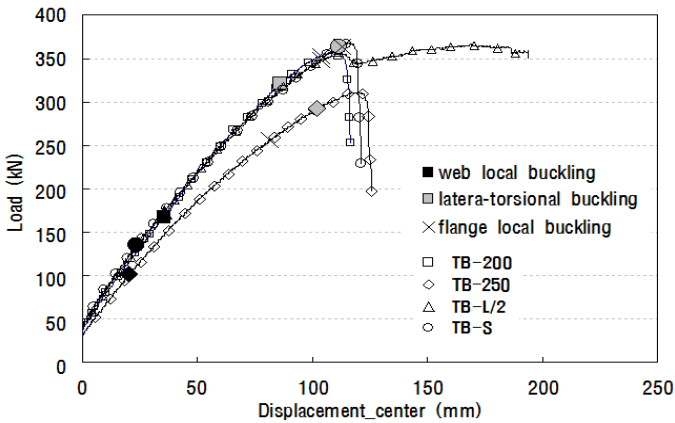
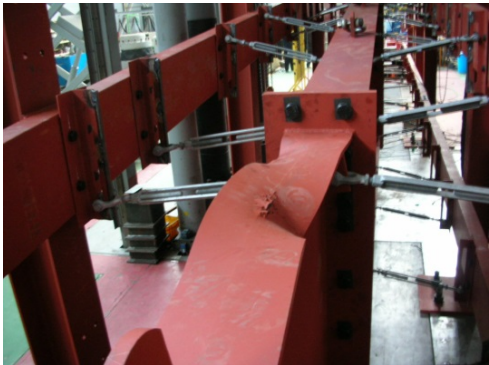
Fig. 16 Test results

(a) Load-Disp relations of specimens

(b) Lateral torsional buckling (TB-250)

(c) Flange local buckling (TB-L/2)

Because the rafters used in a P.E.B system are slender, local buckling and lateral torsional buckling are highly feasible depending on the unbraced length. As shown in Figs. 15 and 16 and Table 4, previously conducted studies showed that specimens with a large web width-thickness ratio were vulnerable to web local buckling, lateral buckling and flange local buckling and had the lowest stiffness. Also, a shorter unbraced length (TB-L/2) coincided with better ductility. Therefore, in order to confine lateral buckling completely in a P.E.B system using rafters with tapered webs, the web width-thickness ratio should be small where buckling is expected and the setup angle associated with lateral force and sectional size should be taken into consideration in flange brace design. In addition, the lateral braced length should be short to secure ductility.

- Web width-thickness ratio should be small in the section of rafter with tapered web where buckling is feasible. Flange braces should be designed with setup angle associated with lateral force and sectional size taken into consideration. In addition, lateral braced length of flange braces should be short in order to secure ductility.
