## Loss of strength in asbestos-cement water pipes due to leaching

**Abstract.** Asbestos-cement is a material with valuable strength and durability. It was extensively used for water distribution pipes across the world from the 1950s until the early 1980s. The network of pipes in this case study dates from the 1970s, and after more than 30 to 40 years of service, some pipes have been found to break under common service pressure with no apparent reason. A set of mechanical tests was performed including bending, compression, pressure and crushing tests. Microscopy analysis was also used to understand the material behaviour. Tests showed that there was a clear loss of strength in the pipes and that the safety factor was under the established threshold in most of the specimens. Microscopy results showed morphological damage to the pipes. The loss of strength was attributed to a leaching effect. Leaching damages the cement matrix and reduces the frictional interfacial shear stress.

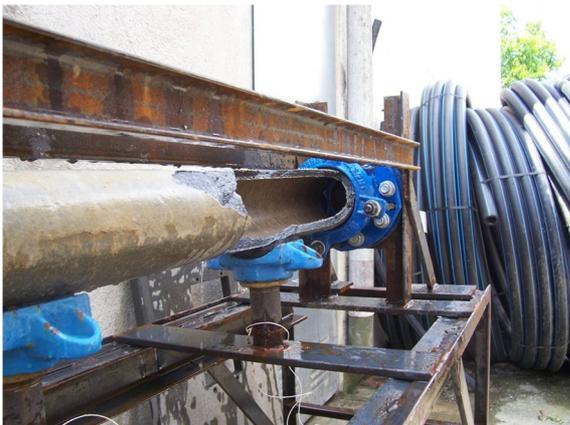
Fig. 1 Failure of a pressure test

We obtained 51 specimens from the network that were chosen randomly but distributed such that all areas of territory were explored. All the specimens had the same length, thickness and diameter. We performed 51 failure tests by pressure (Fig. 1), crushing (Fig. 2), and compression (Fig. 3), and we performed 16 additional bending tests (Fig. 4). Pressure, crushing and bending tests followed European Standards EN 512 (1995). Compression tests are not standardised for asbestos-cement pipes, but standards EN 12390-1 (2000) and EN 12390-2 (2000) for concrete aided in the experimental design. Extreme care was taken to ensure a good planar surface between opposite sides, and all specimens were capped with sulphur to reduce the effects of stress concentrations during loading.

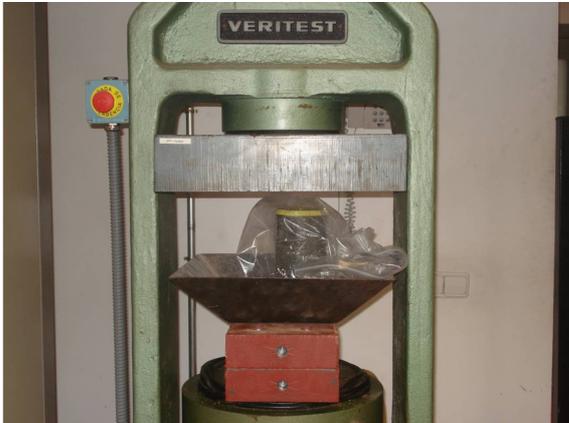
Fig. 3 Compression test

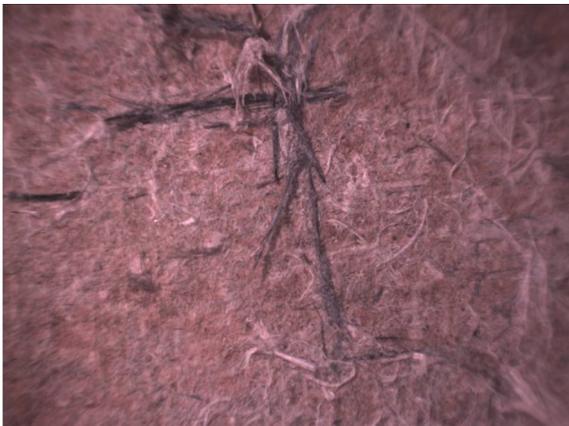
Microscopy results showed that there was a morphological change among specimens. The healthy pipes had a dark grey colour on the inner and outer side, whereas the weakest pipes had a pale grey colour on the inner side. The inner side of the stronger pipes' surface was uniform and slightly rough, and it was rather difficult to distinguish the fibres from the cement matrix. On the contrary, on the inner side of the weakest pipes, some fibres could be seen separated from the cement with a largely porous and rough surface.

Figs. 9 and 10 show one of the weakest pipes; when compared with Figs. 11 and 12, which show one of the strongest pipes, the differences are clear.

Fig. 9 Microscopy image of pipe's inner surface (weak pipe)

Fig. 10. Microscopy image of pipe's inner surface (weak pipe)

Microscopy observation showed that most of the specimens, especially the weakest ones, had a rough and porous inner surface and had fibres that were not glued to the cement matrix. On the contrary, the strongest pipes showed a smooth surface on which it was impossible to distinguish fibres from matrix. Moreover, there were colour changes from dark grey on the outer surface of the pipe to pale grey on the inner surface. There is a fuzzy frontier between both colours in the cement paste. Destructive tests showed that many pipes lost strength capability under pressure, crushing and bending. The loss of compressive strength was especially significant for all specimens.
