## Structural evaluation of Aspendos (Belkıs) Masonry Bridge

Temel Türker\*

**Abstract.** In this study, the structural performance of a seven span masonry arch bridge was evaluated. Investigations were performed on Aspendos (Belkıs) Masonry Arch Bridge which was located on road of Aspendos Acropolis City in Antalya, Turkey. The old bridge was constructed in the early of fourth century AD, but it was exposed to the earthquakes in this region and the overloading by the river water. The old bridge was severely damaged and collapsed by probably an earthquake many years ago and a new bridge was then reconstructed on the remains of this old bridge by Seljuk in the 13th century. The bridge has also been affected from overflowing especially in the spring of each year, so some protective measures should be taken for this monumental bridge. Therefore, the structural performance under these loading has to be known. For this purpose, an initial finite element model was developed for the bridge and it was calibrated according to ambient vibration test results. After that, it was analyzed for different load cases such as dead, live, earthquake and overflow. Three load combinations were taken

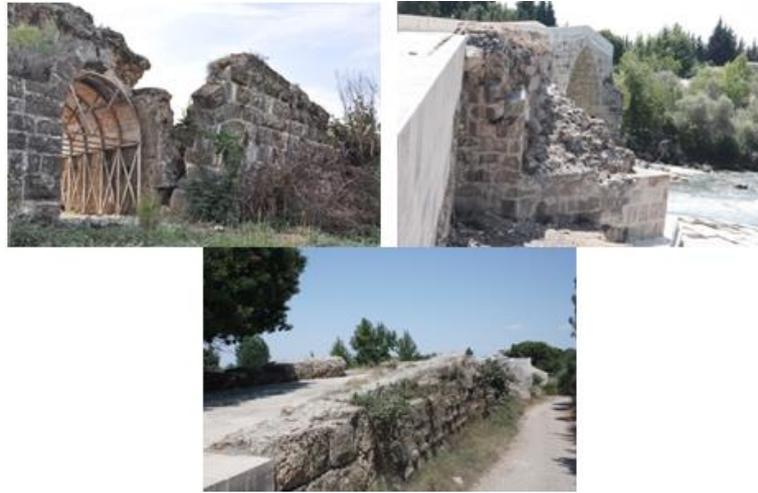
Fig. 1 The ruins of the old Aspendos Bridge

The Aspendos Masonry Bridge was a late Roman bridge over the Köprüçay River in southern Anatolia. The bridge was situated on the road of Antalya-Manavgat and approximately 2km from Aspendos Acropolis City. It was known as Eurymedon in ancient times. It was damaged and many of its arches collapsed. The bridge lost a lot of former splendor. The shape and course of the old bridge had been reconstructed digitally, based on the still extant remains of the ancient structure: parts of the ramps, the abutments, as well as the foundation of a pier by Kesenner and Piras (1998) and Klaus (1999). Several pieces of the original bridge were found scattered in the river bed. It can be seen some parts of the old bridge in two sides in Fig. 1.

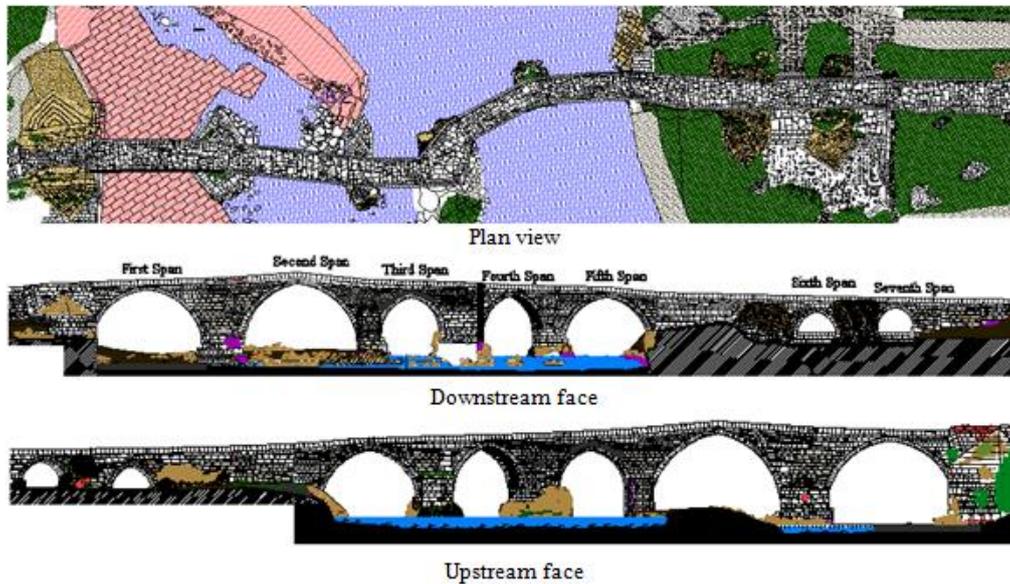
Fig. 5 The detailed drawing of Aspendos Masonry Arch Bridge including water level

The bridge was mainly constructed of stone blocks, while parts of the old bridge have been reused including the duct stones, which were built into the new ramp. In the late 1990s, restoration works in the bridge's crumbling breastwork also revealed stone inscriptions in Greek and Arabic. The total length of the bridge is 220m and the width of the bridge varies between 3.5m and 6.5m. It has seven arch spans and the length of the biggest span is approximately 16.5m. Stream water flows from five of these spans and the two spans in the right side is above the stream water level as shown in Figs. 3-4. The biggest span is the second span and it has approximately 16m arch length. The smallest span is the sixth span and it has 5.4m arch length as demonstrated in Fig. 5.

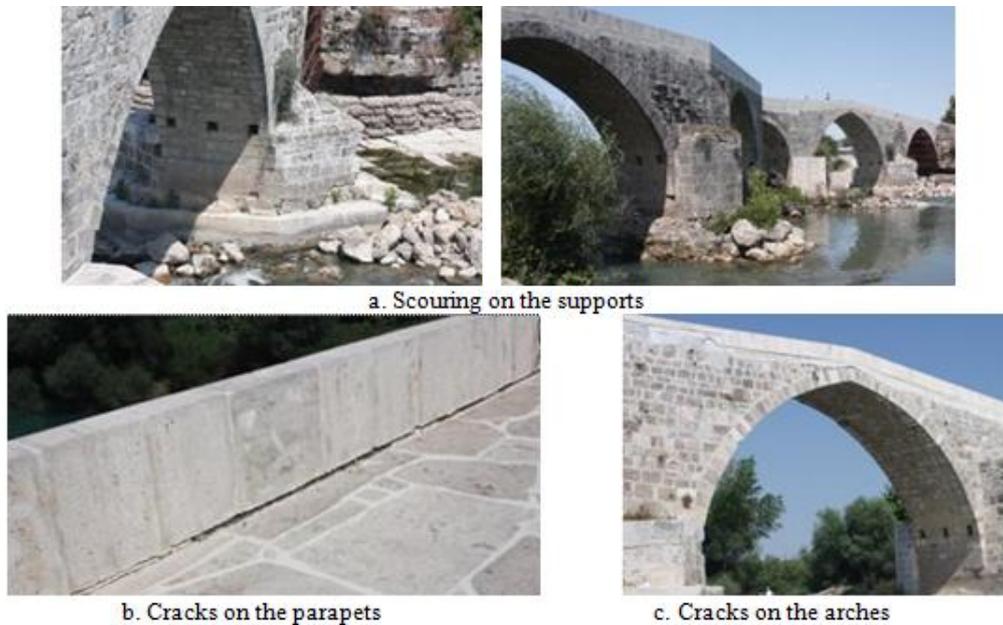
Fig. 6 The damages on Aspendos Masonry Arch Bridge

There are many distortions on both structural and non-structural members of the bridge. In the flood in 2003, the bridge severely damaged. A restoration application was applied to the bridge. But it was damaged again in the flood in 2010. The current damages occurred after the last flood. Some of them are visual distortions and low level while the others are severe in view of structural behavior. The distortions, such as scouring on the supports, cracks on parapets, arches and walls, joint segregation, mainly come into exist due to stream water pressure. Fig. 6 shows some of the damage on Aspendos Masonry Arch Bridge.

The scouring on the supports caused vertical movements on some parts of the main body and the damages on the arches and walls. The damages concentrated on the second and third spans. It can be clearly seen the disintegration between the parapets and the bridge deck as shown in Figure 6b.

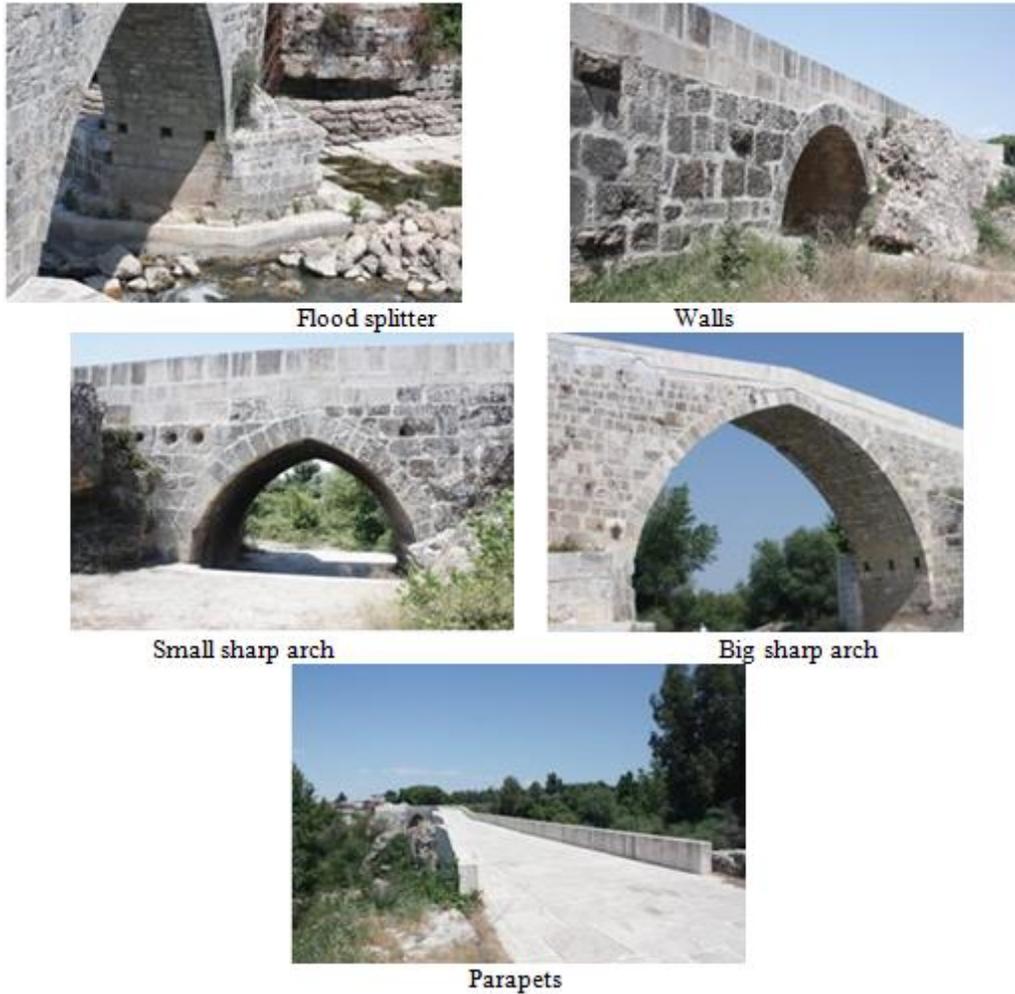
Fig. 7 The architectural members in Aspandos Masonry Arch Bridge

The bridge consists of many architectural members, such as walls, decks, ledges, parapets, and flood splitter, etc, as given in Fig. 7. The bridge has different type arches constructed according to Roma and Seljuk times. Also, there are different types of stones on main body of the bridge because of the restoration applications in different times.

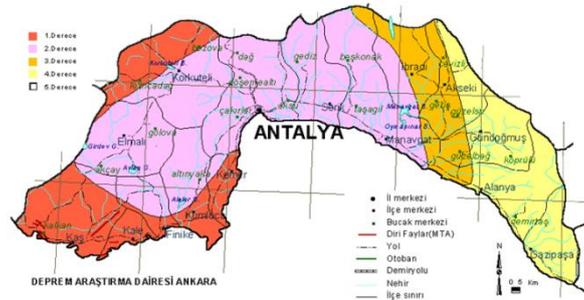
Fig. 8 The definition of the earthquake region of Antalya

in the spring of each year. The bridge was located in Antalya, which is in the second earthquake region defined by Turkish Earthquake Guide (DBYBHY 2007), as given in Fig. 8.

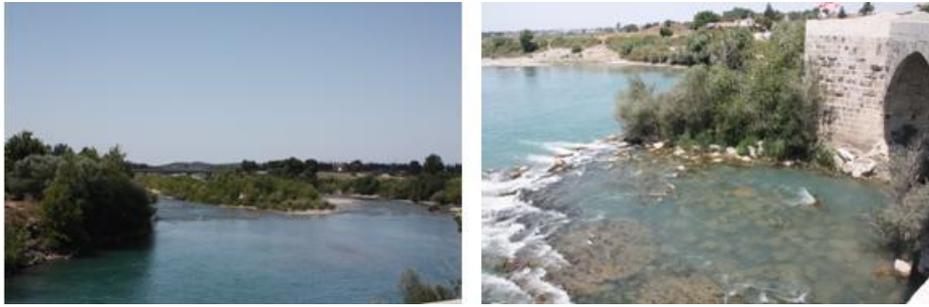
Fig. 9 Views from the river water and permanent fortifications in river bed

The bridge has seven spans and only five of those are in use in normal time. In this portion of the river, the speed of flow is very high. To decrease flowing speed, the permanent fortifications were constituted as shown in Fig. 9. The maximum water level in the Köprüçay River was 6.4m.

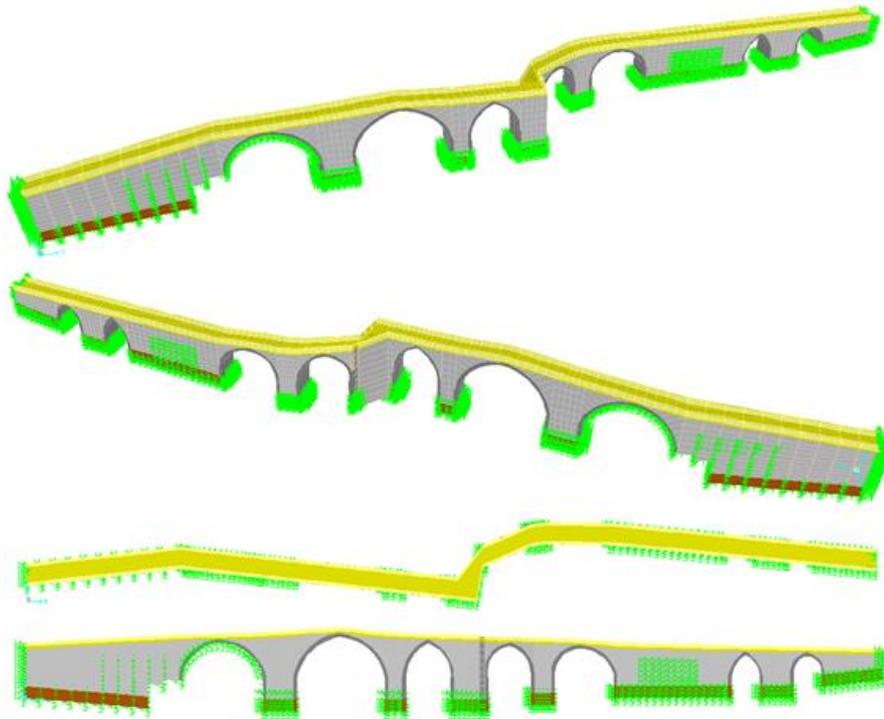
Fig. 10 The finite element model of Aspendos Masonry Arch Bridge

A finite element model of Aspendos Masonry Arch Bridge was developed by using the dimensions on the building surveys and a detailed model was created by SAP2000 Finite Element Program as shown in Fig. 10 (SAP2000 2008). The finite element model consists of four nodes solid elements having three degree of freedom in each node. In the finite element model, totally 9098 finite elements were used. The finite element model was named as initial finite element model because of the many assumptions in boundary conditions, material properties, etc.

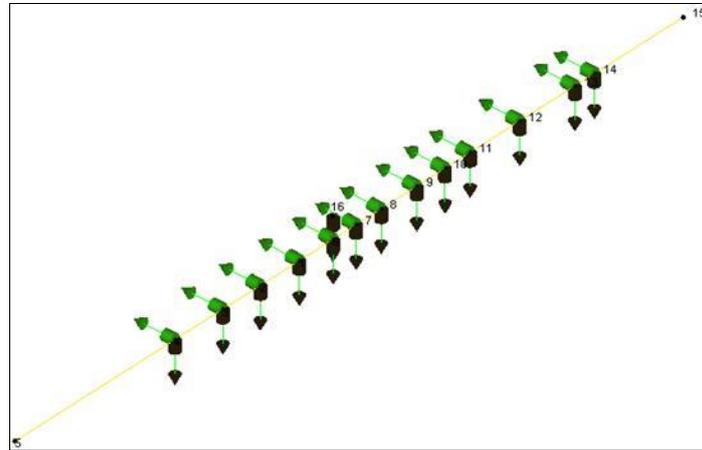
Fig. 11 The accelerometer positions in the measurement of Aspendos Masonry Arch Bridge

These results in Table 2 were compared with the ambient vibration test results. The test was carried out during the in-situ investigations on the damaged bridge to identify the real dynamic characteristics. The structural responses were acquired by using uniaxial seismic accelerometers from the thirteen different points in vertical and lateral directions. A simplified model for the accelerometer positions on Aspendos Masonry Arch Bridge are given in Fig. 11. Also, some views from the measurement are presented in Fig. 12.

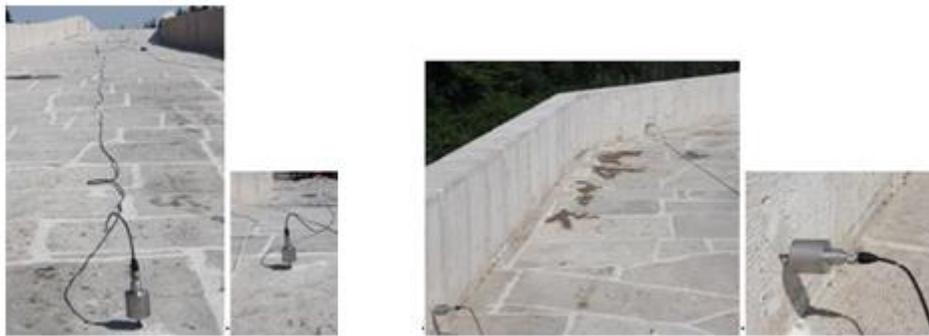
Fig. 12 The accelerometer connections on Aspendos Masonry Arch Bridge

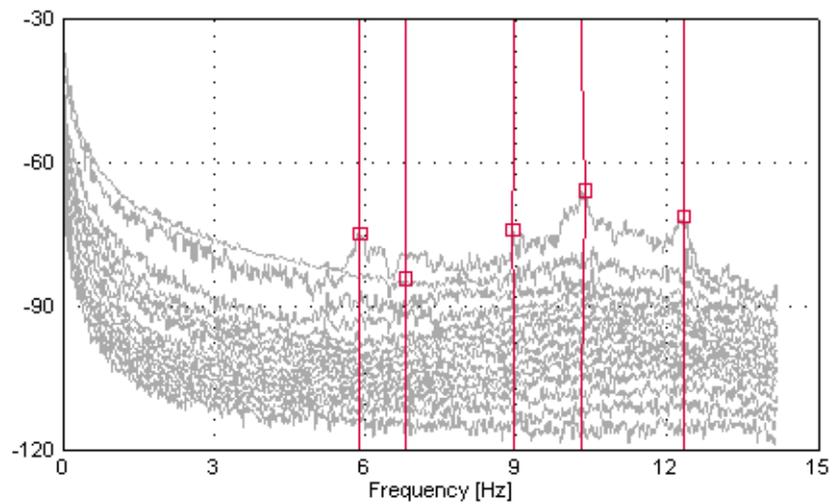
[dB | (1 m/s<sup>2</sup>)<sup>2</sup> / Hz]Enhanced Frequency Domain Decomposition - Peak Picking  
Singular Values of Spectral Density Matrices  
of Data Set: Measurement 2

Fig. 13 The singular values of spectral density matrices of Aspendos Masonry Arch Bridge

The collected signals were analyzed by using PULSE and OMA software (PULSE 2006; OMA 2006). The natural frequencies, mode shapes and modal damping ratios of the bridge were attained from the signals by Enhanced Frequency Domain Decomposition method in 0-12.5Hz frequency range. The singular values of spectral density matrices are plotted in Fig. 13 for the test. The investigations were reported by Bayraktar (2011). The natural frequencies and the modal damping ratios of the bridge were given in Table 3. Also, the first five mode shapes of the bridge were presented in Fig. 14.

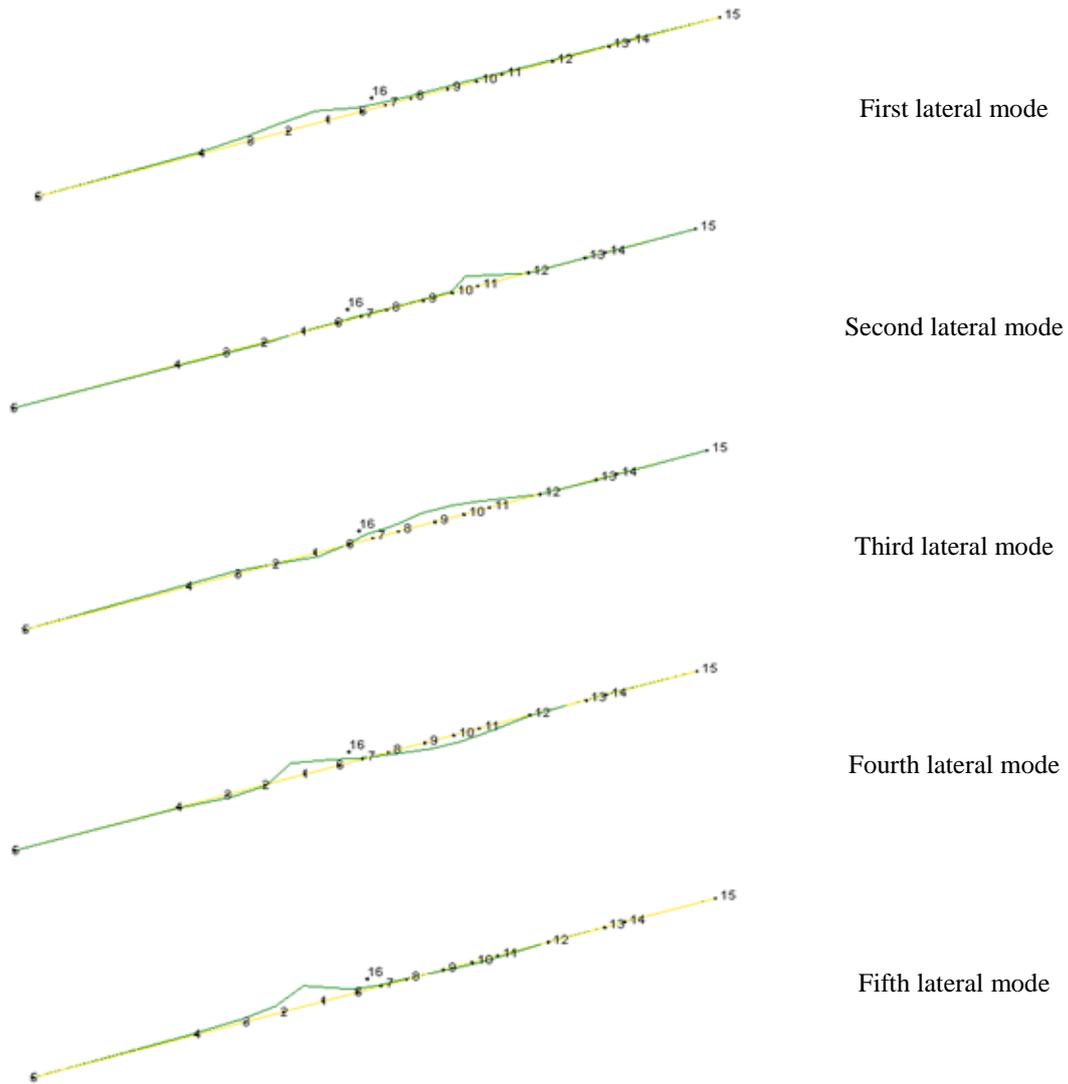
Fig. 14 The first five mode shapes of Aspendos Masonry Arch Bridge

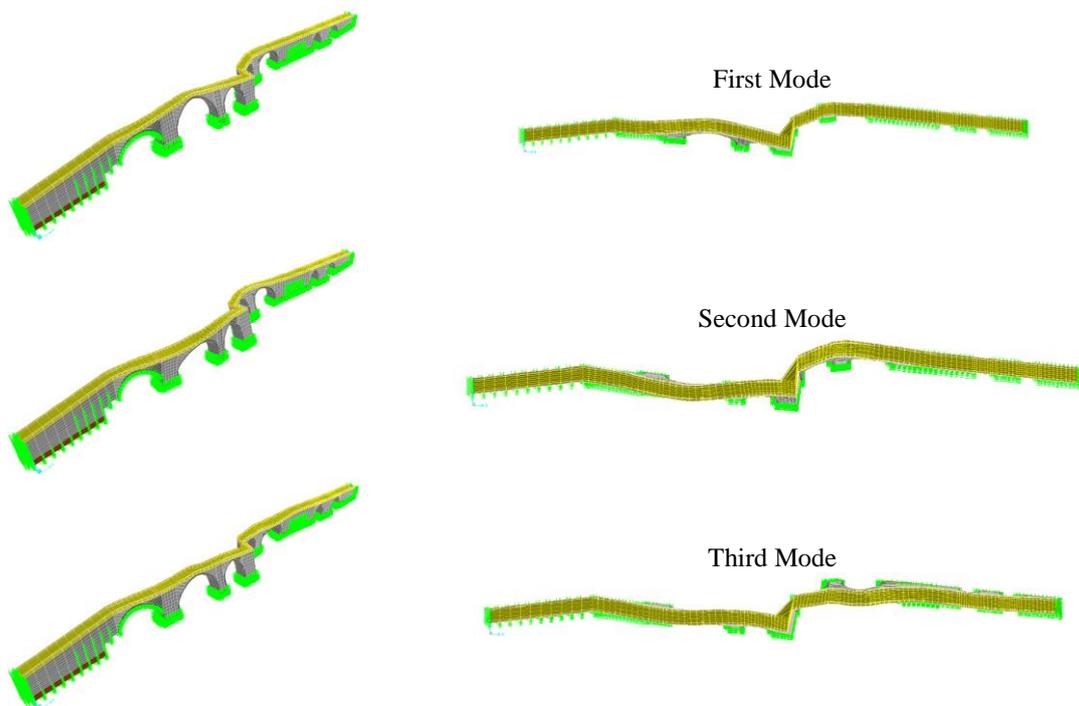
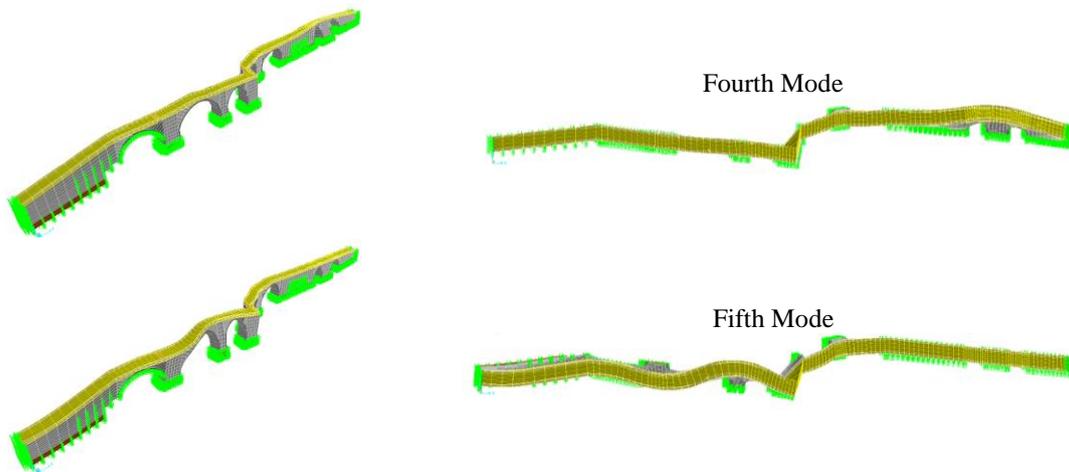
Fig. 15 The first five mode shapes of Aspendos Bridge from the calibrated finite element model

To decrease the differences, the initial analytical model was calibrated by considering the damage effects and river bed condition. Manual updating method (trial and error) was used and the in-situ observations were applied to the initial finite element model. Therefore, the coefficient of soil reaction was considered as  $96 \cdot 10^6 \text{N/m}^3$ . The natural frequencies for the calibrated case are given in Table 4 and the mode shapes are presented in Fig. 15. By the calibrating process, the average difference was decreased to considerably. It can be stated that the calibrated finite element model reflects the real behavior of the bridge more accurately than the initial finite element model.

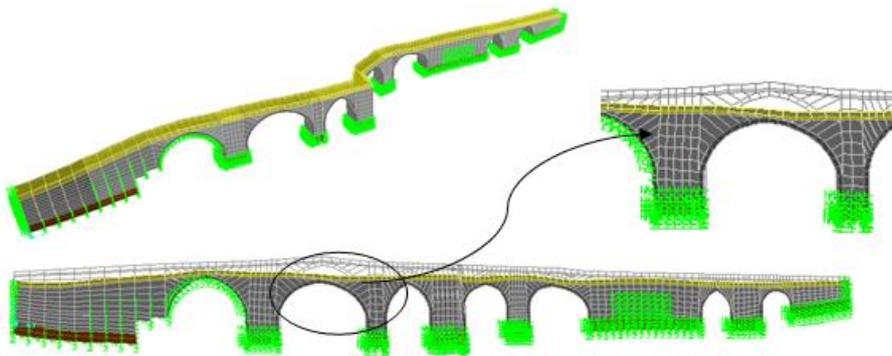
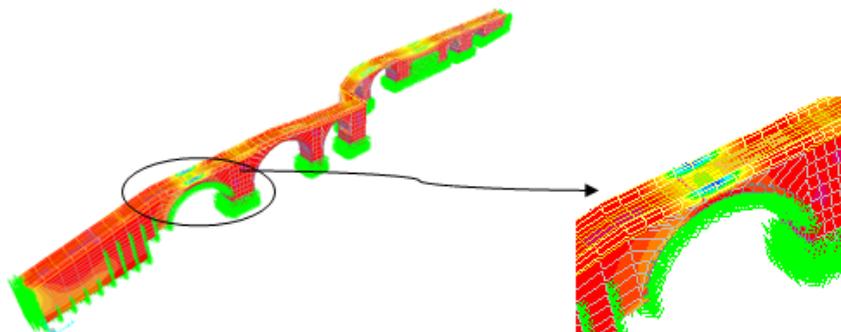
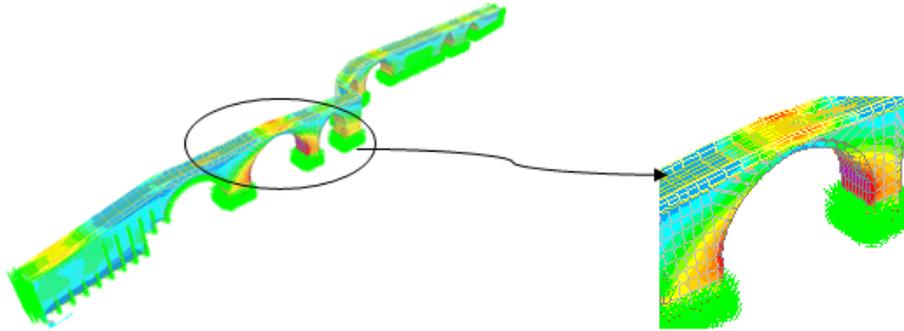
Fig. 16 The displacement of the bridge under the dead load

Fig. 17 The distribution of the tensile stress on the bridge under the dead load

Fig. 18 The distribution of the compressive stress on the bridge under the dead load

Firstly, Aspendos Masonry Arch Bridge was analyzed for the dead load. The displacements, tensile stress and compressive stress were attained under this load case as shown in Figs. 16-18.

The maximum displacement occurred in the second span in the vertical direction as 1.08mm. The maximum tensile stress occurred in the first span as 0.36MPa, the maximum compressive stress was occurred in the second span, which is the biggest span, as 0.60Mpa.

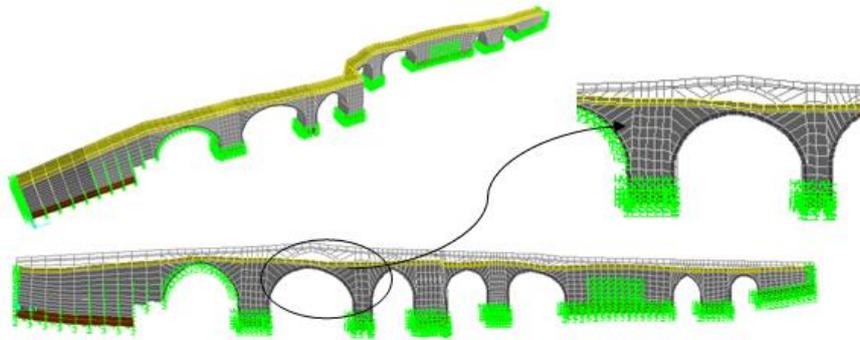
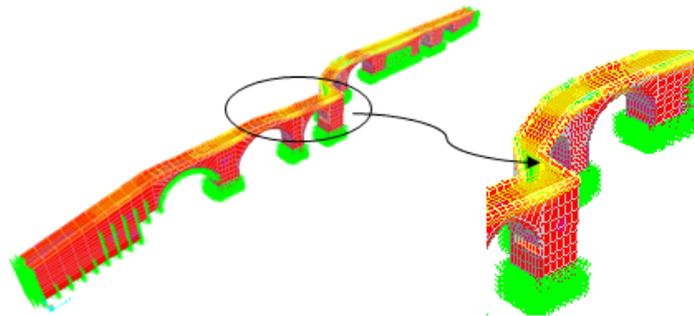
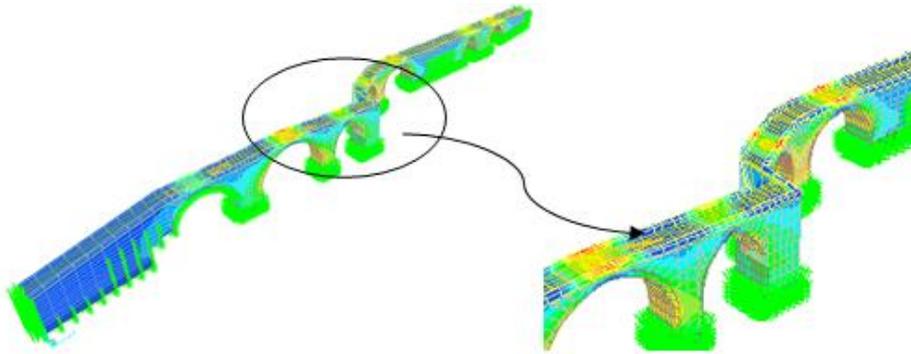
Fig. 19 The displacement of the bridge under the live load

Fig. 20 The distribution of the tensile stress on the bridge under the live load

Fig. 21 The distribution of the compressive stress on the bridge under the live load

Secondly, Aspendos Masonry Arch Bridge was analyzed for the live load, which is 500kN/m<sup>2</sup>. The displacements, tensile stress and compressive stress were attained under this load case as shown in Figs. 19-21.

The maximum displacement occurred in the second span in the vertical direction as 0.2mm. The maximum tensile stress occurred in the fifth span as 0.12MPa, the maximum compressive stress was occurred in the second, fifth and sixth spans as 0.18Mpa.

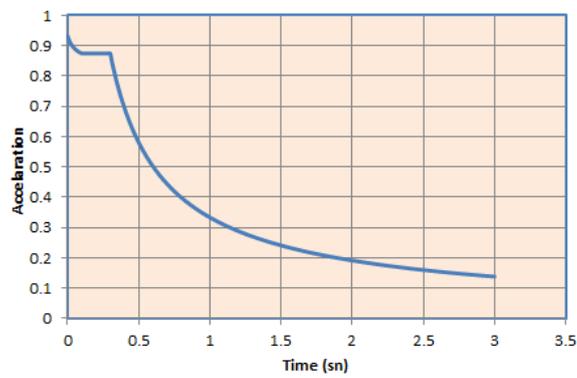
Fig. 22 The response spectrum used in the earthquake analysis

Thirdly, Aspendos Masonry Arch Bridge was analyzed for the earthquake load. Because earthquake motions are random and dependent on factors such as local soil conditions and distance from the source, it is most practical to use response spectra for earthquake loads. Therefore, the earthquake analysis was performed by using response spectrum analysis method, which was defined according to the Turkish Earthquake Guide (DBYYHY 2007). The region is in the second seismic zone depicted in Seismic Zoning Map of Turkey prepared by the Ministry of Public Works and Settlement. The used response spectrum is given in Fig. 22. The displacements, tensile stress and compressive stress were attained under this load case as shown in Figs. 23-25.

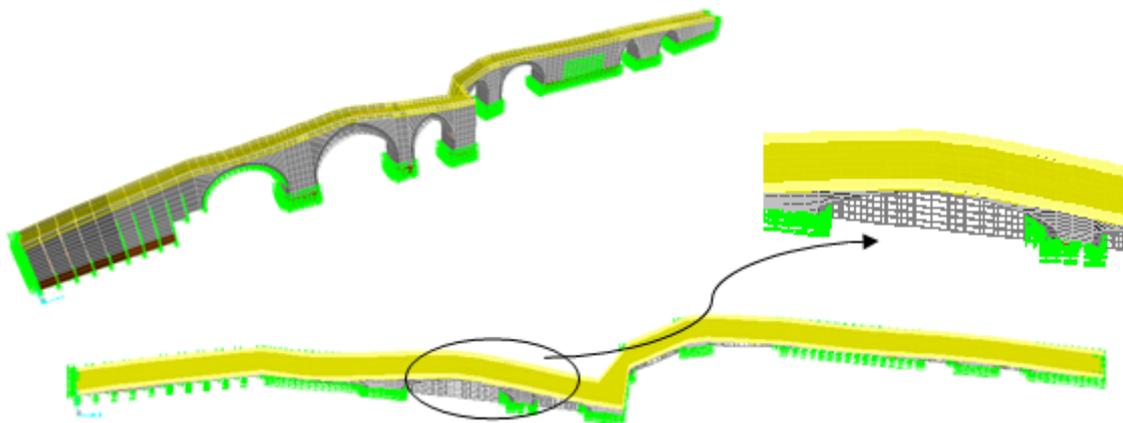
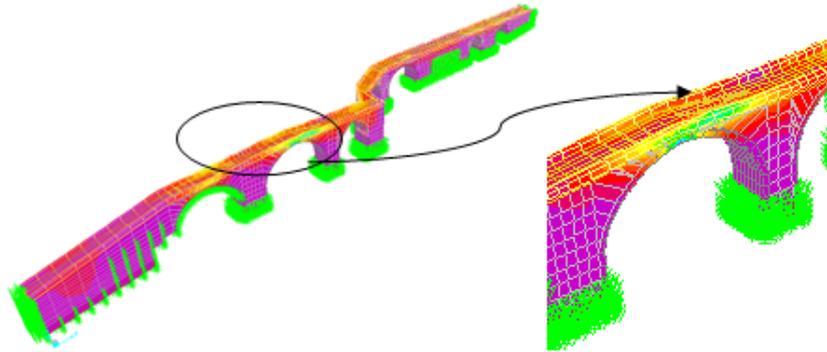
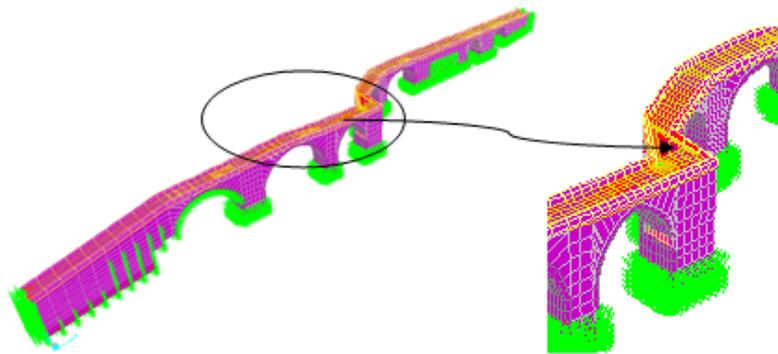
Fig. 23 The displacement of the bridge under the earthquake load

Fig. 24 The distribution of the tensile stress on the bridge under the earthquake load

Fig. 25 The distribution of the compressive stress on the bridge under the earthquake load

The maximum displacement occurred in the second span in the lateral direction as 3.7mm. The maximum tensile stress occurred in the second span as 1.54MPa, the maximum compressive stress was occurred in the fifth span as 0.84Mpa.

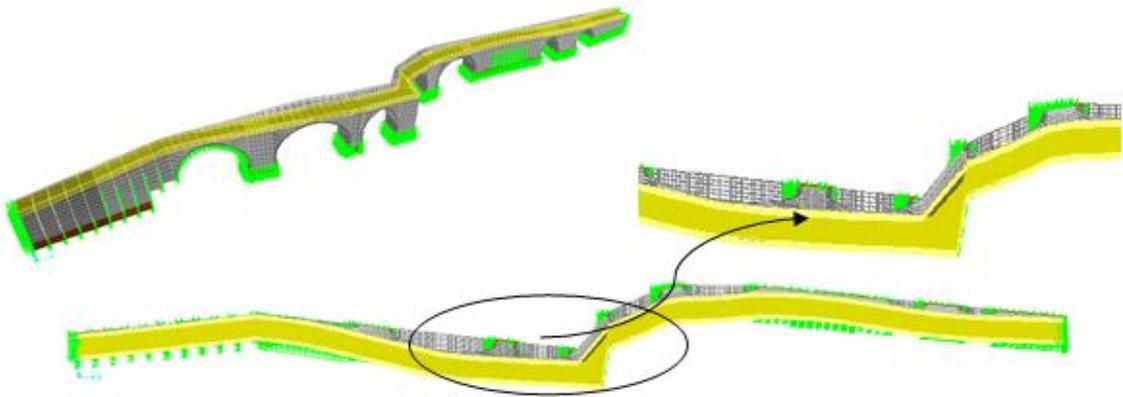
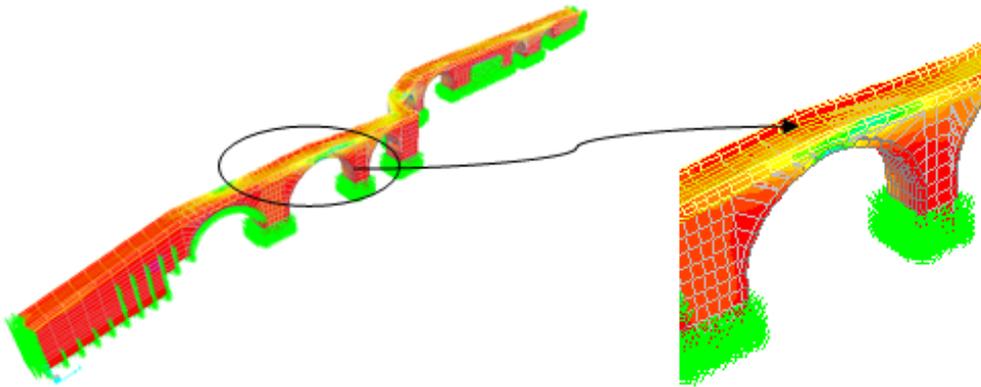
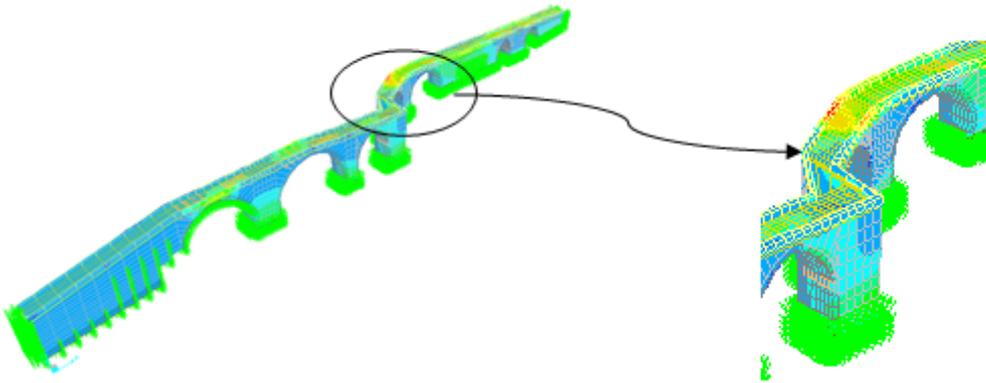
Fig. 26 The displacement of the bridge under the river water load

Fig. 27 The distribution of the tensile stress on the bridge under the river water load

Fig. 28 The distribution of the compressive stress on the bridge under the river water load

Finally, Aspendos Masonry Arch Bridge was analyzed for the river water load. The water pressure was calculated according to the maximum water level. The water loads were applied to the upstream face. The displacements, tensile stress and compressive stress were attained under this load case as shown in Figs. 26-28.

The maximum displacement was occurred in the second span in the lateral direction as 7.05mm. The maximum tensile stress was occurred in the second span as 2.28MPa, the maximum compressive stress was occurred in the fifth span as 3.12Mpa.
