Seismic capacity of brick masonry walls externally bonded GFRP under in-plane loading

Abstract. By carrying out the experiment of eight pieces of brick masonry walls with pilaster strengthened by Glass fiber reinforced polymer (GFRP) and one piece of normal masonry wall with pilaster under low reversed cyclic loading, the failure characteristic of every wall is explained; Seismic performances such as hysteresis, stiffness and its degeneration, deformation, energy consumption and influence of some measures including strengthening means, reinforcement area proportion between GFRP and wall surface, “through-wall” anchor on reinforcement effects are studied. The test results showed that strengthening modes have little influence on stiffness, stiffness degeneration and deformation of the wall, but it is another thing for energy consumption of the wall; The ultimate load, deformation and energy consumption of the walls reinforced by glass fiber sheets was increased remarkably, rigidity and its degeneration was slower; Seismic performance of the wall which considers strengthening means, reinforcement area proportion between GFRP and wall surface, “through-wall” anchor at the same time is

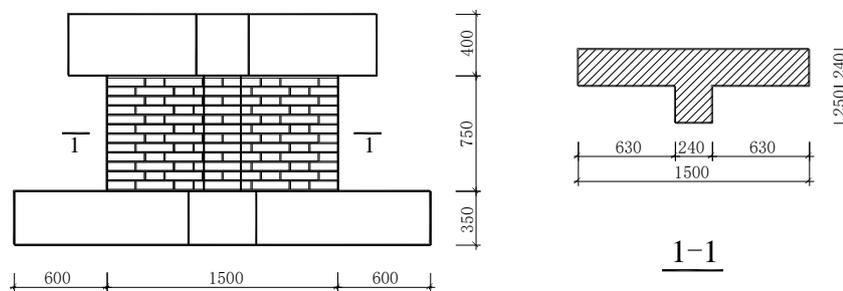
Fig. 1 Dimensions of specimens

The objective of this investigation is to determining seismic behavior of brick masonry walls externally bonded GFRP under in-plane loading reversals. Tests and observations have shown that the mechanisms of seismic behavior and failure modes of masonry walls in seismic situation depend mainly on the geometry of the wall. To a great degree, they depend on the ratio of height to width of the wall. The wall should be designed as a squat one. Based on the reviewed test carried out and contrasting between this research and others, the ratio of 0.5 may be justified. It is not practical to test very large walls in the laboratory. These are built as large as possible for the available handling and testing equipment. To simulate even large walls, the specimens are designed as walls with reduced size. For practice related investigation, a carefully selection of the test specimen is required. To be of possible contrast between this research and others, the main bodies of specimens, each having pilaster that has a section of 240 mm×240 mm and the same height of the main body, are of the nominal dimensions of 1500 mm×750 mm×240 mm, see Fig. 1. It is of relevant importance that the boundary restraints and loads acting on the walls, the top RC beam is built for distributing applied vertical and lateral forces evenly. The base of each specimen is anchored rigidly to the bottom RC beam for prevent wall rotation.

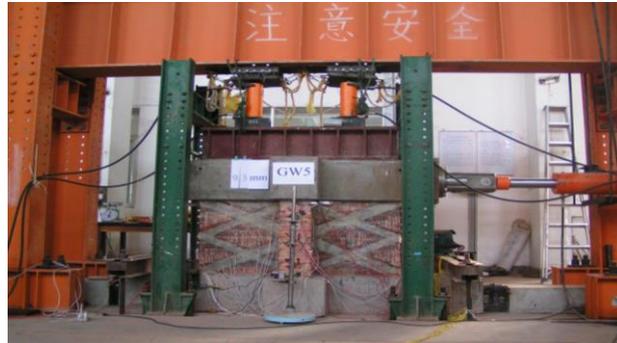
Fig. 2 shows the testing arrangement. A combination of vertical compression (representing loads from the building above) and in-plane shear load was applied to each specimen.

The vertical prestress load was applied through two connected hydraulic jacks. This load was distributed across the top of the specimen by a stiff steel reaction beam. The horizontal load (shear

Fig. 2 Test apparatus arrangement

load) was applied to the specimen by a horizontal double-acting jack.

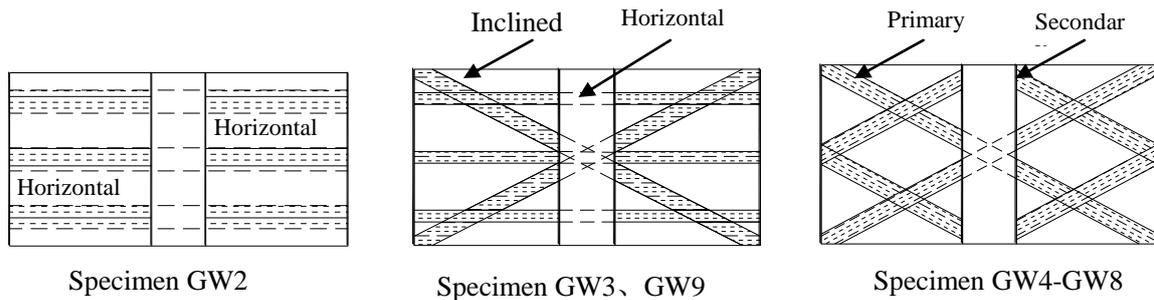
Fig. 3 Reinforcement scheme of specimens

Before applying the GFRP, the specimen was first cleaned from dust and mortar protrusions manually using a wire brush. In this preparation, attention was focused on cleaning the joints and removing excessive mortar and loose particles from the wall surface. A light layer epoxy resin was then applied to the using wall by a hand held paint roller to the wall surfaces. A mixture of the epoxy resin and silica fume was then used to fill the tooled joints and smooth the prepared surface before applying the GFRP. Prior to application on the walls, the dry fabrics were cut to lengths and the epoxy was worked into it with a paint roller. In order to minimize trapped air voids, the roller was run several times on the wet fabrics.

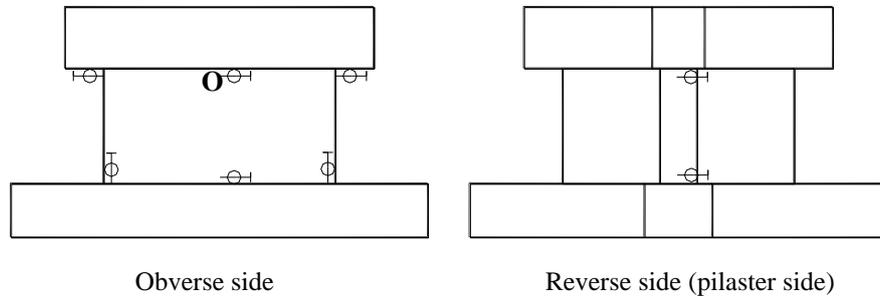
Vertical load and horizontal load were measured by load transducer and the horizontal deformation was measured by displacement meter, which formed a integrated collection system. Strain gauges were applied to the surface of the GFRP, to measure the strain along the tensile diagonal. The displacement measurement arrangement was shown in Fig. 4.

Fig. 4 Displacement measurement arrangement

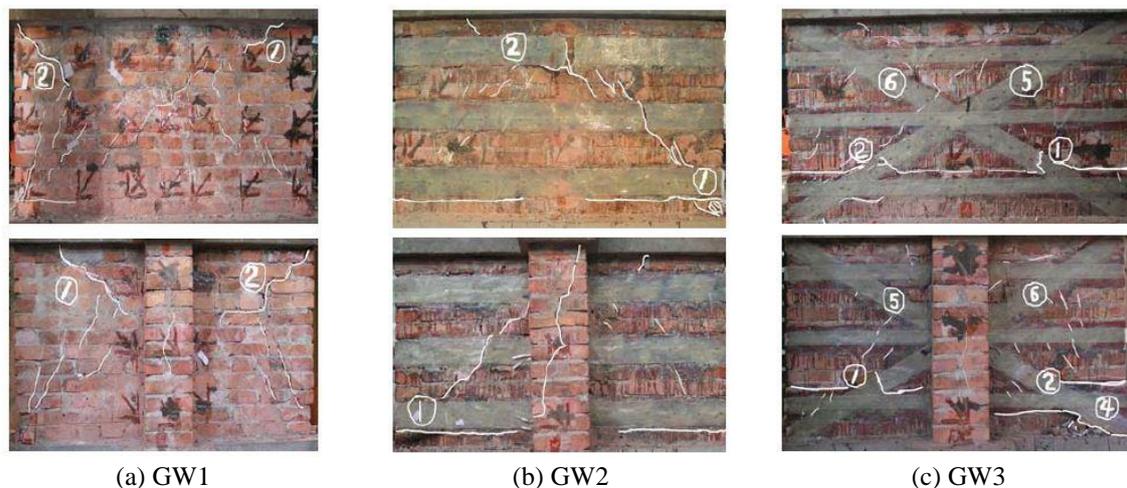
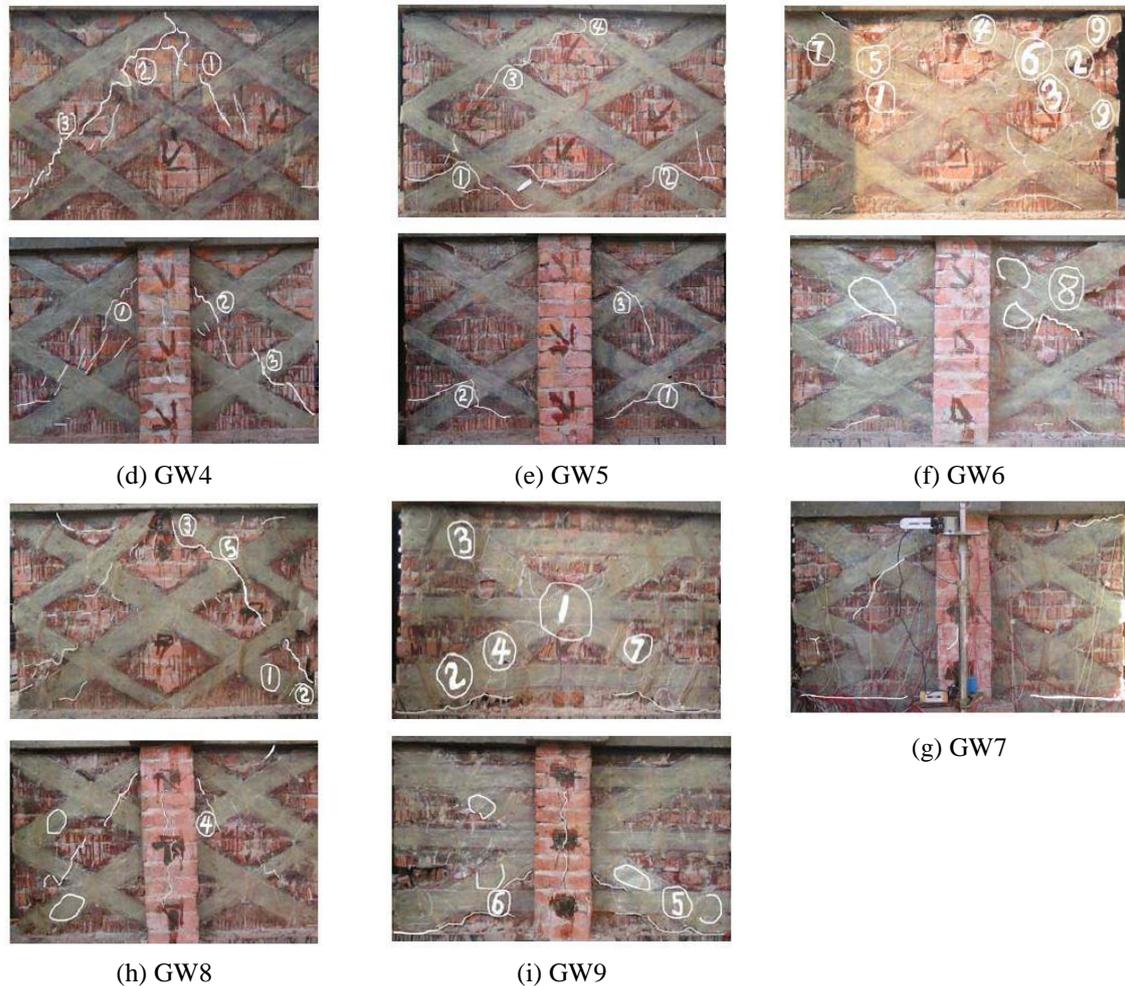
Fig. 5 Failure modes of specimens

Fig. 5 Continued

The first specimen was bare brick masonry wall with pilaster (GW1). The first set of loading was applied to the wall, which was investigated with no signs of concentrated damage. Furthermore, the load-displacement relation was investigated and it confirmed that the wall was still behaving in an elastic manner on condition that the peak value of horizontal load of every cycle is not more than approximately 90 kN. At -188 kN ($P = -188$ kN), the first crack was formed in this wall starting from the bottom corner. With the increasing of the pure control displacement (Δ), this wall began to rock and at 2.6 mm the horizontal load reaches the maximum of all the peak value of every cycle. As the rest of the cycles continued, two dominant cracks occurred at the upper corners which are marked ①② shown in Fig. 5(a). At 4.5 mm, the \times shaped diagonal cracks appeared and the wall was divided into four separate blocks which lead to complete loss of integrity of the wall. The final failure mode of the wall is shown in Fig. 5(a).

The second specimen was the wall whose Reinforcement mode was horizontal (GW2). When the horizontal load P less than 110 kN, no visible phenomena were found. At -190 kN, the first crack is formed at the bottom shown in Fig. 5(b) and propagate toward the vertical centerline of the wall along the mortar bed. At 3.7 mm, the sound of mortar being crushed can be heard and when the pure control displacement reached -6 mm, the uppermost strip ruptured with a loud bang at the middle of it (② shown in Fig. 5(b)), then a dominant crack starting from the place ② formed, the test was stopped. The final failure mode of the wall is shown in Fig. 5(b).

The third specimen was the wall whose Reinforcement was mixed mode which is the combination of horizontal mode and gradient mode (GW3). In order to study the influence of reinforcement mode on the propagation of crack and failure mode, the total reinforcement amount was equal to that of specimen GW2 on condition that the horizontal strips and gradient strips had the same amount. No visible phenomena were found during the preliminary load cycles. At -230 kN, the first crack is formed at the third mortar bed from the bottom shown in Fig. 5(c). At 3.5 mm, one gradient strip ruptured with a loud bang in the vicinity of cross of two strips (① shown in Fig. 5(c)), then At -5.5 mm, the other gradient strip also ruptured in the same way (② shown in Fig. 5(c)). At -6.1 mm, the gradient strip and horizontal strip debonded at the bottom near pilaster

(④ shown in Fig. 5(c)), the debonded length is about 350 mm. The final failure mode of the wall is shown in Fig. 5(c).

The fourth specimen was the wall whose Reinforcement mode was gradient (GW4). The total reinforcement amount was equal to that of specimen GW3 on condition that the width of every strip was same. In the first five cycles, no visible phenomena were found. At 205 kN, the first horizontal crack in the bed joint occurred between the second and third courses from the bottom of the wall, but because of the restriction of the gradient strip, this crack just extended to the outside edge of the strip. As the rest of cycles continued, some visible 45° inclined crack occurred and the wall began to rock with the increase of displacement. When the horizontal load reduced to -236 kN from the maximum of -254 kN, the gradient strip ruptured suddenly at the place of ① shown in Fig. 5(d) and then in the subsequent cycle, at 202 kN, the other principle strip also ruptured at the place of ② shown in Fig. 5(d). The final failure mode of the wall is shown in Fig. 5(d).

In order to research influence of the width of strip on the test results when the reinforcement amount was equal, the fifth specimen was the same as specimen GW4 except that the width of every strip is not equal. During the preliminary several load cycles, the phenomena of the specimen were similar to specimen GW4, but from the first displacement stage, the propagation of 45° inclined cracks were obviously slower than horizontal cracks that occurred between the second and the third courses from bottom, which was dissimilar to specimen GW4. With the increase of the displacement the cracks in the head faces were also formed and severe corner crushing occurred with parts of the wall spalling out at the bottom. At -4.2 mm, one gradient strip ruptured with a loud bang in the vicinity of cross of two strips (① shown in Fig. 5(e)), then At 6.1 mm, the other gradient strip also ruptured in the same way (② shown in Fig. 5(e)). Up to now, the two horizontal cracks that were formed originally at the two bottom corners were jointed. When the pure displacement reached 7.6 mm, then the inclined crack (③ and ④ shown in Fig. 5(e)) also formed, which was the sign of the end of the test. The final failure mode of the wall is shown in Fig. 5(e).

With view to studying influence of the reinforcement amount on the test results when the reinforcement mode was same, the sixth specimen was the same as specimen GW5 except that the reinforcement amount of this specimen was larger than that of GW5. At 217 kN, a first vertical crack initiated at the place of ① shown in Fig. 5(f), then at -3.6 mm, cracking began at the edge of primary strip (② shown in Fig. 5(f)) and at edge of secondary strip (③ shown in Fig. 5(f)). At 3.9 mm, a delamination crack was formed (④ shown in Fig. 5(f)), but the strip wasn't completely separated from the surface of the wall. At 5.6 mm, the strip is debonded from the surface of the wall, the debonded length is about 20 mm. When the pure displacement increased to 5.6 mm, a phenomenon that some close reinforcement region was hollow (can be defined as "hollow phenomenon" was found (for example, the region of ⑤ and ⑥ shown in Fig. 5(f)). With the increase of the pure displacement, the hollow region became larger than ever and the spread of cracks across the masonry was accompanied by local de-bonding of the GFRP from the masonry, so that a band of debonded GFRP formed along a band roughly parallel to the cracks. At 187 kN, the GFRP on the top is debonded from the masonry suddenly, the test was stopped. The final failure mode of the wall is shown in Fig. 5(f).

Specimen GW7 was similar to GW6 except that "through-wall" anchors which were made by narrow strips were used to reduce or avoid the debonding and hollow regions. At 205 kN, cracking initiated at the bottom and then propagated to the edge of pilaster. With the increase of the pure displacement, hollow regions also occurred, but due to the existence of "through-wall" anchors,

the area and number of the hollow regions were less than that of GW6. At -6.0mm, the gradient strip on the top surface of pilaster is debonded with vibrancy ringing, and at 7.9 mm, one principle strip ruptured suddenly, which indicated end of this test. The final failure mode of the wall is shown in Fig. 5(g).

Specimen GW8 was similar to GW5 except that “through-wall” anchors which the anchor amount was equal to GW7 were used. At -198 kN, a horizontal crack occurred at the bottom. Hollow regions can be found and sounds thought to be masonry blocks splitting were heard at -3.8 mm. As the rest of the 8.6 mm cycle continued the wall suffered cracking in the form of inclined starting from the middle of the heading course to bottom corner (③ and ⑤ shown in Fig. 5(h)). The final failure mode of the wall is shown in Fig. 5(h).

Specimen GW9 was similar to GW3 except for the two aspects of reinforcement amount and anchorage measure. For the purpose of comprehensive contrast, the reinforcement amount was similar to GW6 and GW7 and anchorage measure and anchor were same as GW7 and GW8. In the first five cycles, no visible phenomena were found. a horizontal crack was found at the bottom at -198 kN, then small regions of local debonding initially formed near the displacement application point (at -4.5 mm) and the hollow phenomena (① and ③ shown in Fig. 5(i)) occurred which is similar to Specimen GW8. When the pure displacement reached 9.3 mm, a vertical crack in the pilaster starting from the top propagated to the bottom. At -11.2 mm, the gradient strip and horizontal strip debonded from the surface of the wall at the bottom near pilaster with vibrancy ringing (⑤ shown in Fig. 5(i)). At last, the pure displacement reached 22 mm which was much larger than that of the other specimens. The final failure mode of the wall is shown in Fig. 5(i).

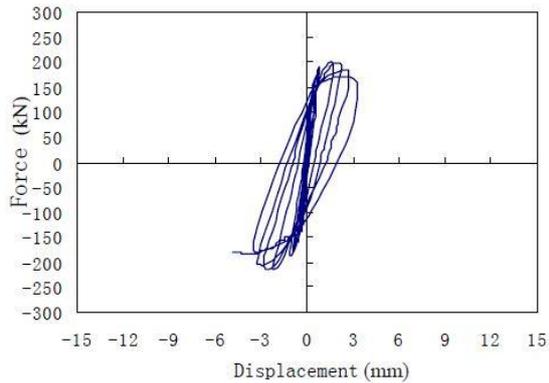
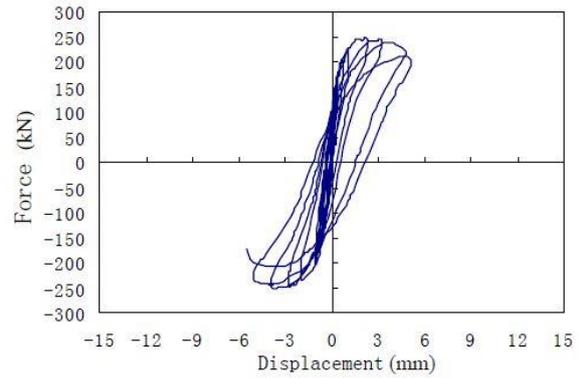
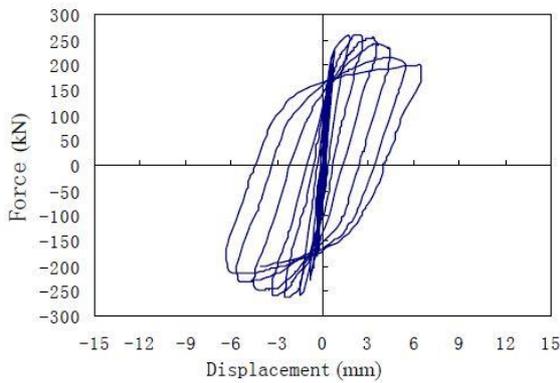
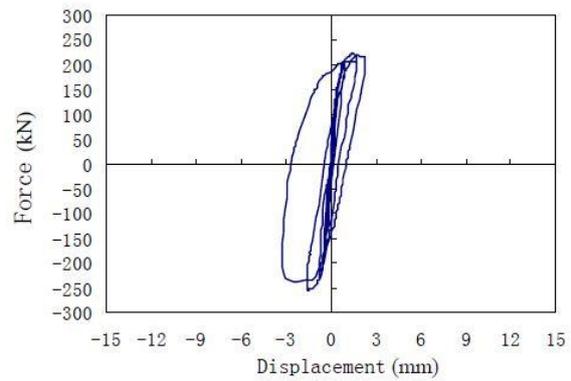
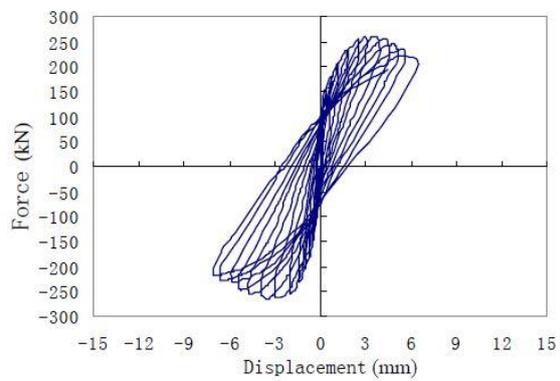
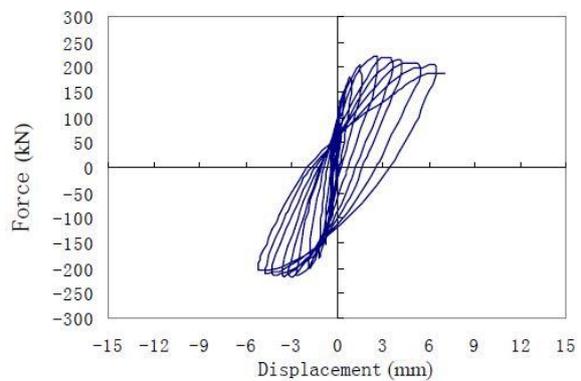
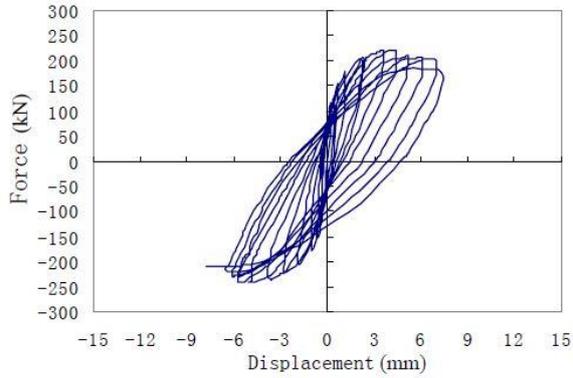
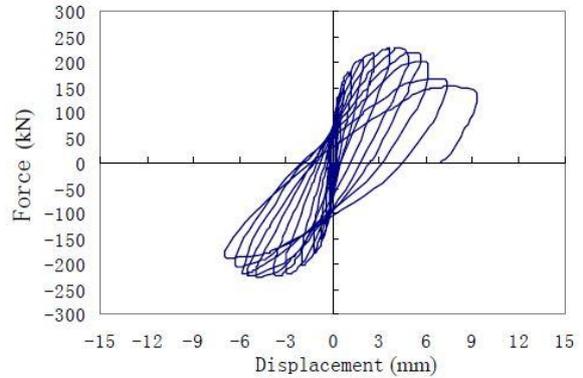
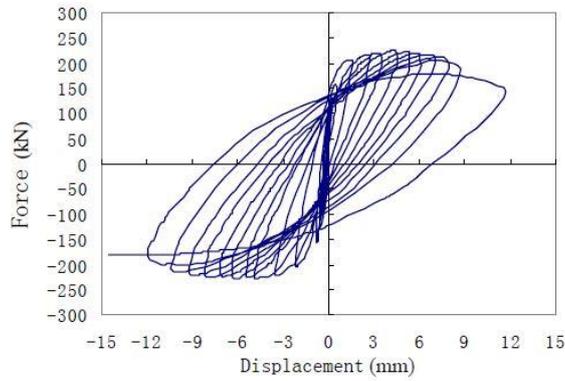
Fig. 6 Load-displacement relation

Fig. 6 Continued

four elementary shapes: shuttle shape, arch shape, reverse *S* shape and *Z* shape. For most structures, the shape of hysteresis loop curve often begins with shuttle shape and then develops to arch shape, reverse *S* shape and *Z* shape finally by Li (2004). The hysteresis curve of every specimen was shown in Fig. 6.

It can be seen from the Fig. 6 that all the hysteresis loop curve of every specimen was of arch shape except for that of specimen GW2 which was the only specimen reinforced only by horizontal strips. As far as specimen GW2 concerned, the horizontal crack at bottom occurred earlier and propagated faster than other specimens, therefore horizontal slide was much larger than that of the others, so the hysteresis curve shape of GW2 was of reverse *S* shape (as shown in Fig. 6(b)) which was different from the others. For specimen GW4, because of the change of loading sequence which was attributed to the testing apparatus, the last hysteresis loop (as shown in Fig. 6(d)) can't be used to make analysis. It was also obvious that the area of hysteresis loop of specimen GW3 and GW9 that was strengthened by horizontal and gradient strips at one time was

much larger than that of other specimens, from which a conclusion could be drawn that specimen reinforced by mixed mode was superior to the other two modes in energy dissipation.

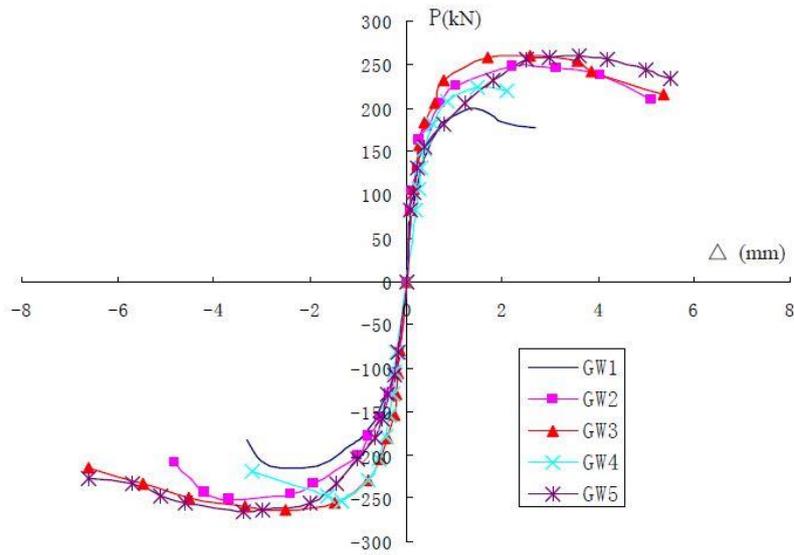
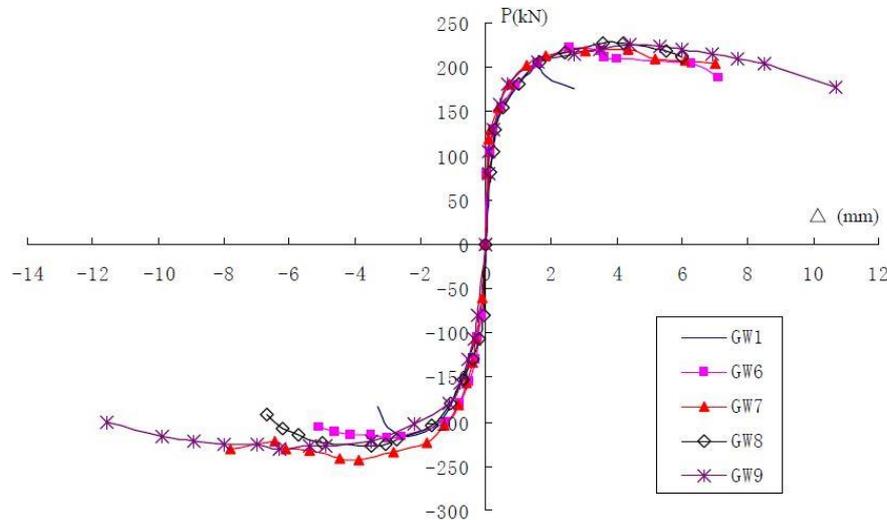
Fig. 7 Skeleton curves of lateral load versus deformation

Fig. 7 Continued

Qualitative analysis of seismic performance and the main characteristics of ductility can be analyzed through skeleton curves of lateral load versus deformation (as shown in Fig. 7) by Wang (2003). It can be seen from Fig. 7 that the difference between original stiffness of every specimen was small. This was because of the fact that stiffness of this stage was in relation to the strength of mortar and brick and vertical load. With the increase of horizontal load, the displacement of the bare wall increased better than that of the others and the stiffness began to drop. It also can be seen from Fig. 7 that under the condition of the same displacement, the horizontal load of the bare wall was less than the reinforced specimens, and this tendency was severe with the increase of displacement. Skeleton curve of the bare wall occurred an inflexion at 200 kN, from which a conclusion can be drawn that horizontal load dropped fast after it reached ultimate load and the ultimate displacement less than that of the other specimens.

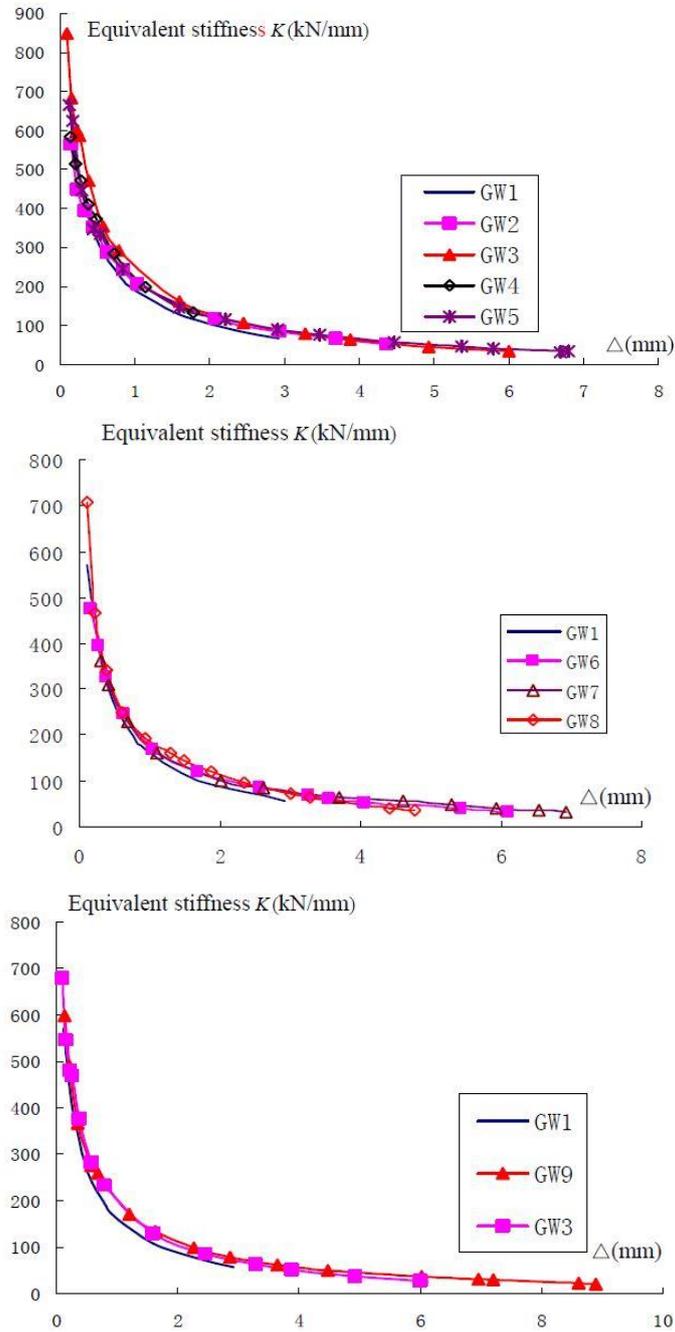
Fig. 8 Stiffness degradation curves

With increase of the displacement of structure, the property of loop stiffness of structure becoming small gradually is called stiffness degradation by Zhu (1989). On one hand, secant stiffness of structure under repeated horizontal load can be substituted for tangent stiffness by Wang (2003). On the other hand, according to literature (JGJ101-96), the secant stiffness, which is also named equivalent stiffness, is the ratio of absolute value of summation of repeated horizontal load to summation of the pure displacement in two directions. Stiffness degradation of every specimen was shown in Fig. 8.

It can be seen from Fig. 8 that the curve of stiffness degradation can be divided into three stages: sudden drop stage; calm drop stage and steady stage. Both strengthened specimens and bare specimen (GW1) were of the similar stiffness change due to the fact that the deformations of the specimens were mainly connected to strength of mortar, not the GFRP whose deformations were still little when the horizontal load was relative small. However, with the increase of the pure displacement of the specimens, the stiffness degradation of bare specimen speeded up because of

the occurring of the many cracks which was the main factor of leading to lose the load-bearing capacity; on the contrary, the stiffness degradation of reinforced specimens was slowed down with view to the restriction of GFRP.

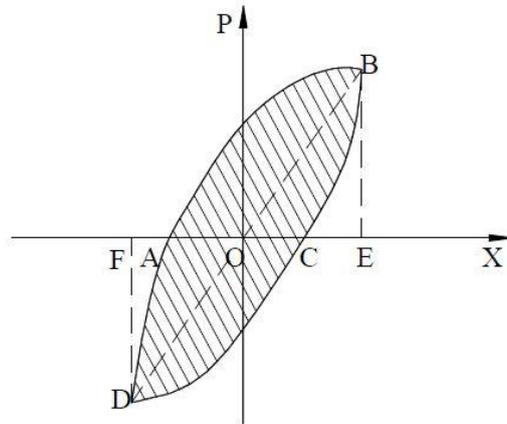
Fig. 9 Calculated sketch map for energy dissipation coefficient (E)

The capacity of absorbing energy of structure subjected to low reversed cyclic loading was the reflection of energy dissipation capacity of structure. However, there was the unified criterion of evaluating energy dissipation capacity of structure. At present, the commonly used methods were equivalent viscosity damping coefficient (Wang *et al.* 2003) and energy dissipation coefficient. The later method was adopted in this paper to assess the energy dissipation capacity of specimens at two special states: ultimate load state and ultimate displacement state. The calculated sketch

map for energy dissipation coefficient is shown in Fig. 9. According to literature (China Academy of Building Research, 1997), energy dissipation coefficient (E) can be obtained using Eq. (1) and were shown in Table 9.

$$E = \frac{S_{(ABC+CDA)}}{S_{(OBE+ODF)}} \tag{1}$$

where $S_{(ABC+CDA)}$ =area of the whole hysteresis loop and $S_{(OBE+ODF)}$ =the whole area of ΔOBE and ΔODF .
