Experimental characterization of timber framed masonry walls cyclic behaviour

Ana Maria Gonçalves^{*}, João Gomes Ferreira^a, Luís Guerreiro^b and Fernando Branco

*Department of Civil Engineering, Technical University of Lisbon from University of Lisbon,
Lisbon 1049-001, Portugal*

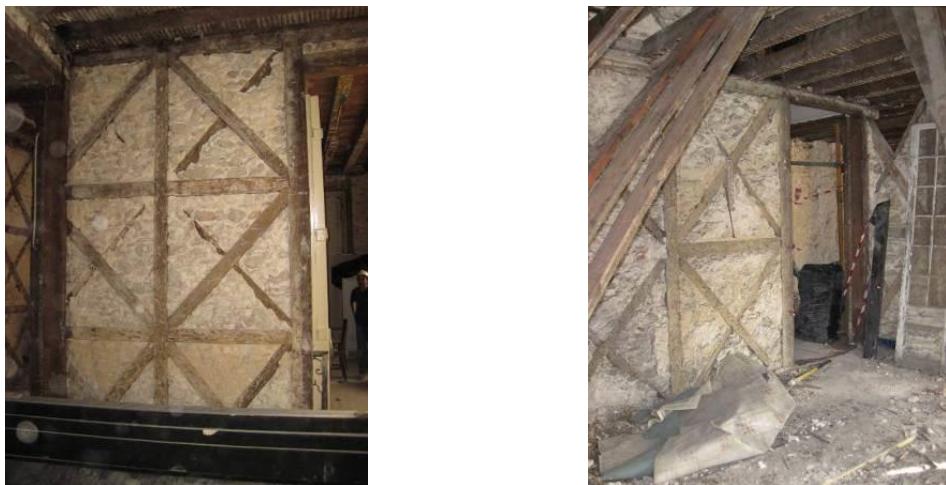
Fig. 1 Timber framed wall in “pombalino” building (Gonçalves *et al.* 2011)

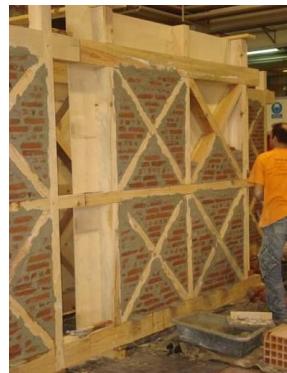
Fig. 5 Masonry wall fabrication

The choice of the type of masonry was very important since there are several types of infill, including mortar with bricks or mortar with tiles or even mortar mixed with small stones. In this study, mortars with bricks (Fig. 5) were used. The masonry consists of bricks and cement-lime-sand mortar with a volume ratio of 1:2:6 (hydrated lime: portland cement 32.5 N: sand). Although

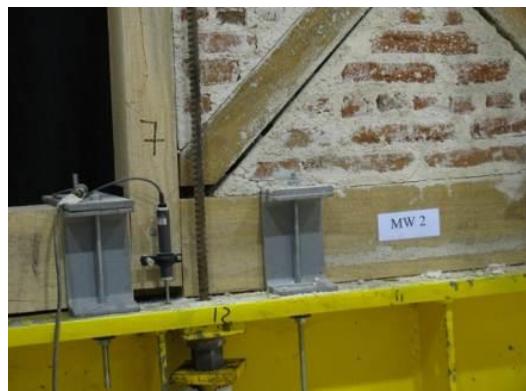
Fig. 14 Vertical lift of bottom beam and vertical member

A certain vertical lift of the bottom beam occurred during the wall test, as well as a separation of the vertical timber elements from the bottom beam, as an effect of a rocking movement that was not eliminated, becoming more significant with the increase of the overall deformation (Fig. 14).

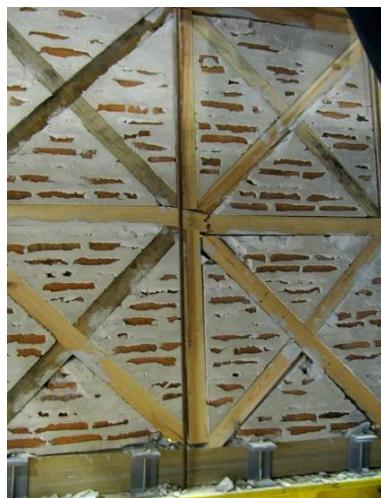
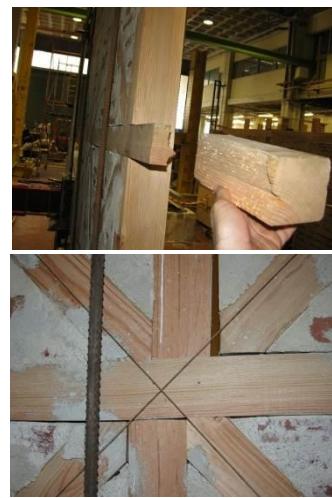
Fig. 18 Failure mode of masonry walls.

(a) Failure by shear of intermediate timber beam in MW1

(b) Failure by longitudinal shear of intermediate timber beam in MW2

Figs. 18 (a)-(b) shows the failure modes of the masonry walls. Rupture in MW1 is associated with compression of the diagonals that caused the shear failure of the intermediate beam. In the case of the model MW2 the wall had an early rupture by shear parallel of the timber fibres at one end of the intermediate beam.
