Damage assessment of shear connectors with vibration measurements and power spectral density transmissibility

Abstract. Shear connectors are generally used to link the slab and girders together in slab-on-girder bridge structures. Damage of shear connectors in such structures will result in shear slippage between the slab and girders, which significantly reduces the load-carrying capacity of the bridge. Because shear connectors are buried inside the structure, routine visual inspection is not able to detect conditions of shear connectors. A few methods have been proposed in the literature to detect the condition of shear connectors based on vibration measurements. This paper proposes a different dynamic condition assessment approach to identify the damage of shear connectors in slab-on-girder bridge structures based on power spectral density transmissibility (PSDT). PSDT formulates the relationship between the auto-spectral densities of two responses in the frequency domain. It can be used to identify shear connector conditions with or without reference data of the undamaged structure (or the baseline). Measured impact force and acceleration responses from hammer tests are analyze

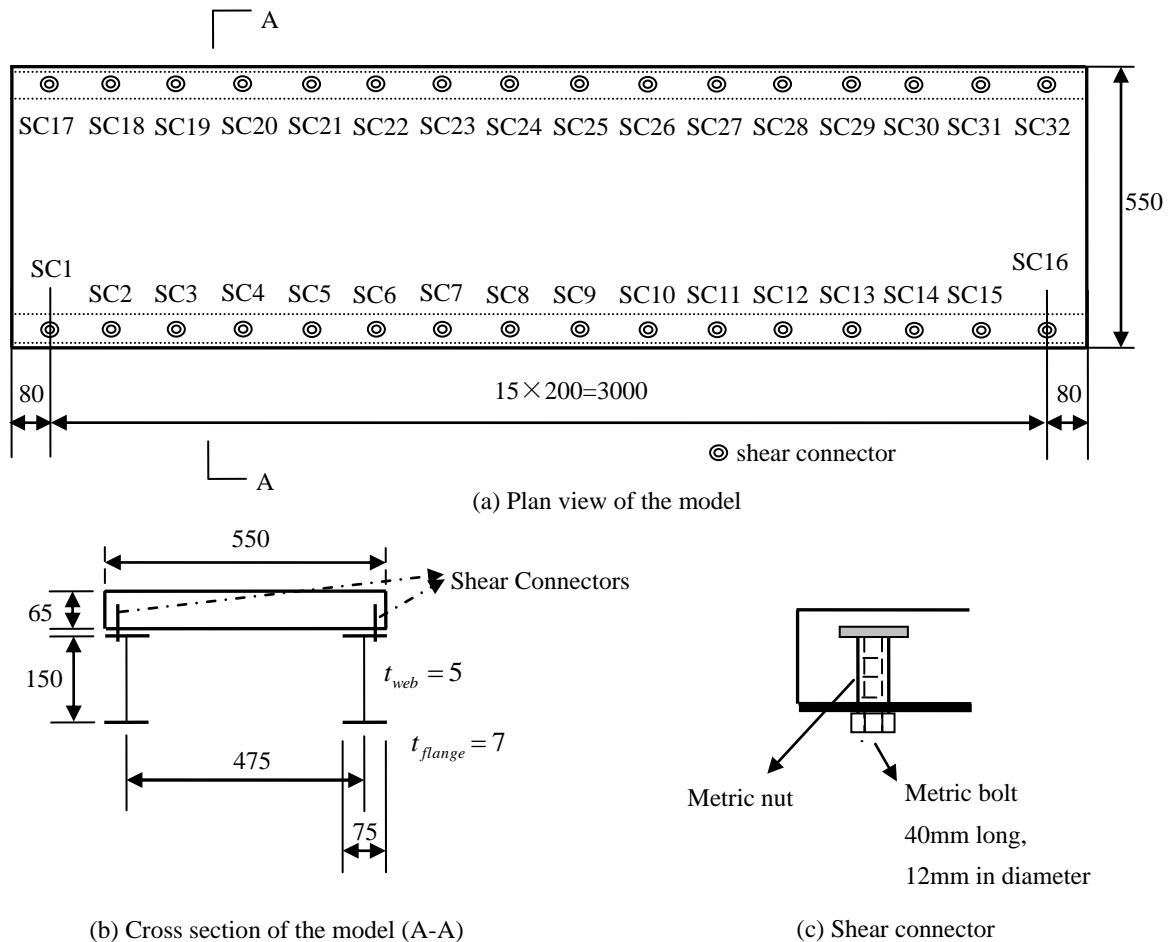
Fig. 1 Dimensions and shear connector details of the slab-on-girder structure (unit: mm)

Numerical studies on a simply-supported slab-on-girder bridge structure are conducted to illustrate the accuracy and efficiency of the proposed approach for damage detection of shear connectors. Fig. 1 shows the plan view and cross section of the structure and details of a shear connector. The concrete slab is supported on two steel I-type girders, and shear connectors are used to link the slab and girders together. Each girder has sixteen shear connectors with equal space and there are thirty-two shear connectors in total in the structure. They are denoted as SC1~SC32 in Fig. 1(a). The cross-section of the structure is shown in Fig. 1(b). To be consistent with the laboratory tests that will be described later, the shear connector is simulated as a metric bolt screwing into a metal nut, as shown in Fig. 1(c). The shear link fixity is provided by securing the metric bolt. The failure of bolts will cause the shear slippage between the slab and girder and reduce the load-carrying capacity of composite bridges. In this study, the bolt is fully unscrewed from the metal nut to simulate the failure of shear link.

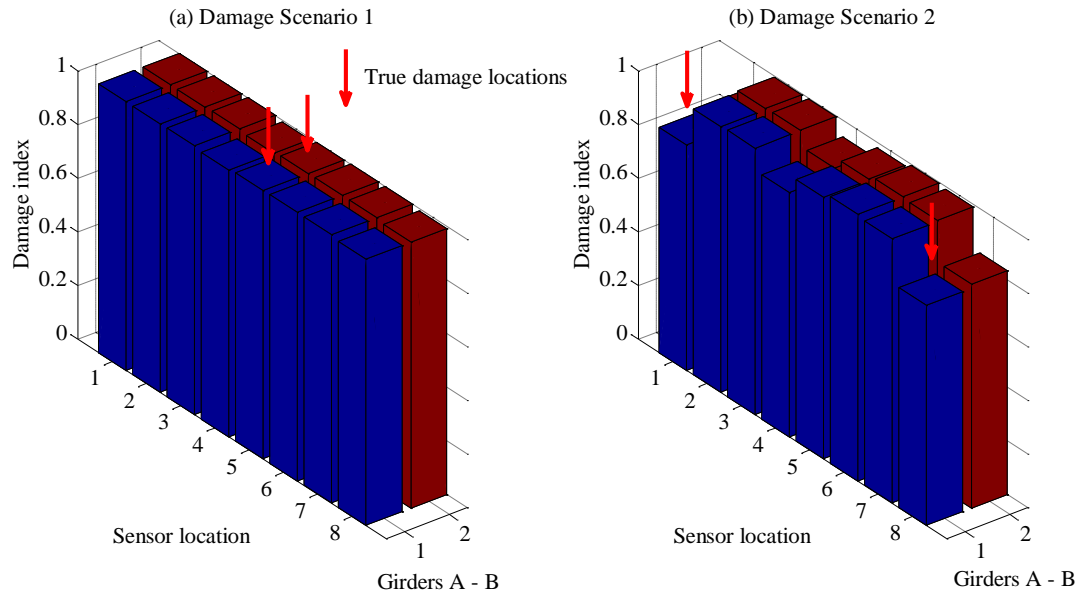
Fig. 3 Damage detection results with COMAC

Damage detection results with COMAC based on the identified four mode shapes are shown in Fig. 3. It can be seen that COMAC fails to identify the damages in Scenario 1 as no obvious reductions in COMAC values are observed at the sensor location No. 5 in both girders. For Scenario 2, COMAC can identify the damages in sensor locations No. 1 and No. 8 of Girder A. However, two false identifications are detected at sensor locations No. 1 and No. 8 of Girder B as they are close to the true damages, and two more false identifications at sensor location No. 4 in both girders. Fig. 4 shows the damage detection results with changes in flexibility. It can be found

Detection results with COMAC and changes in flexibility shown in Figs. 3 and 4 demonstrate that using global modal information may not correctly identify the damages of shear connectors in minor damage case with very small frequency and MAC changes. The proposed local dynamic condition assessment approach can successfully identify the shear connector damage locations in two damage scenarios and shows the advantages over the traditional detection method based on global modal information with more accurate results and less false identifications. A few false identifications occur at the mid span owing to relatively large displacement response at this location since the steel girders and concrete slab are not continuously connected together in the model considered in this study. This false identification might become more prominent when the simulated data are smeared with 5% noise.

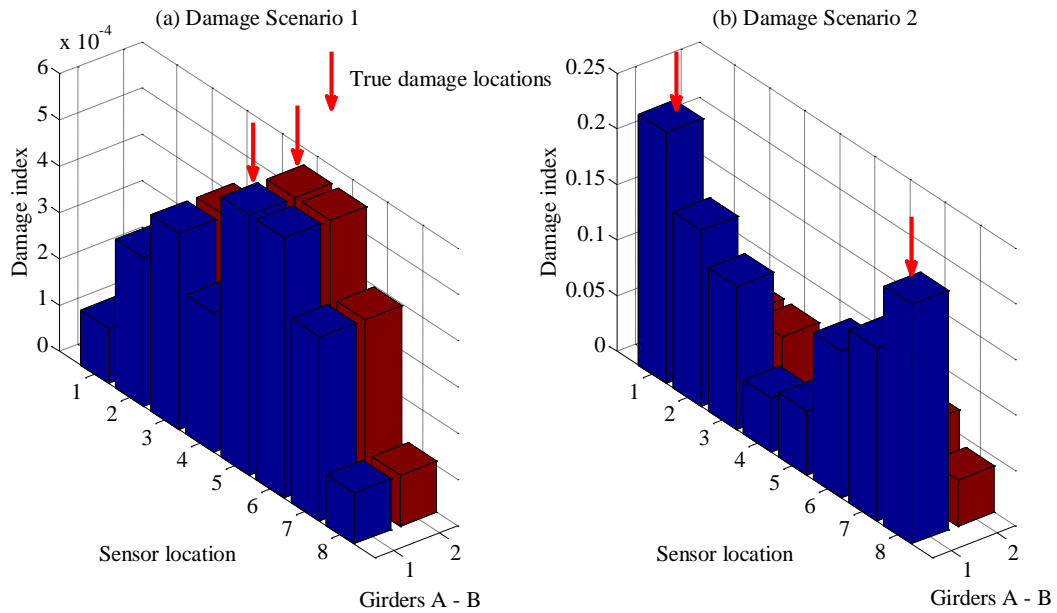
Fig. 4 Damage detection results with changes in flexibility

that the damages in sensor location No.5 of Scenario 1 can be detected, while two false identifications are observed at sensor location No. 6 in both girders as they are near the true damage locations. The damages in Scenario 2 are identified accurately indicating that the detection using changes in flexibility is more sensitive than COMAC.

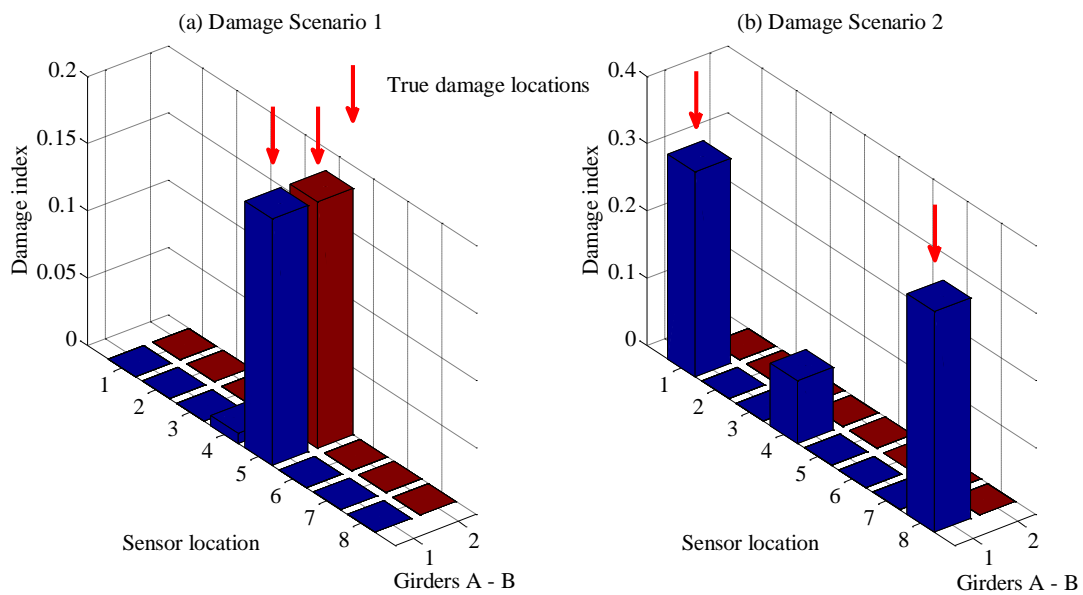
Fig. 5 Damage detection results using PSDT with data from undamaged structure available (no noise)

identified mode shapes and avoiding the oscillation frequency band due to the initialization process. α is set to be 0.02 in Eq. (17) to obtain the upper confidence limit and then compute the new damage indicator ($DI-UL$) with consideration of this threshold value. Fig. 5 shows the damage detection results of two damage scenarios from measurements without noise effect. Identified results of Scenario 1 for Girders A and B are shown in Fig. 5(a). It can be clearly seen that high damage indices at the sensor location No. 5 in both girders are observed. The damage index is around 0.2, indicating the simulated damage locations are identified correctly. Fig. 5(b) shows the detection results of Scenario 2 in Girders A and B. It can be seen that damage index values at sensor location No. 1 and No. 8 in Girder A are around 0.3, indicating the existence of damage of shear connectors in these sensor locations. These identified locations match well with the introduced damage locations. However, it should be noted in Fig. 5 that damage index values corresponding to the two damage scenarios at sensor location No. 4 in Girder A where there is no shear connector damage are also relatively high, implying false damage identification. This is because the response at the mid span of the simply-supported model is the largest. Because the steel girder and concrete slab in the current structure model are only connected by 16 shear connectors between each girder and slab, some different responses between slab and girder is expected, and which is most significant when the response is relatively large at the mid span. This response difference is also picked up by the proposed damage index.

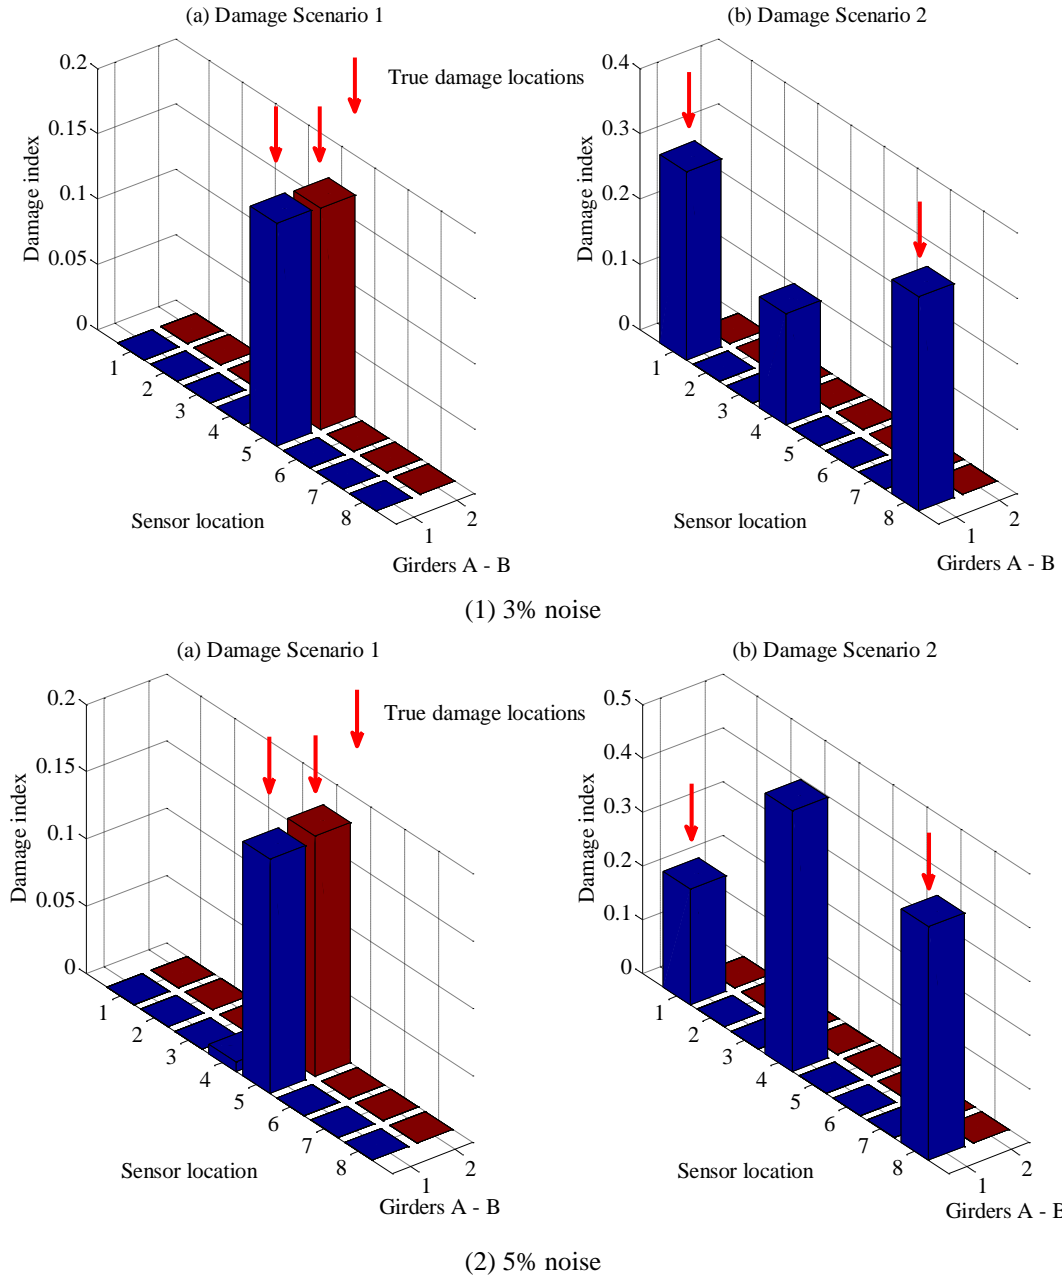
Fig. 6 Damage detection results using PSDT with data from undamaged structure available (with noise)

Fig. 6 shows the detection results from the simulated responses with smeared noise. The damage index values in Scenario 1 at the sensor location No. 5 in both girders are around 0.2 with two noise levels considered in the study, indicating the damage locations of shear connectors are identified accurately. Damage index values in Scenario 2 at sensor locations No. 1 and No. 8 in Girder A are greater than 0.2 for both the noise level cases, indicating again that the true damage location is successfully identified. However, similar to the observations from Fig. 3, a false identification at sensor location No. 4 in Girder A exists. In damage Scenario 2, the falsely identified damage index at this location increases with the noise level and is up to 0.4 with 5% noise.

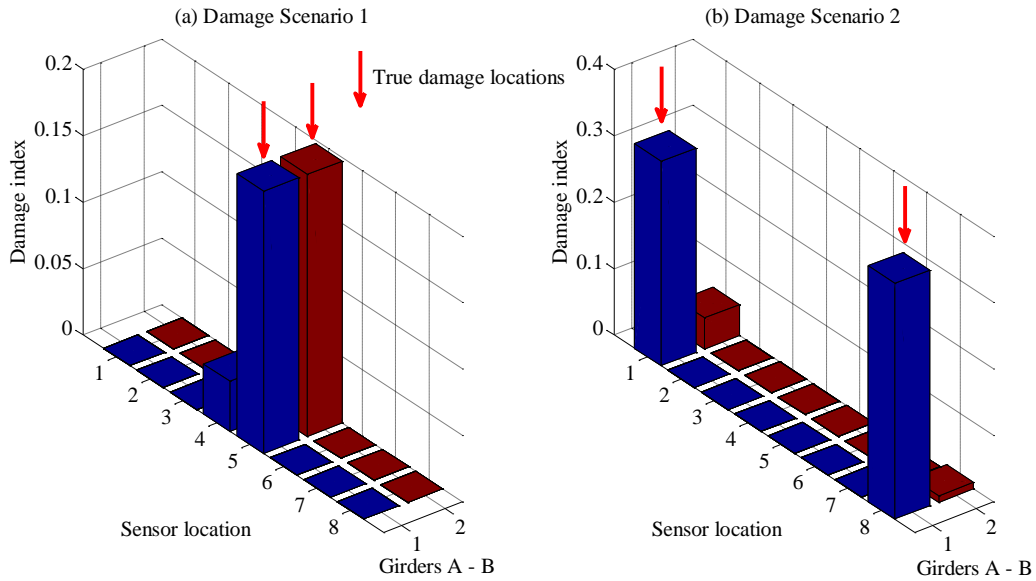
Fig. 7 Damage detection results using RDFRF without data from the undamaged structure (no noise)

and hammer impact force from the structure in the damaged state are required to extract the FRFs for identification. Figs. 7 and 8 show the damage detection results based on the relative difference of FRFs without and with noise effect, respectively. The introduced damages are identified correctly with several false identifications close to the true damage locations, such as sensor

Compared with the detection results shown in Figs. 7 and 8, it can be found that the damage indices calculated from the proposed method with PSDT are generally larger than those from the relative difference of FRFs. It may indicate that the proposed condition assessment method has a higher sensitivity to detect the damage however a false identification is observed in the results with the proposed approach. The robustness of the proposed approach for damage detection of shear connectors from noisy measurements is demonstrated.

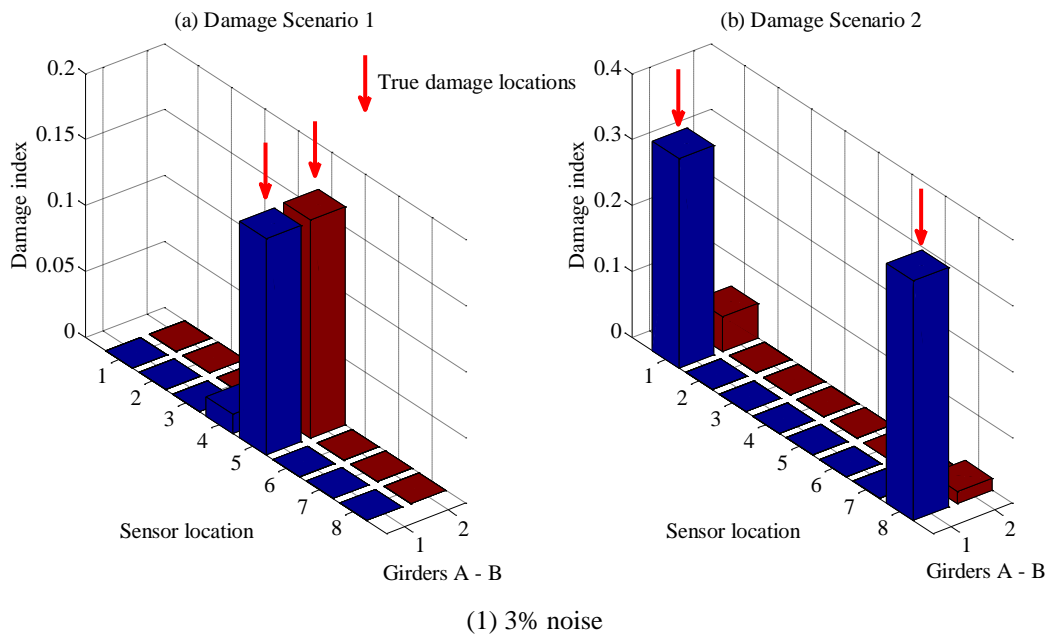
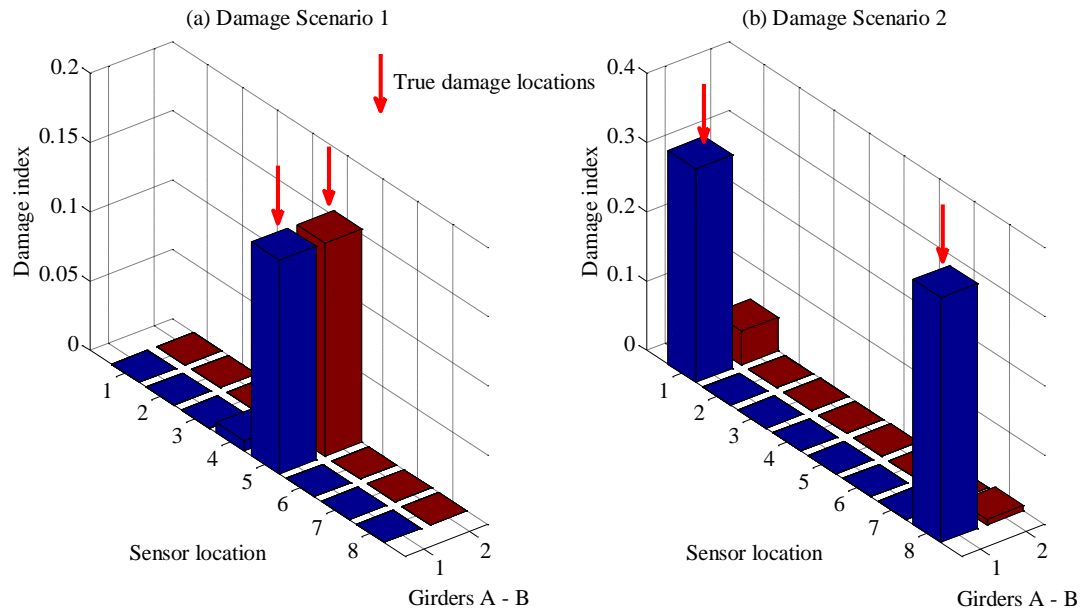
Fig. 8 Damage detection results using RDFRF without the data from the undamaged structure (with noise)

(2) 5% noise

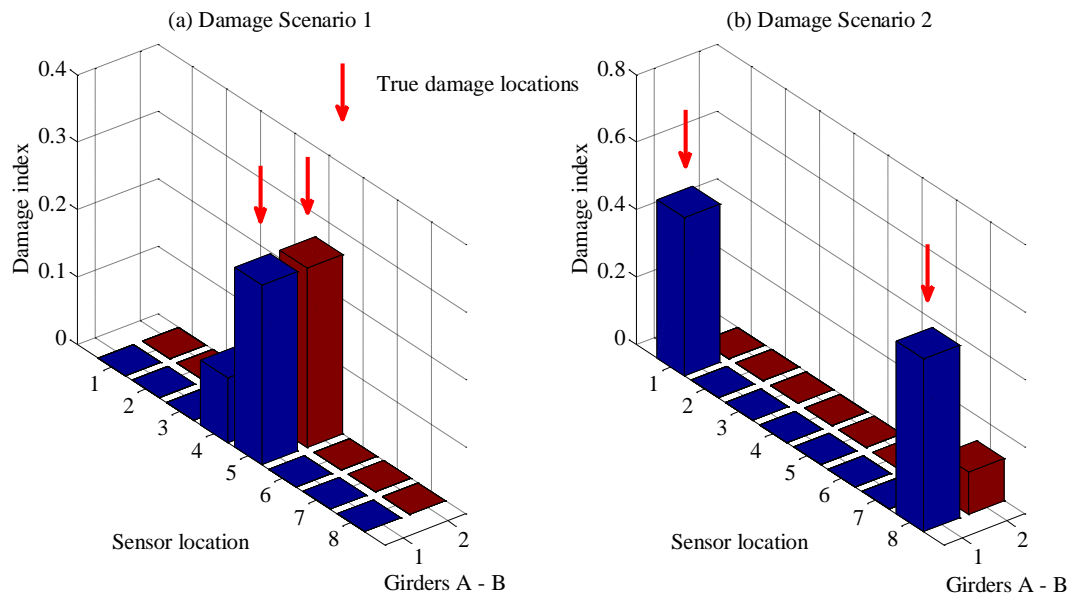
Fig. 9 Damage detection results using PSDT with data from undamaged structure unavailable (No noise)

As discussed above, when the measured data of undamaged structure are not available, a reference measurement is obtained to computer the PSDT from the reference response to those measured on slab and on girder locations for damage identification. The reference sensor location is thus included in the sensor placement configuration of the above studies. It is placed on the central slab location on the top of Girder A, as shown in Fig. 2. Other sensor locations stay unchanged. PSDT vectors from the reference sensor response to the slab and girder responses are obtained with Eq. (15), and PSDT vectors in the frequency range of 25~115 Hz are used to compute the damage index from Eq. (16). α is set to be 0.02 to calculate the threshold value with Eq. (17). Figs. 9(a) and 9(b) show the identified results from the measured responses without noise for damage Scenarios 1 and 2, respectively. It can be clearly seen that the introduced damages of shear connectors at the sensor location No.5 in two girders are identified accurately in Scenario 1. A false identification is observed at the sensor location No. 4 in Girder A. For Scenario 2, the introduced shear link damages are close to sensor locations No. 1 and No. 8 in Girder A and are detected accurately. A small false positive is found at sensor location No. 8 in Girder B. False identifications exist in these two scenarios from measured responses without noise effect due to the smearing effect as they are close to the true damage locations. It is interesting to note that the false identification at the mid span does not appear in this case in damage Scenario 2. This is because the reference point used in calculating PSDT is located at the mid span of the girder A, which effectively eliminates the false identification at this location.

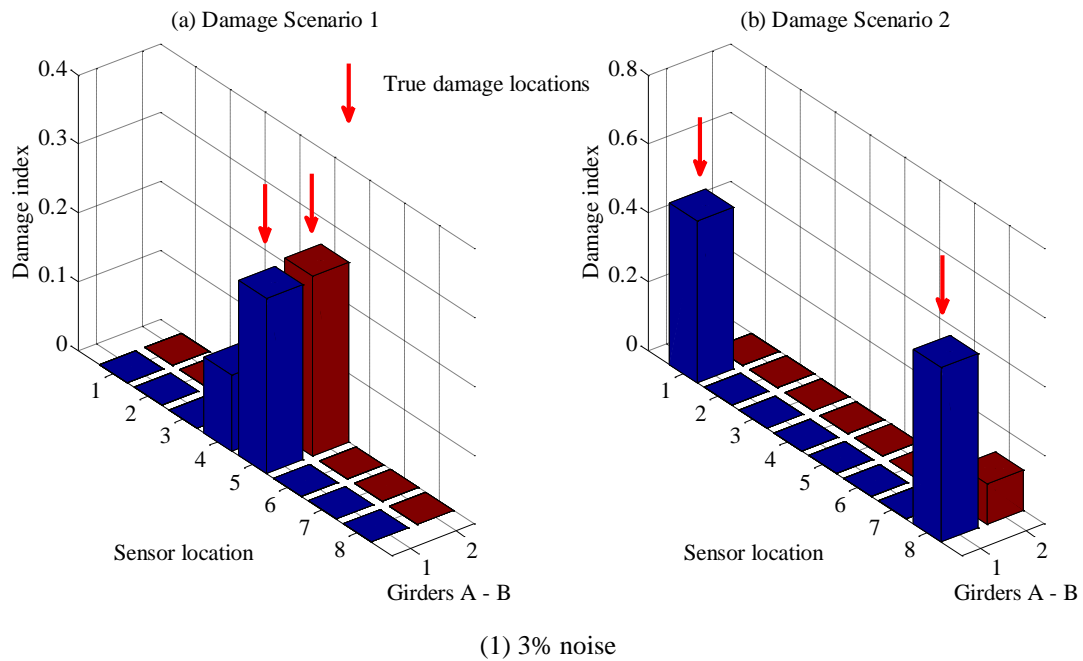
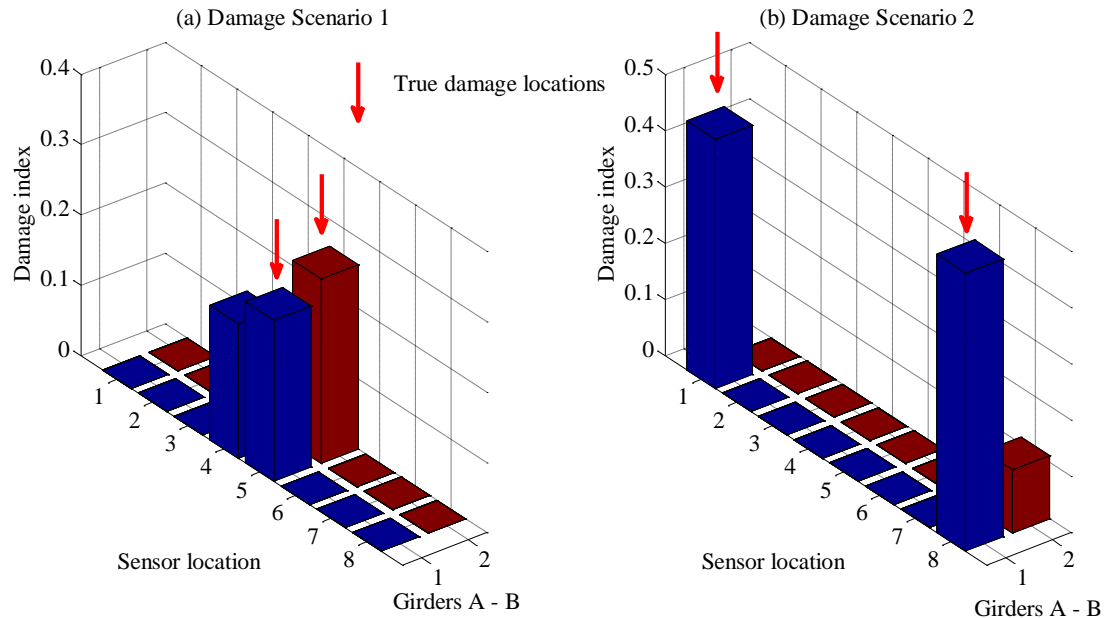
Fig. 10 Damage detection results using PSDT with data from undamaged structure unavailable (with noise)

(2) 5% noise

Fig. 10 shows the damage detection results from simulated responses with two noise levels. The identified results demonstrate that the locations of damages in both scenarios are detected accurately. The damage index values in Scenario 1 at sensor location No. 5 in both girders are

around 0.25 in two noise level cases. The identified damage indices in Scenario 2 at sensor location No. 1 and No. 8 in Girder A are around 0.4. Several false identifications, such as sensor location No. 4 of Girder A in Scenario 1 and sensor location No. 8 of Girder B in Scenario 2, are observed. It should be noted that the damage index value at sensor location No. 4 in Girder A of Scenario 1 increases to 0.15 when the 5% noise is smeared in the responses.

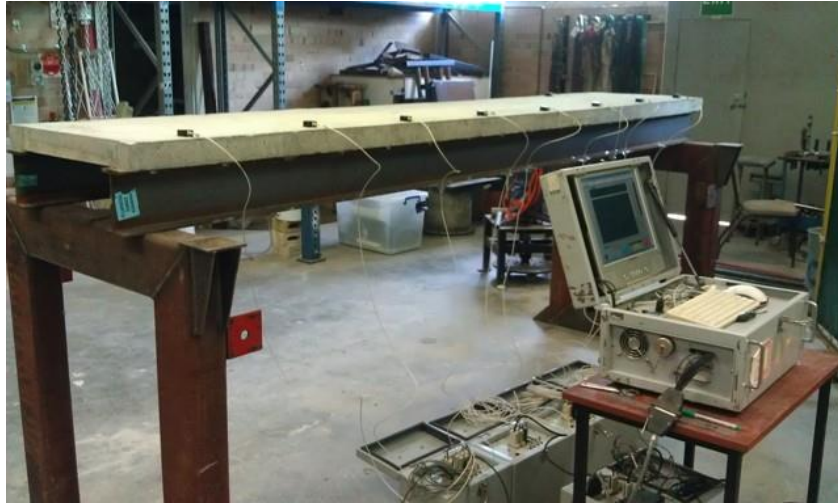
Fig. 11 Experimental setup of the slab-on-girder structure

The testing model was constructed with a concrete slab supported on two steel girders. Sixteen shear connectors were mounted with equal space in each girder to link the slab and steel girder

together. It was located on two steel frames which were fixed on the strong ground as shown in Fig. 11. The design of shear connectors considers the ability not only to simulate failure of specific shear links, but also to reset-up them to the undamaged state. Therefore, a metric bolt screwing into a metric nut casted in the slab was used to connect the slab and girder. The metric nuts were welded onto the reinforcement bar in the slab before pouring. Design and setup of shear connectors can be seen in Fig. 12. If all the bolts are screwed into their nuts, the structure condition corresponds to the undamaged state. The damage of shear connectors is introduced into the structure by fully unscrewing several specific metric bolts to simulate the failure of shear links. The dimensions of the laboratory model are the same as those of the model in the numerical study. It should be noted that the proposed damage detection approach for shear connectors is non-model based as the finite element model of the structure is not required. Therefore the dimensions, boundary conditions of the model and material properties of the slab, girder and shear connectors are not introduced because they are not required for damage identification.

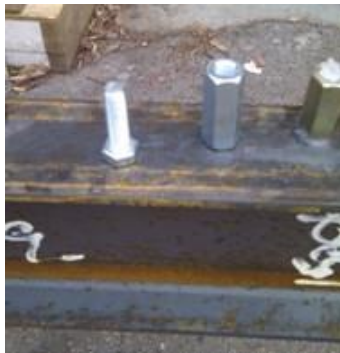
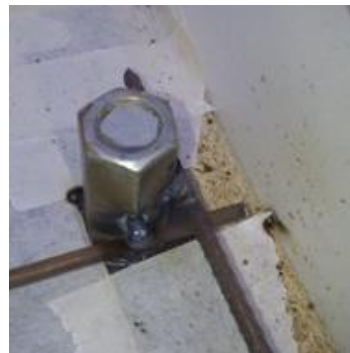
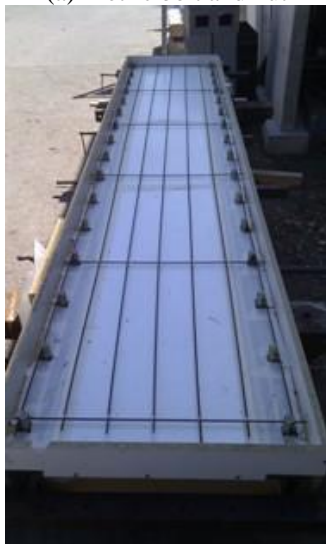
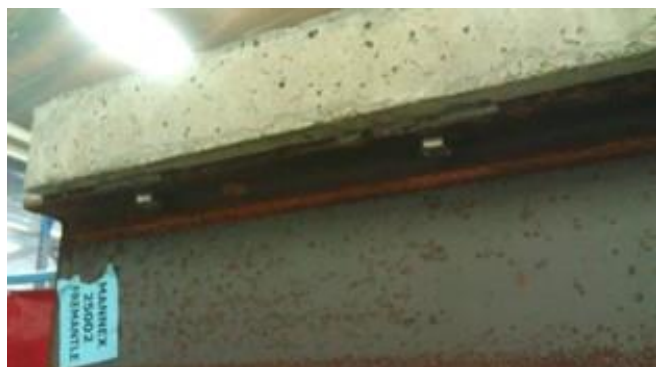
(a) Metric bolt and nut

(b) Bolt screwed into the nut

(c) Plan view of shear connectors

(d) Shear connector in the structure

Fig. 12 Design of shear connectors

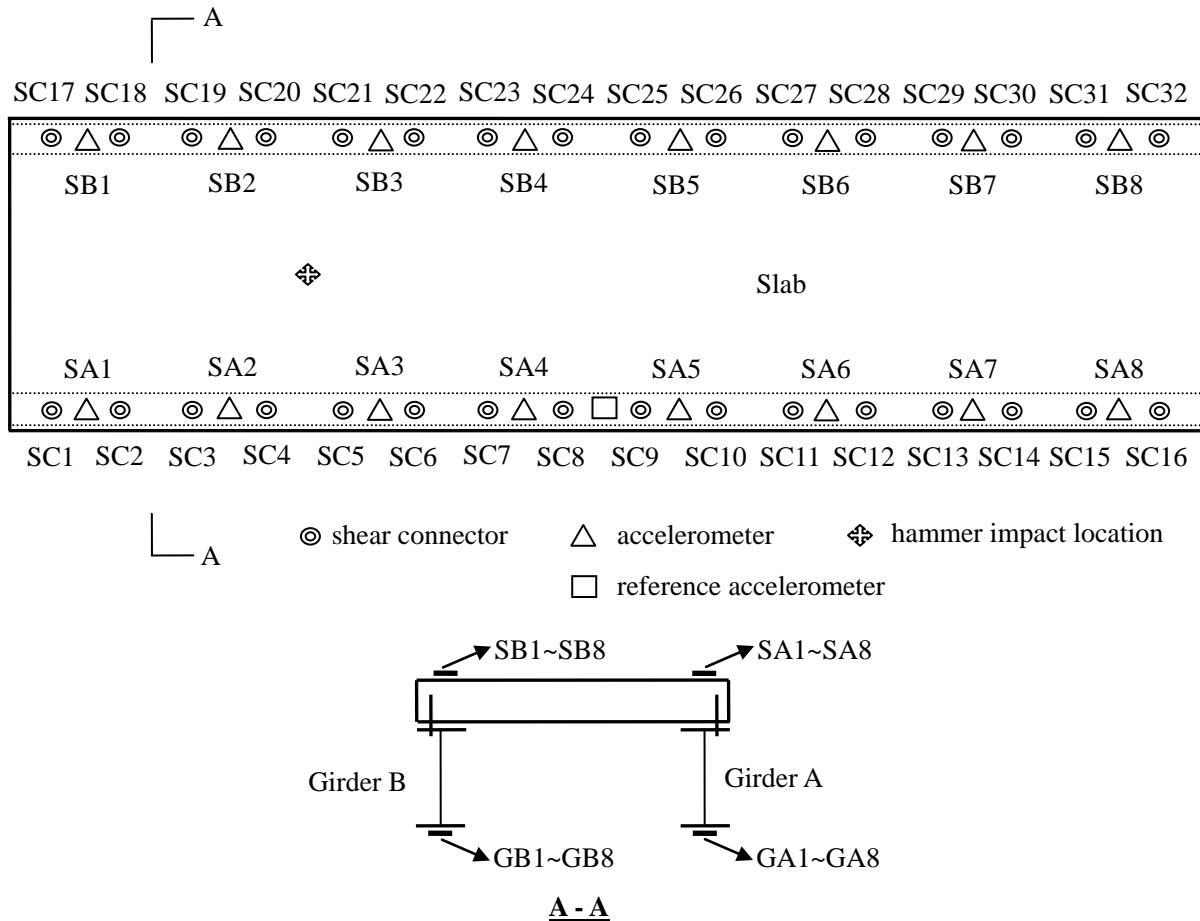
Fig. 13 Experimental sensor placement

Fig. 13 shows the numbering of shear connectors and sensor locations defined in the tests. Each girder has sixteen shear connectors linking the concrete slab and steel girder together and one sensor is located at the center of two shear connectors. A sensor is placed at the central slab on the top of Girder A as the reference sensor and its location stays unchanged during the testing. Other eight sensors were repeatedly placed on the slab or underneath the girders to measure the responses at sensor locations SA1~SA8, SB1~SB8, GA1~GA8 and GB1~GB8. It is noted that the number of sensors is not a significant factor to perform the proposed damage detection approach since repeated tests with those movable sensors would measure a number of responses at different locations. Two damage scenarios are listed in Table 4. Excitation with hammer impact was applied at the left quarter span of the slab as shown in Fig. 13.

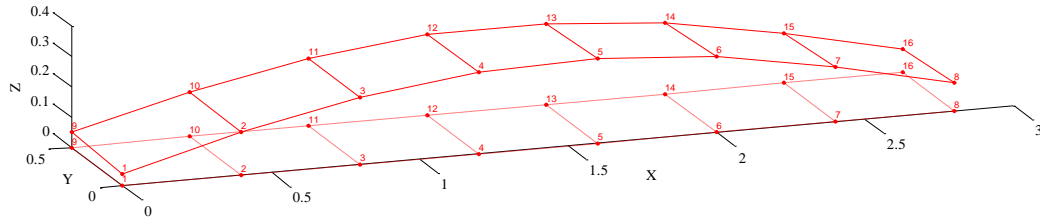
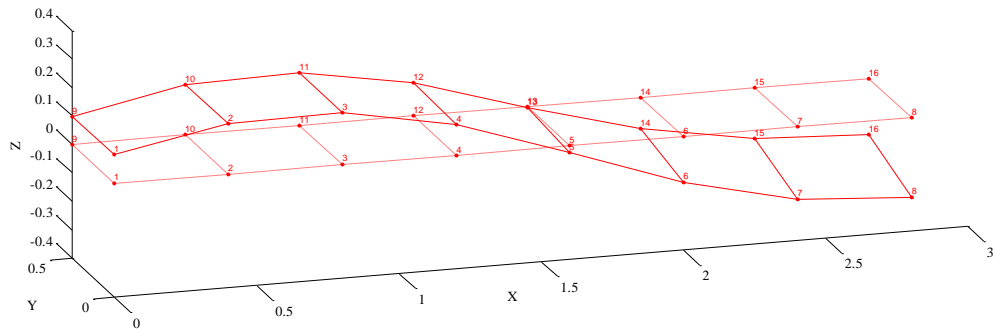
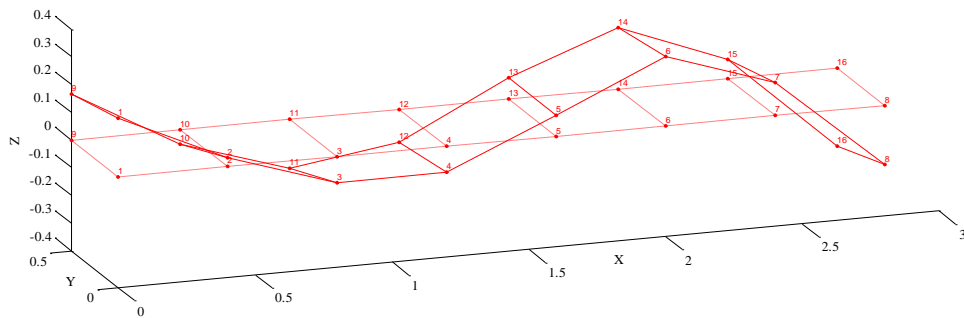
(1) First mode

(2) Second mode

(3) Third mode

Fig. 14 Identified first three mode shapes of the undamaged structure

The first three identified natural frequencies of the undamaged and damaged structures are listed in Table 5. Fig. 14 shows the corresponding identified mode shapes of the undamaged structure. The identified mode shapes of the damaged structure are similar and therefore are not shown here. MAC values at the slab sensor locations of two damage states are shown in Table 6. It can be seen from Table 5 that minor changes of the first three frequencies are observed in damage Scenario 1. The largest one is only 0.82% at the third frequency, and its corresponding MAC value is 0.923. Therefore it will be difficult to confidently identify the damage of shear connectors with the changes of frequencies and mode shapes. For the damage Scenario 2, the largest change of natural frequency is 17.08% at the third mode, and its MAC value is 0.449. This observation is consistent with that in the numerical study. Since this structure has no diaphragms at two ends, the damage of shear connectors at support locations induces large changes of frequencies and MAC values. Table 7 shows the comparison between the natural frequencies of experimental and numerical models. The differences come from the model errors, such as in the materials properties and boundary conditions. If model-based damage detection approaches are employed, initial finite element model updating has to be conducted to adjust the numerical model.

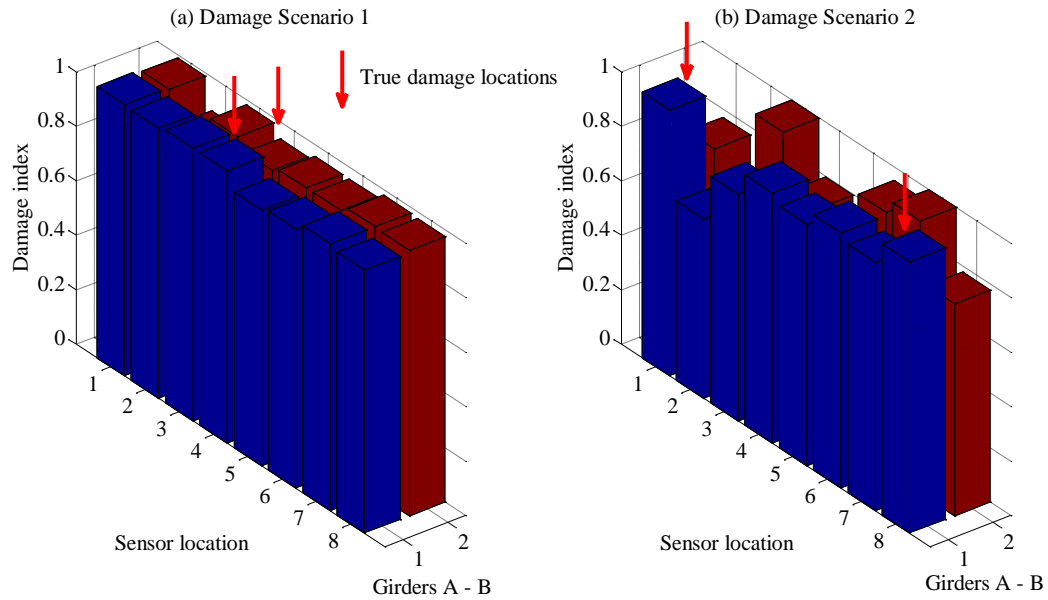
Fig. 15 Damage detection results with COMAC

It can be seen from Fig. 15 that COMAC fails to identify the damages in Scenarios 1 and 2 indicating that COMAC is not a good indicator to detect the local damage of shear connectors

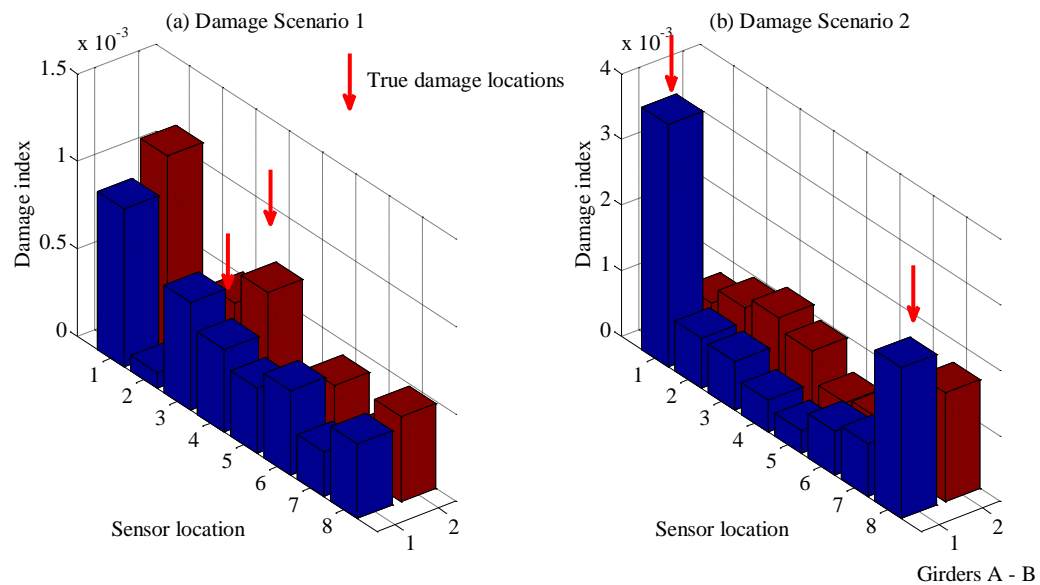
Fig. 16 Damage detection results with changes in flexibility

because the identified frequency and mode shapes would be polluted by the noise effect in lab testing. Fig. 16 shows the damage detection results with changes in flexibility. It can be found that the damages in Scenario 1 are not detected correctly, while damages in Scenario 2 are identified accurately indicating that the detection using changes in flexibility is more powerful than COMAC but not applicable for the minor damage case with smaller modal information changes.

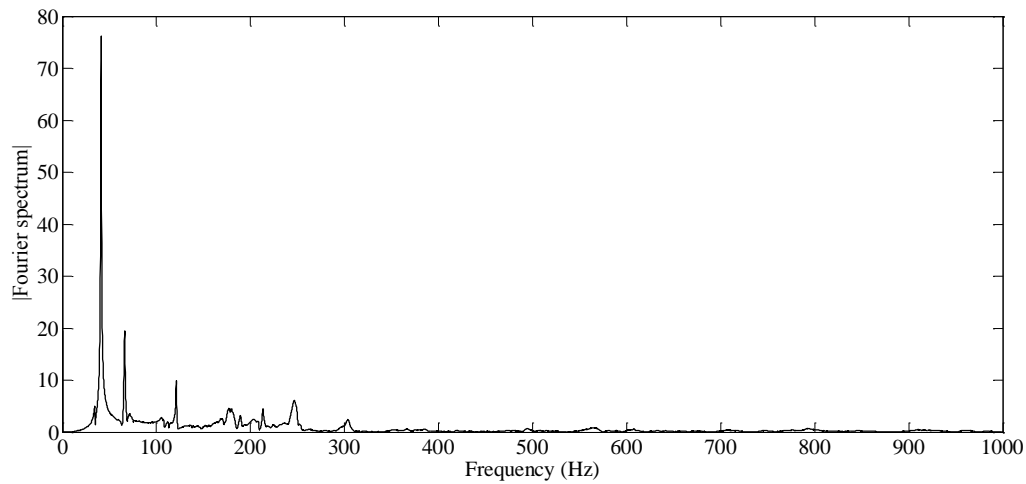
Fig. 17 Fourier spectrum of the measured response at SB5 from damage Scenario 1

FRF at each sensor location. Hanning window was used to reduce the leakage in the fast Fourier transform. PSDT vectors in the undamaged and damaged states were calculated with Eq. (14). Fig. 17 shows the Fourier spectrum of the measured response at sensor location SB5 from damage Scenario 1. As shown the magnitude of Fourier spectrum after 400 Hz is very small, therefore PSDT vectors in the frequency range of 15 Hz ~ 400 Hz are used to compute the damage index with Eq. (13) and identify the damage location of shear connectors. Since more uncertainties may exist in the experimental testing, α is set as 0.05 such that the cumulative probability of the upper confidence limit is 95%.

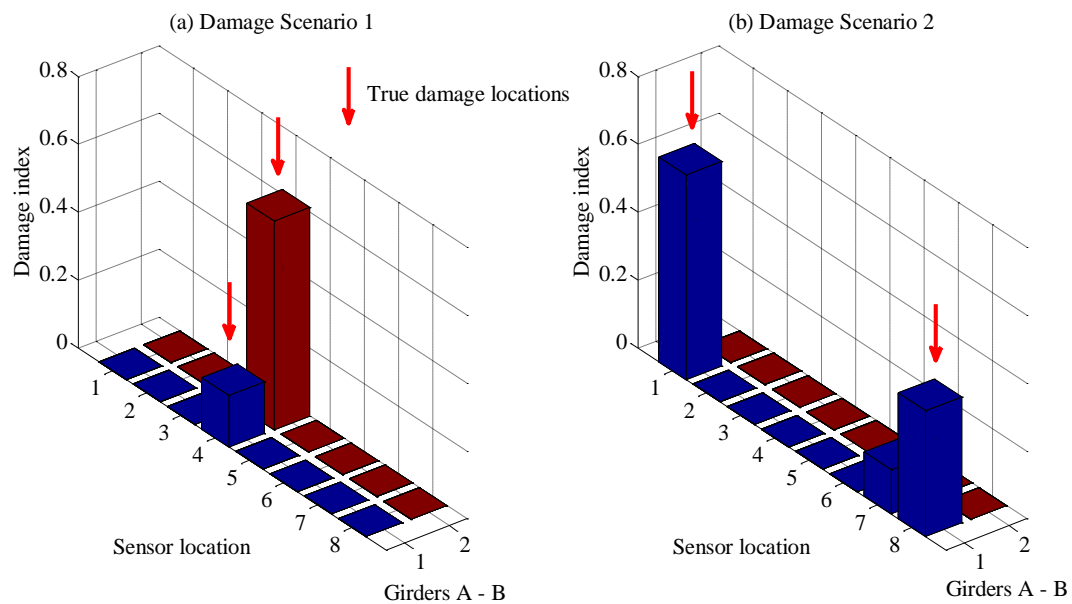
Fig. 18 Damage detection results using PSDT with data from undamaged structure available

Figs. 18(a) and 18(b) show the identified results of Scenarios 1 and 2, respectively. It can be found from Fig. 18(a) that two damage index values at the sensor location No. 4 in two girders are obtained, indicating that the damages of shear connectors are presented in these two areas in damage Scenario 1. This observation illustrates that the introduced damage of SC7, SC8, SC23 and SC24 are identified correctly. It should be noticed that the damage index at the sensor location No. 4 in Girder B is around 0.6, while it is around 0.15 at sensor location No. 4 in Girder A although the damage severities at these two locations are the same. One possible reason for this difference is the possible different frictions between the steel girders and concrete slab. Although the two steel girders used in the structure model are the same, the surface conditions of the concrete slab at the two locations might be different owing to construction quality control, which results in different frictions between steel girders and concrete slab and hence affects the calculated damage indices at the two locations. Moreover, this observation also indicates that the absolute damage index value cannot be used to quantify the damage. This limitation is the drawback of non-model based methods, i.e., they can locate the damage but very difficult to quantify the damage. If a finite element model is involved in the analysis, the model updating and damage quantification can be conducted with the proposed PSDT concept (Li *et al.* 2015). Then the damage locations and extents in structures can be identified with the output-only vibration measurements. However, it should be noted that the reliability of the model updating approach very much depends on the accuracy of the FE model of the structure. For a civil engineering structure, it is not necessarily straightforward to establish a FE model based on design drawings to accurately represent the true structure. Model updating analysis based on inaccurate FE model may lead to inaccurate structural condition identifications. Therefore, developing condition monitoring method without the need to involve the structural model will find wide applications.

Damage detection results for Scenario 2 are shown in Fig. 18(b). It can be found that these two introduced damage locations are identified accurately. A false identification appears in sensor location No. 7 in Girder A as this area is close to the true damage location at SA8. The above results demonstrated that the proposed method with PSDT using experimental testing data to detect the damage of shear connectors gives better and more accurate results than those with global modal information, and indicates that the proposed method is more robust to the environmental and measurement noise effect.

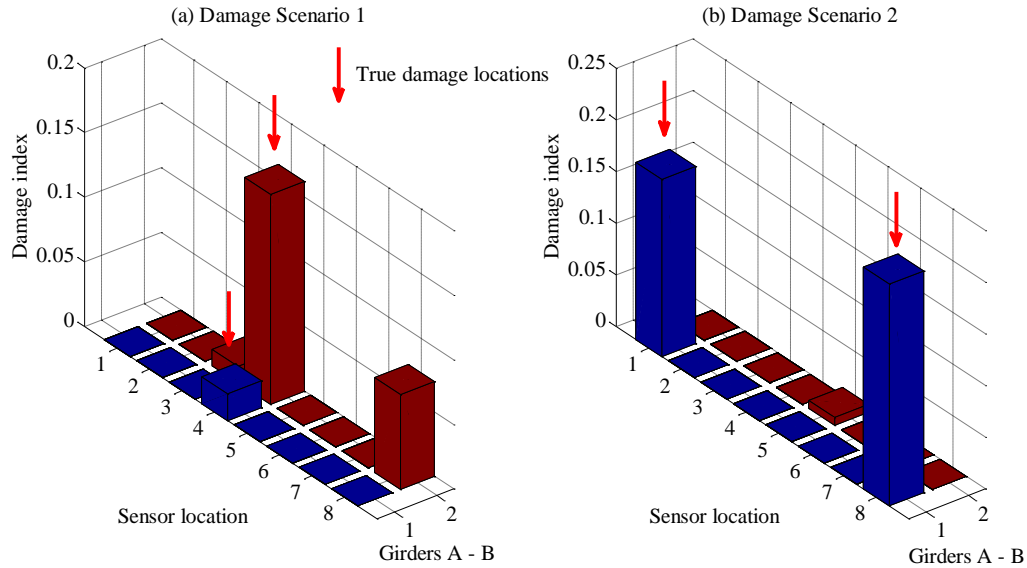
Fig. 19 Damage detection results using RDFRF without the data from the undamaged structure

Fig. 19 shows the damage detection results with the relative difference of FRFs between slab and girder. It can be found that the damages in both scenarios are identified, but with several false identifications, for example, sensor locations No. 3 and No. 8 of Girder B in Scenario 1, sensor location No. 5 of Girder B in Scenario 2.

A comparison between Figs. 19 and 21 indicates that the proposed damage detection method with PSDT is more sensitive to the damage and can give higher damage indices and less false identifications. These results demonstrated again that the proposed condition assessment approach based on PSDT can identify the damage locations of shear connectors efficiently with and without measurement data from the undamaged structure. Although a few false identifications might occur, the proposed method can be used effectively to identify possible shear connector damages that cannot be reliably detected by routine visual inspections.

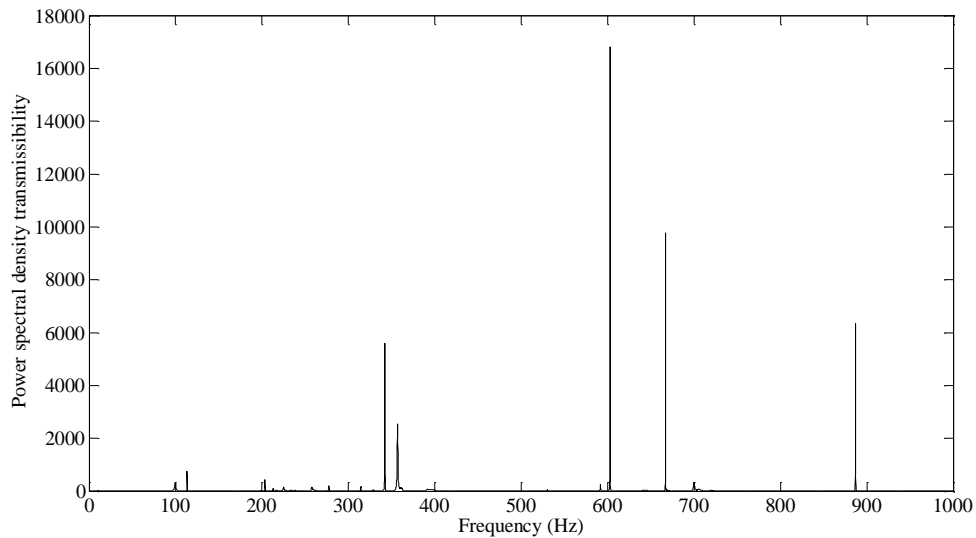
Fig. 20 Power spectral density transmissibility at sensor location SA1 of damage Scenario 1

A reference sensor location is defined as shown in Fig. 13. Fig. 20 shows the PSDT from the reference sensor response to the slab response at sensor location SA1 of damage Scenario 1. It is a vector with scalar numbers covering all the frequency lines with the same order of magnitude values. Therefore, PSDT vectors in the frequency range of 15 Hz~1000 Hz are used to compute the damage index with Eq. (16). Figs. 21(a) and 21(b) show the damage detection results for Scenarios 1 and 2, respectively. It can be seen that the introduced damages of shear connectors in

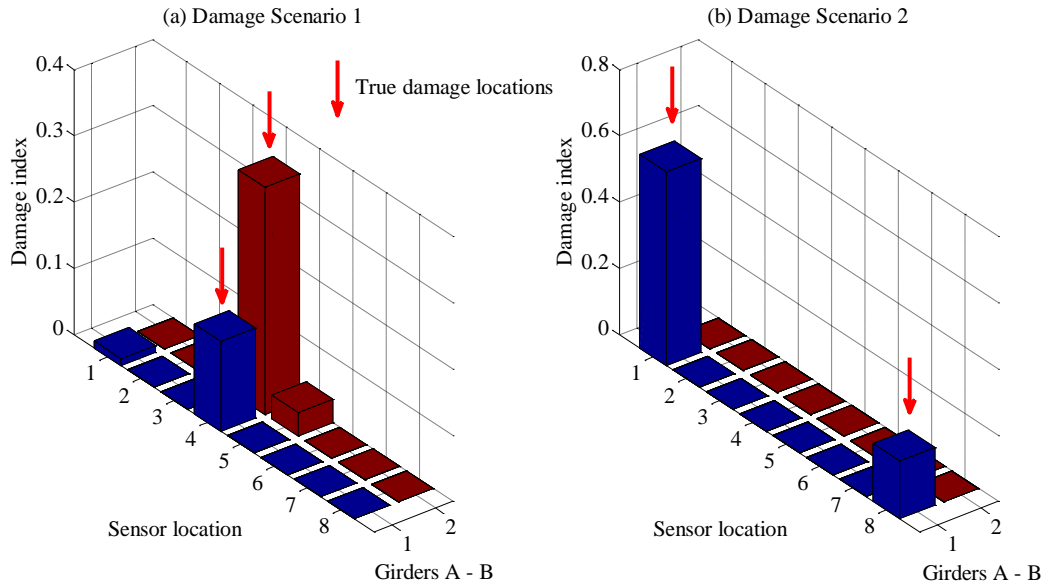
Fig. 21 Damage detection results using PSDT with data from undamaged structure unavailable

both damage scenarios are identified accurately. Several small false identifications are observed at sensor locations No. 1 in Girder A and No. 5 in Girder B of Scenario 1 and their damage index values are less than 0.05.

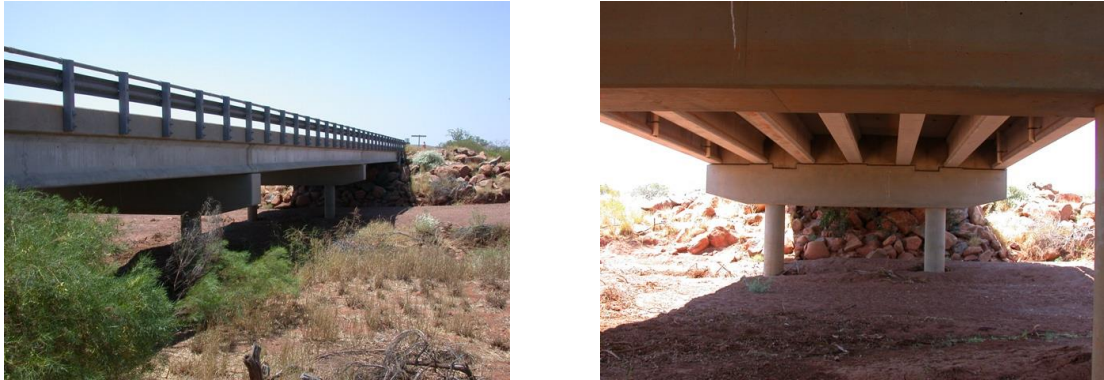
Fig. 22 General view of Bridge No. 852

The proposed damage detection method is further applied to evaluate the shear link conditions of a real bridge. Bridge No. 852 is located on North West Coastal Highway over the Balla Balla River in the Shire of Roebourne, Western Australia. It is a pre-stressed concrete bridge constructed in 1975, which consists of three spans with an overall length of 53.95 m and width of 9.398 m. The central span of the bridge is 18.288 m and the external spans are 17.831 m. The deck of the bridge is the cast-in-situ reinforced concrete slabs supported by seven precast pre-stressed I-type girders, as shown in Fig. 22. The shear connectors are used to link the slab and girders together. They are 12 mm in diameter and enter the RC slab for a 100 mm length before being bent for anchorage. Spacing of the connectors varies from 76 mm in the ends to 381 mm in the center of the girders. More details about the design of the bridge are referred to a technical report (Xia *et al.* 2005).
