Damage assessment of shear connectors with vibration measurements and power spectral density transmissibility

Abstract. Shear connectors are generally used to link the slab and girders together in slab-on-girder bridge structures. Damage of shear connectors in such structures will result in shear slippage between the slab and girders, which significantly reduces the load-carrying capacity of the bridge. Because shear connectors are buried inside the structure, routine visual inspection is not able to detect conditions of shear connectors. A few methods have been proposed in the literature to detect the condition of shear connectors based on vibration measurements. This paper proposes a different dynamic condition assessment approach to identify the damage of shear connectors in slab-on-girder bridge structures based on power spectral density transmissibility (PSDT). PSDT formulates the relationship between the auto-spectral densities of two responses in the frequency domain. It can be used to identify shear connector conditions with or without reference data of the undamaged structure (or the baseline). Measured impact force and acceleration responses from hammer tests are analyze

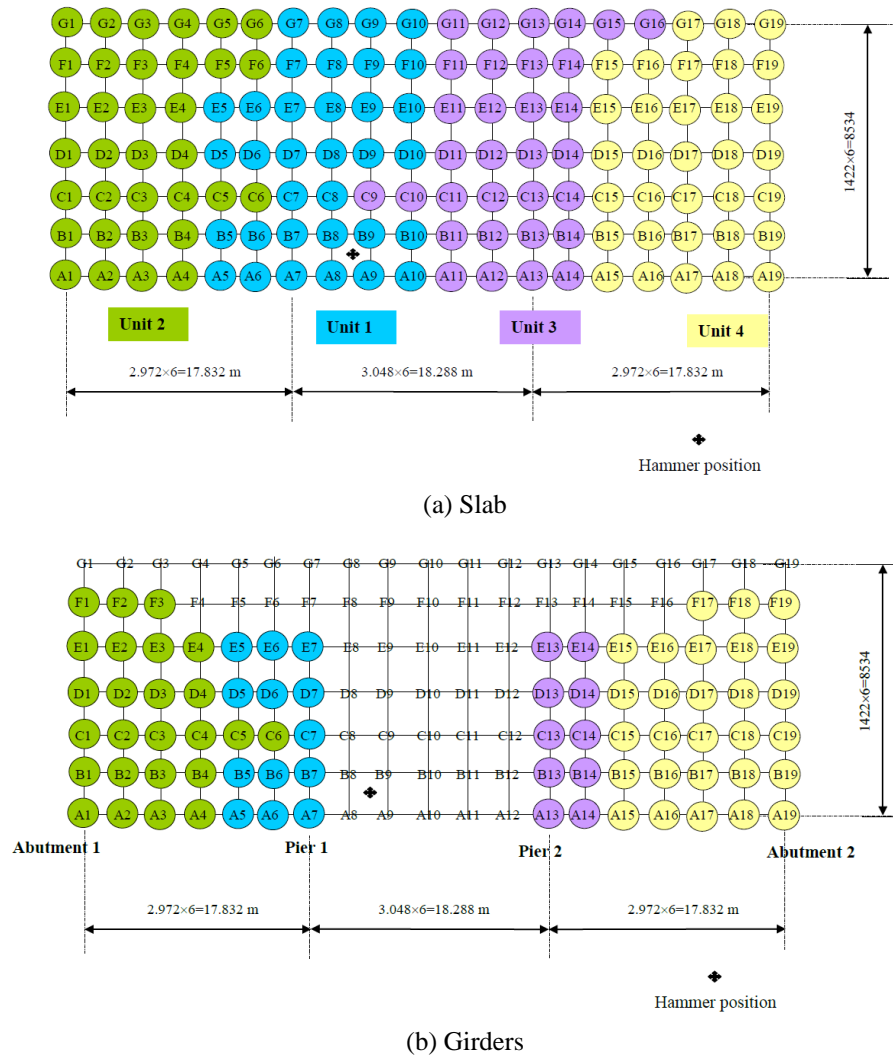
Fig. 23 Sensor placement on slab and girders

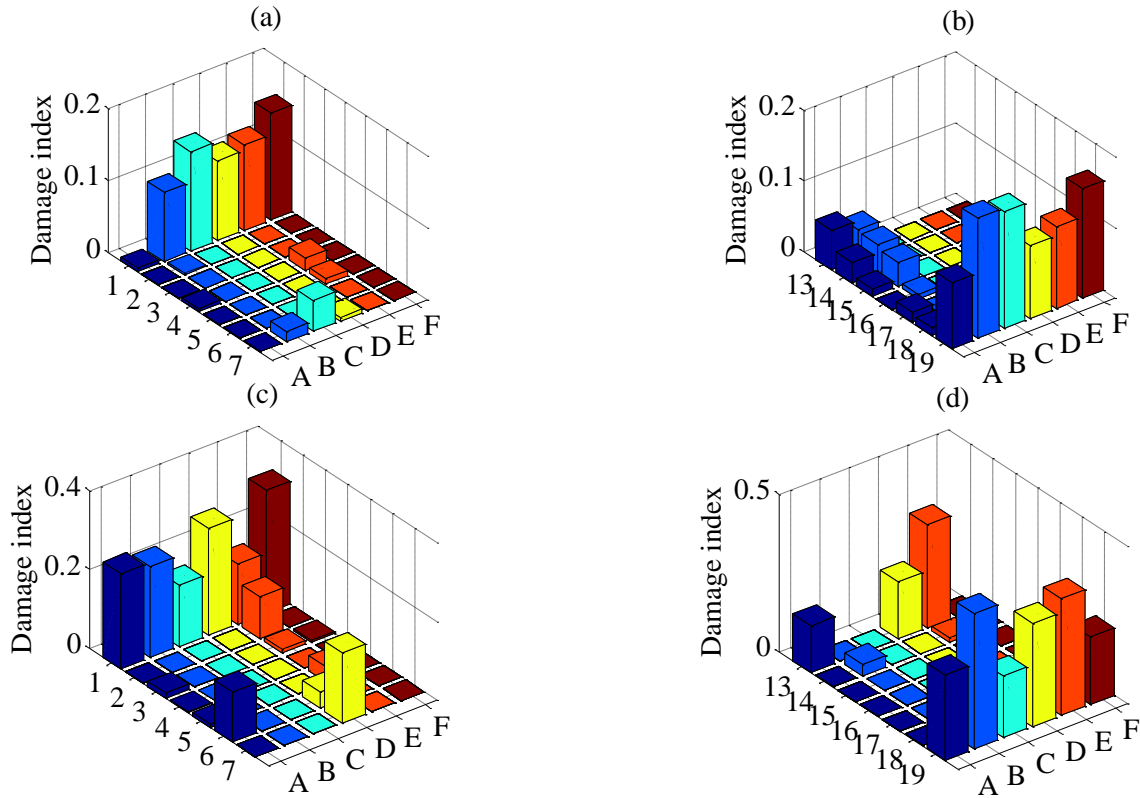
Fig. 24 Damage detection results for Bridge No. 852 (a) with RDFRF, left span; (b) with RDFRF, right span; (c) with PSDT, left span; (d) with PSDT, right span

FRFs were extracted from the measured acceleration response data and hammer impact force with DIAMOND toolbox. Frequency range from 1 ~ 21 Hz is used to include the first ten modes (Doebeling *et al.* 1997). Five reference sensors, e.g., A10, B10, C10, D10, E10 and F10 are defined to average the damage index. Fig. 24 shows the identification results based on the differences of FRFs and PSDT vectors. Damages of shear connectors from both methods are mostly identified at the support locations, especially near the abutments 1 and 2 as the shear forces at the supports are generally larger than those at other locations. Comparing the identification results from these two

methods, detection with PSDT gives higher damage values and indicates that it is more sensitive to the damage. The condition assessment results are reasonable since the shear connections at the support locations are more easily to be damaged. Nonetheless, this cannot be verified as the bridge is still in service. Evaluation of load carrying capacity of the bridge has been carried out by Ding *et al.* (2012).
