Repair of flange damage steel-concrete composite girders using CFRP sheets

Abstract. Damaged steel-concrete composite girders can be repaired and retrofitted by epoxy-bonded carbon fiber-reinforced polymer (CFRP) sheets to the critical areas of tension flanges. This paper presents the results of a study on the behavior of damaged steel-concrete composite girders repaired with CFRP sheets under static loading. A total of seven composite girders made of I20A steel sections and 80mm-thick by 900mm-wide concrete slabs were prepared and tested. CFRP sheets and prestressed CFRP sheets were used to repair the specimens. The specimens lost the cross-sectional area of their tension flanges with 30%, 50% and 100%. The results showed that CFRP sheets had no significant effect on the yield loads of strengthened composite girders, but had significant effect on the ultimate loads. The yield loads, elastic stiffness, and ultimate bearing capacities of strengthened composite girders had been changed as a result of prestressed CFRP sheets, the utilization ratio of CFRP sheets could be effectively improved by applying prestress to CFRP sheets. Both the yield loads and ultimate bearing capacities ha

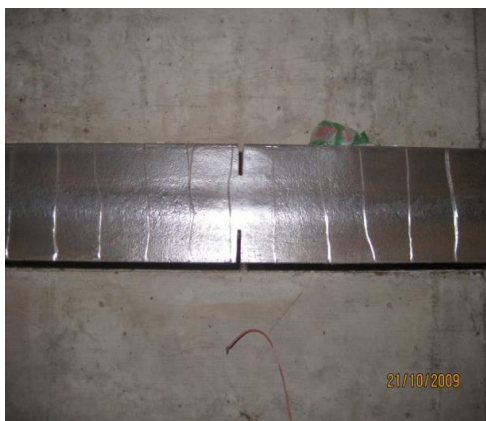
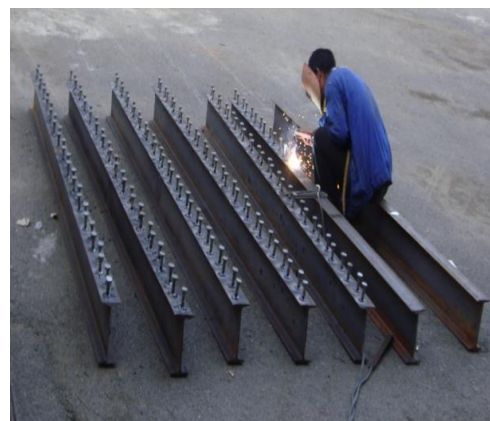
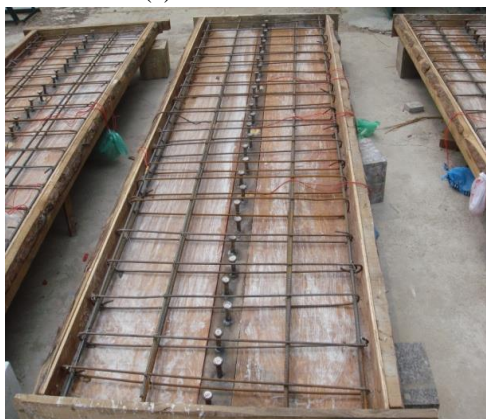
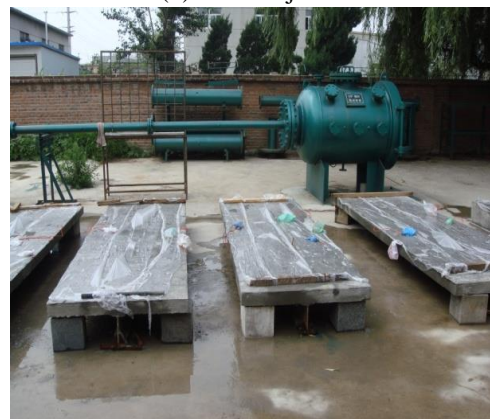
Fig. 2 The preparation of specimens

(a) Corroded model

(b) Welded joints

(c) Formwork for concrete slab

(d) Specimens maintaining

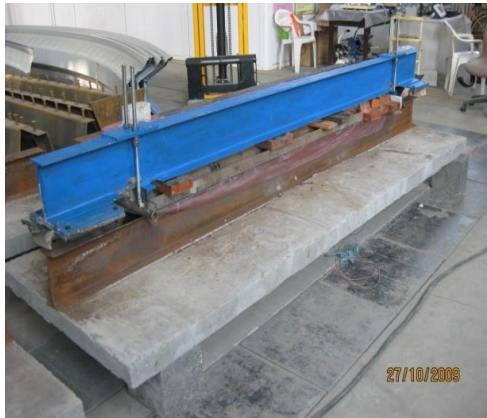
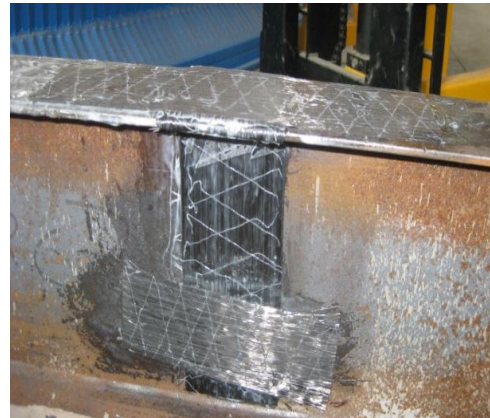
Fig. 2 Continued

(e) Paste prestressed CFRP sheets

(f) Paste CFRP sheet and U-shaped hoop

sheets. The thickness of the CFRP sheets was 0.167 mm, the wide was 80mm and the length was 2,400 mm. Tensile test of CFRP sheets was conducted, and an average tensile strength was 3,456 MPa; elastic modulus was 258GPa. Two different attachment patterns were, namely, CFRP sheet and prestressed CFRP sheet. The prestress was applied to the CFRP sheets by using self-made stretching bed. Implementation method: fixed CFRP sheets by two steel slabs with four bolts at the end of stretching bed and four screws which could move up and down; applied prestress to the CFRP sheets by raising the supports horizontally and pasted prestressed CFRP sheets on the composite girders, as shown in Fig. 2(e); finally, pasted the U-shape hoops at the end of CFRP sheets to make sure the CFRP sheets could be anchored to the composite girders, as shown in Fig. 2(f). The detailed parameters of the composite girders were given in Table 1.

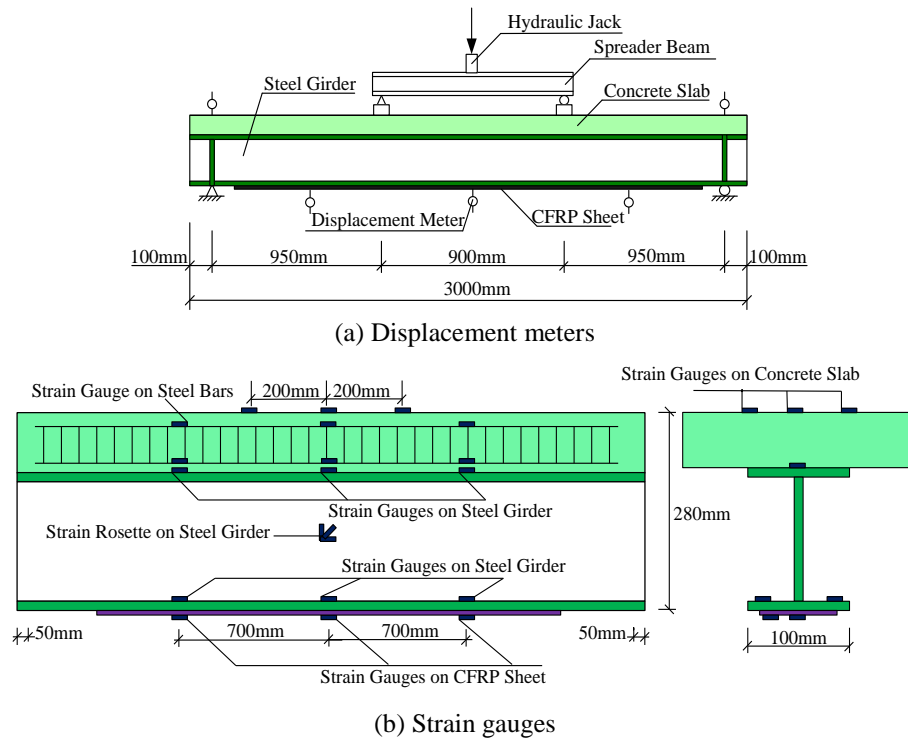
Fig. 3 Schematic of strain gauges and locations of the displacement meters at girders

A total of 7 specimens were tested as simple composite girders with a span of 2,800 mm. The girders were monotonically loaded in four-point bending with 900 mm spacing between the two concentrated point loads, and with two equal shear spans of 950 mm, as shown in Fig. 3. Rubber bearings were used at the supports. Loading was applied across the full width of the concrete slab by 150 mm deep steel hollow structural sections that were placed between the spreader beam and the rubber bearings on the top of the beam. Four-point bending tests were performed using 5,000 kN hydraulic jacks. In order to observe the behavior of the girders under investigation, the strains, loads and deflections were measured at the desired locations. The strains were measured by electrical resistance strain gauges which were placed on the steel bars, the mid-span and the two load points of the steel beam flange, the top of concrete slab and the underside face of CFRP sheets. Five displacement meters which were mounted at both the end of the girders and mid-span were used to measure the vertical deflection.

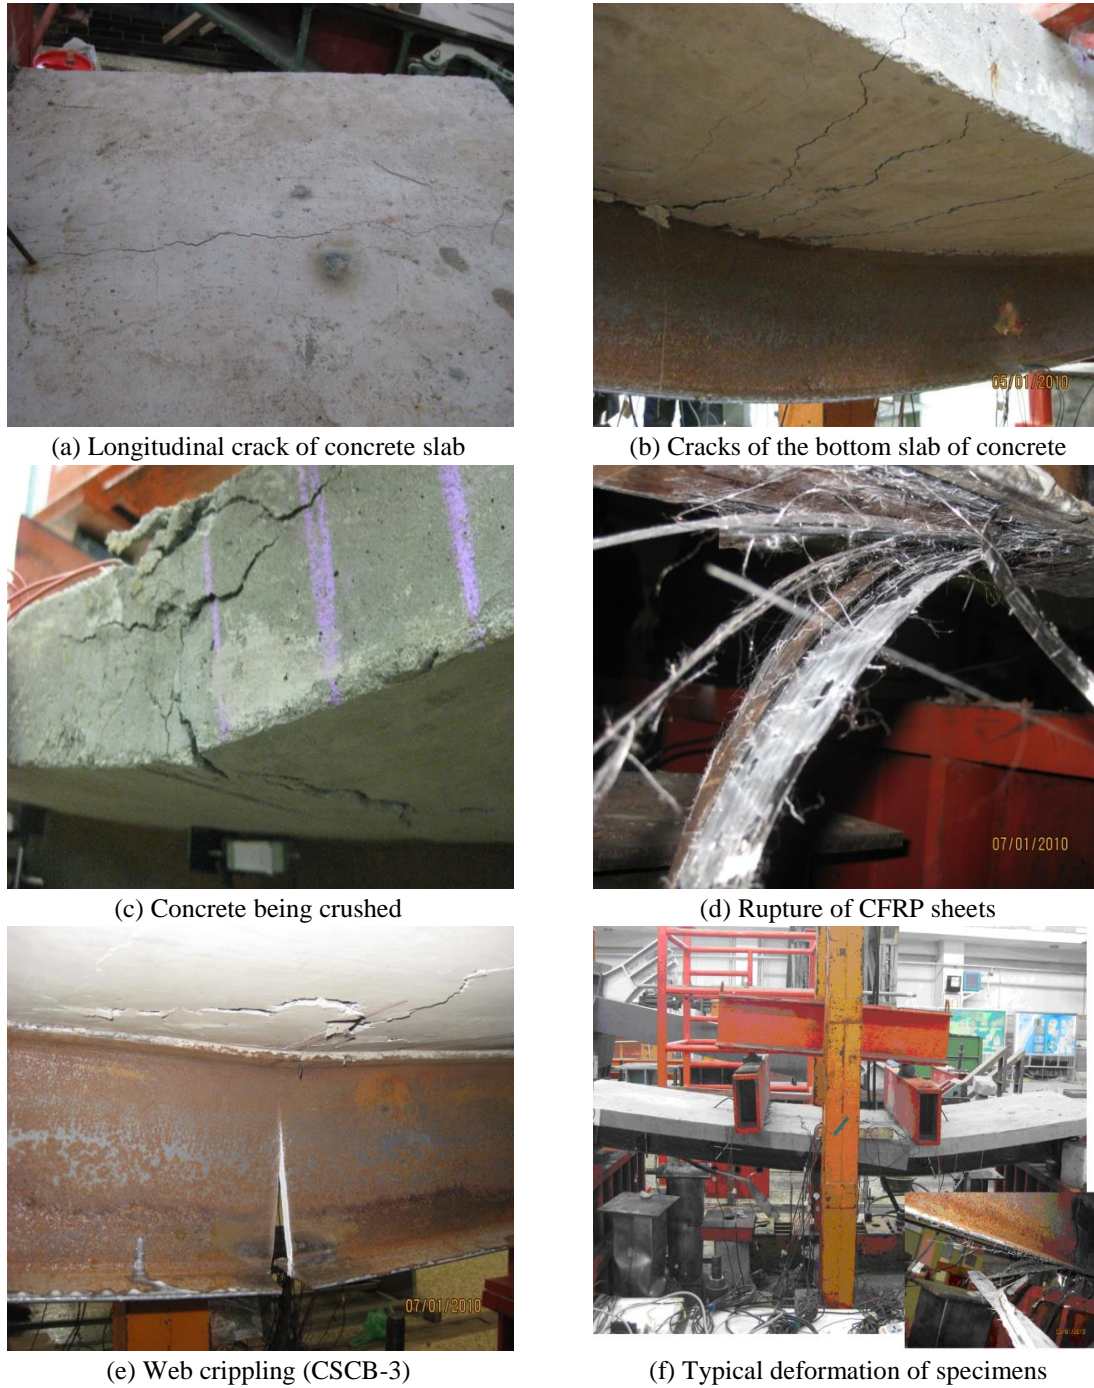
Fig. 4 Failure modes of test specimens

The bottom flange of the steel beams started to yield at about 50% to 60% of the ultimate load. When the load reached about 65% to 75% of the ultimate load, a few longitudinal cracks were observed at the top surface of the concrete slab along the web of steel beam, as shown in Fig. 4(a), but there was no any effect on the result due to the limited width.

The longitudinal cracks tended to increase with the increasing load and could have been prevented by transverse hoop reinforcement in the slab. A few transverse cracks were observed at the bottom surface of the concrete slab along the girder with the increasing load, as shown in Fig. 4(b).

The crushing of concrete, as shown in Fig. 4(c), was the dominating failure mode in all seven retrofitted girders. The tension rupture of CFRP sheets, as shown in Fig. 4(d), was the distinct mode of failure of the composite girders. The rupture of the CFRP sheet was sudden and there was no sign of bonding failure between the CFRP sheet and the steel flange in the specimens of CSCB-2, CSCB-4, CSCB-5, and CSCB-6.

Failure of steel beam being crippled and debonding between the CFRP sheet and steel flange happened in girder CSCB-3. The tensile flange of steel beam began to yield when the load reached about 50% of the ultimate load. As the load increased, the color of CFRP sheet began to darken. The debonding developed quickly from the first sign at the cut in the mid-span (when the load was 90% of the ultimate load). The web of the steel beam ruptured at the same time as the CFRP sheet debonded, as shown in Fig. 4(e).

The experimental results revealed that ultimate failure was usually accompanied with large deflection and some transverse cracks of concrete slab at mid-span of girders. Both the webs and flanges of the steel beams were yielded, but there was no buckling and crippling, as shown in Fig.4 (f).

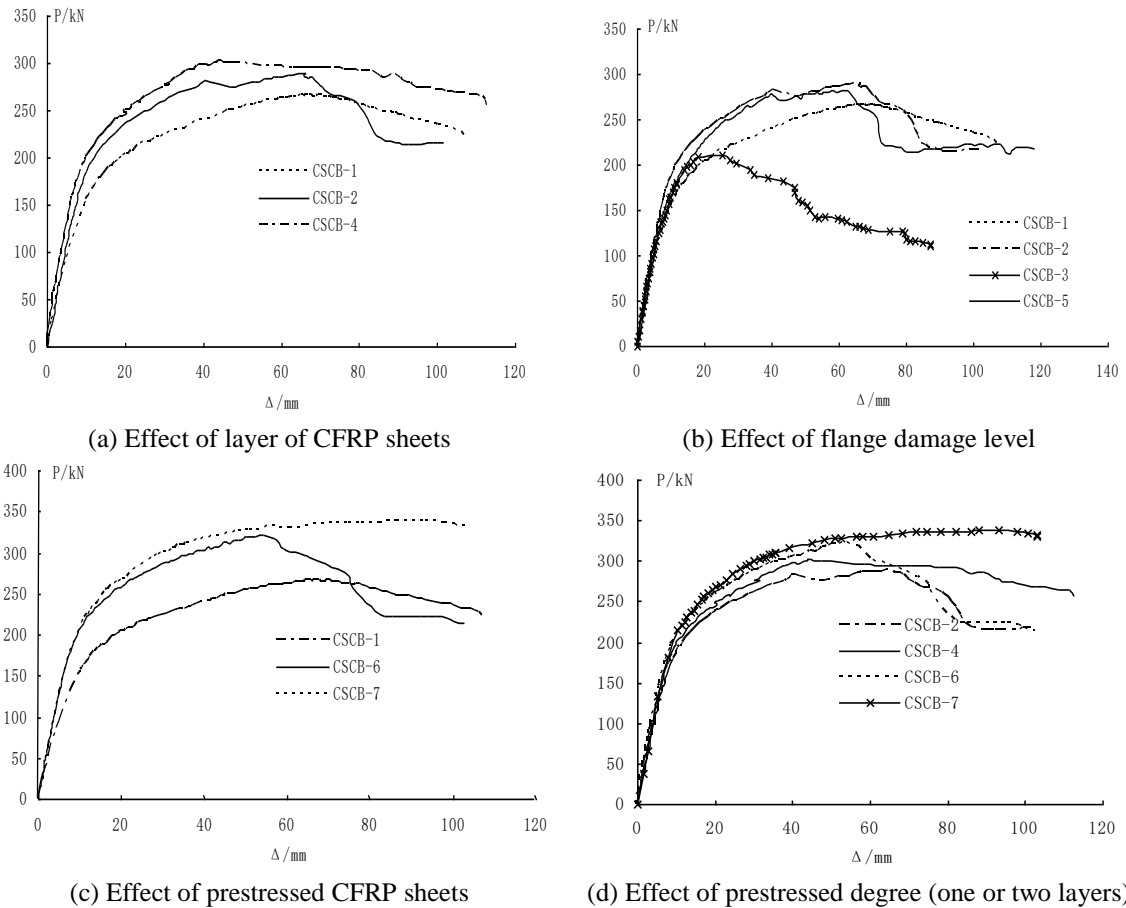
Fig. 5 Relationship between load and deflection of retrofitted composite girders

Fig. 5(a) shows the load versus mid span deflection of the composite girders with 30% flange damage of the steel beams. The thickness of the CFRP sheets was constant and the number of layers was 0, 1, and 2 which were respectively used in the CSCB-1, CSCB-2 and CSCB-4. The yield load of CSCB-2 was 175.2 kN, which was 3.1% greater than that of CSCB-1, and the elastic stiffness was 15.38% greater than that of CSCB-1. The yield load of CSCB-4 was 175.6 kN, that was 3.3% greater than that of CSCB-1, and the elastic stiffness was 26.73% greater than that of CSCB-1. The ultimate load of CSCB-2 was 288.5 kN, which was 8.8% greater than that of CSCB-1, and the ultimate load of CSCB-4 was 302.2 kN, that was 14% greater than that of CSCB-1. The results showed that epoxy-bonded CFRP sheets had significantly increased the ultimate bearing capacity and the elastic stiffness of the steel-concrete composite girders. The effect of CFRP sheets on the yield load was not significant.

Fig. 5(b) shows the load versus mid span deflection of the composite girders with different

flange damage levels, which were repaired with one layer of CFRP sheet. The damage levels of 30%, 50% and 100% loss of tension flange were cut at mid span of steel beams in CSCB-2, CSCB-5 and CSCB-3 respectively, and CSCB-1 was a control specimen. The yield load and ultimate load of CSCB-2 were 175.2 kN and 288.5 kN, which were respectively 10.2% and 3.2% greater than that of CSCB-5, and were 64.2%, 37.4% greater than that of CSCB-3. The ultimate load of CSCB-5 was 281.5 kN, which was 6.1% greater than that of CSCB-1; the ultimate load of CSCB-3 was 210 kN, which was 20.8% smaller than that of CSCB-1. It showed that the yield load and ultimate load had been obviously changed as a result of flange damage level; one layer of CFRP sheet could not cover the girders' shortage of bearing capacity with 100% flange damage, but it could cover the girders' shortage of bearing capacity with 30% and 50% flange damage.

Fig. 5(c) shows the load versus mid span deflection of the composite girders with 30% flange damage, which were repaired with prestressed CFRP sheets. CSCB-1 was a control specimen. CSCB-6 was repaired with one layer of prestressed CFRP sheet, and CSCB-7 was repaired with

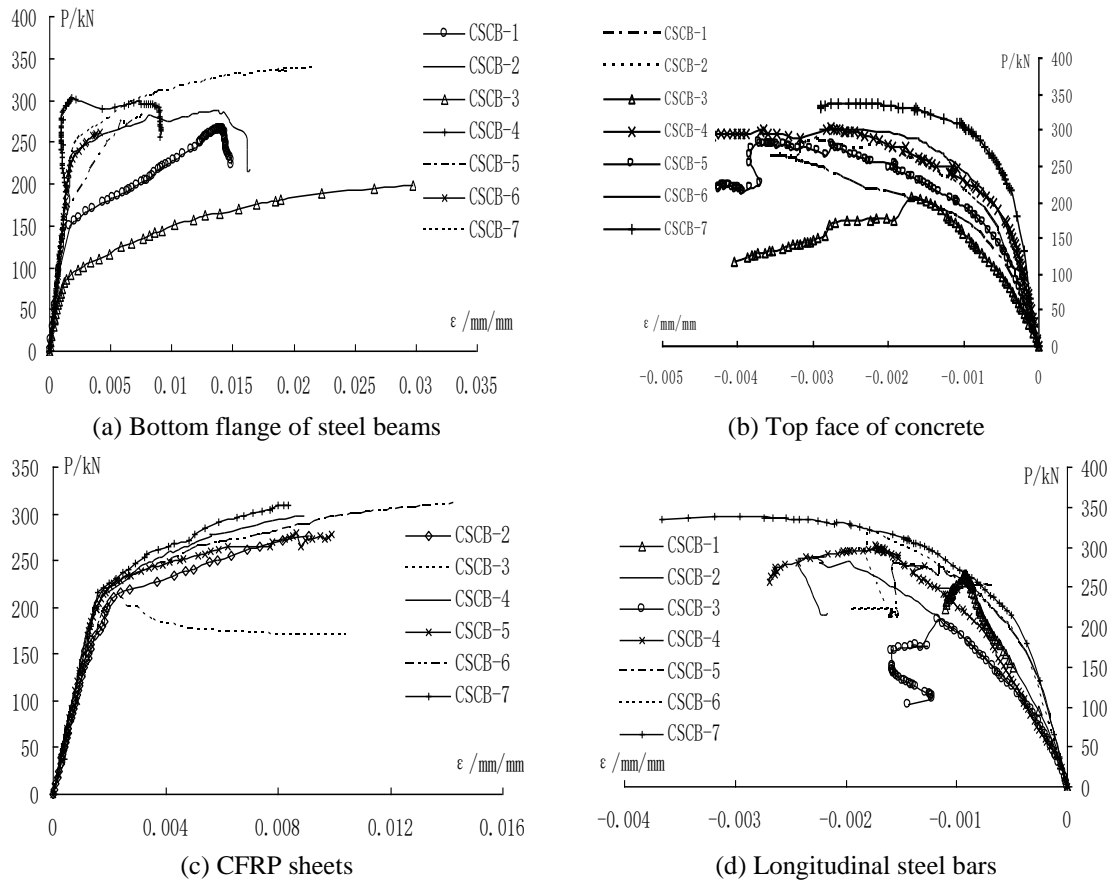
Fig. 6 Relationship between load and strain of retrofitted composite girders

At the beginning of the experiment, the load-strain relationship of the retrofitted composite girders was linear, as shown in Fig. 6. The lines represented the strains in the bottom flanges of steel beams, the top surface of the concrete slabs, the CFRP sheets and the longitudinal steel bars. The bottom flanges of the steel beams started to yield at about 60% of the ultimate loads. After yielding, the effectiveness of the CFRP laminates was much more outstanding. The strains in the tension flanges of the retrofitted composite girders decreased significantly. As the same load level, the strains of the girder with big flange damage were greater than other girders. After tension flange yielding, the compressive strains on the top surface of the concrete slabs became nonlinear and then the compressive concrete reached the limit strain value in the limit state. Because of the steel beam ruptured, the loads of CSCB-3 were smaller than other girders. The CFRP strains of the composite girders strengthened by prestressed CFRP sheets reached over 15,000 $\mu\epsilon$, the CFRP strains of the composite girders strengthened by CFRP sheets were about 9,000 $\mu\epsilon$ and the strains of longitudinal steel bars in the concrete slabs reached over 1,500 $\mu\epsilon$. All of them yielded in limit state. It showed that utilization ratio of CFRP sheets could be effectively improved by applying prestress to the CFRP sheets. The flange damage level of the girders could affect the strains of the retrofitted composite girders.
