Polypropylene fiber reinforced concrete plates under fluid impact. Part I: experiments

Abstract. Static loading and fluid impact tests on plates containing mesh reinforcement and polypropylene fibers in ratios of 0 to 3% by volume were performed. The objective was to observe the effect of fluid mass on the total impulse that caused the impact event and the influence of fiber amount on the impact resistance, and to estimate the velocity of fluid that causes scabbing, perforation or total disintegration. The study is the first to express the fluid impact resistance of polypropylene fiber reinforced concrete plates.

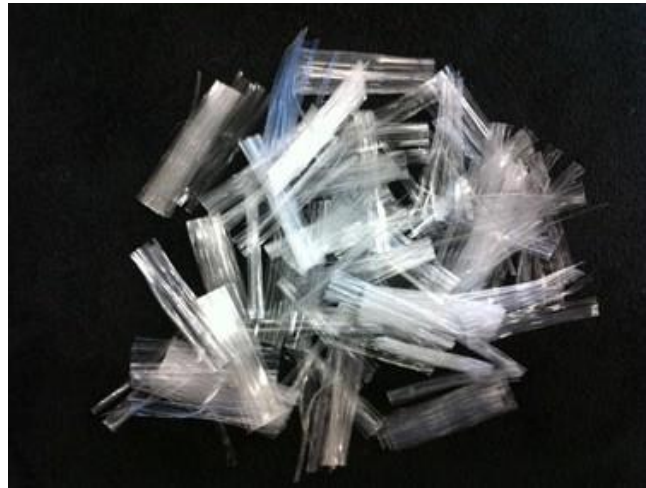
Fig. 1 Polypropylene fibers

requirements of ASTM C 1116/C 1116M (BASF 2015). The fibers are shown in Fig. 1 and physical properties are listed in Table 2.

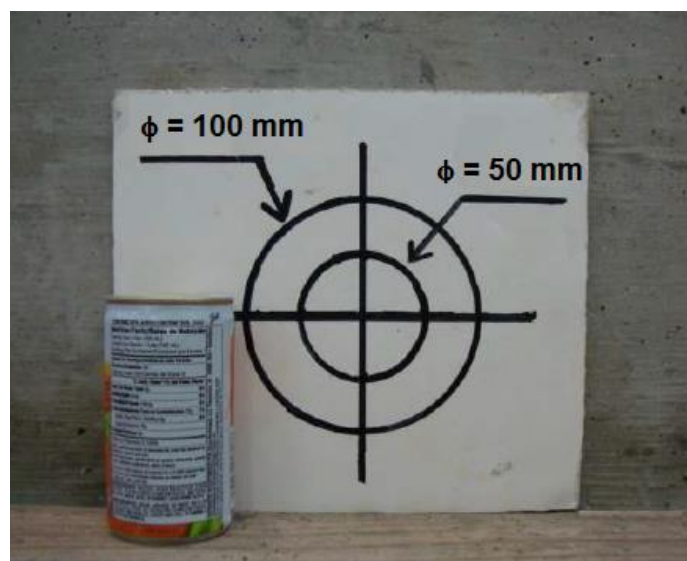
Fig. 2 Thin-walled cylindrical container

Plates were casted using foam-board forms. The fresh concrete had been cured under $20 \pm 5^\circ\text{C}$ temperature and 95% of humidity for a week. Thin-walled cylindrical container is shown in Fig. 2. The mechanical properties of the wire are given in Table 3.

In each group, four specimens were subjected to impact tests. Impacting projectiles were thin-walled aluminum containers filled with water. These cylindrical containers had a length of 95 mm and a diameter of 51 mm, and wall thickness of 0.05 mm. The average weight of the water in the container was 185 g and the weight of the container was 9 g. The mechanical properties of the aluminum are given in Table 5.

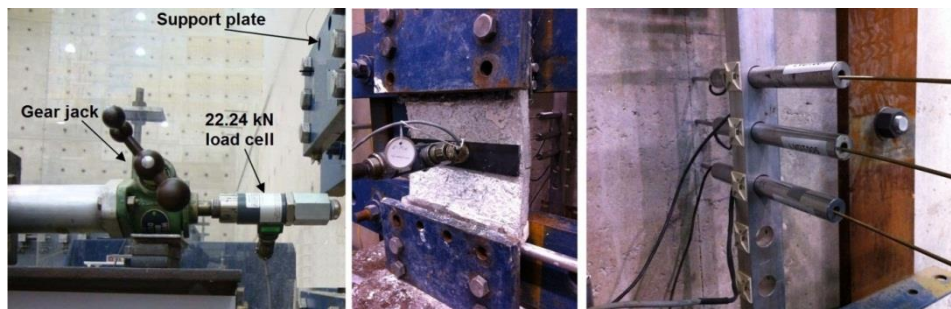
Fig. 3 The static test setup

In order to obtain the flexural capacity of the plates, a distributed load at the mid-span line was subjected to the mid-span of the beams by a 22.24 kN load cell fixed to a gear jack which is shown in Figs. 3 and 5. The deflections were measured using linear variable differential transformers (LVDTs) which were located at the rear of the mid-span and quarter points of the plates. Plates

were restrained against rotation along the top and bottom edges. The static test setup and support conditions are shown in Figs. 3-4. Post-test views of statically loaded plates from both sides are shown in Fig. 5. Load-displacement curves obtained at the mid-span are given in Fig. 6.

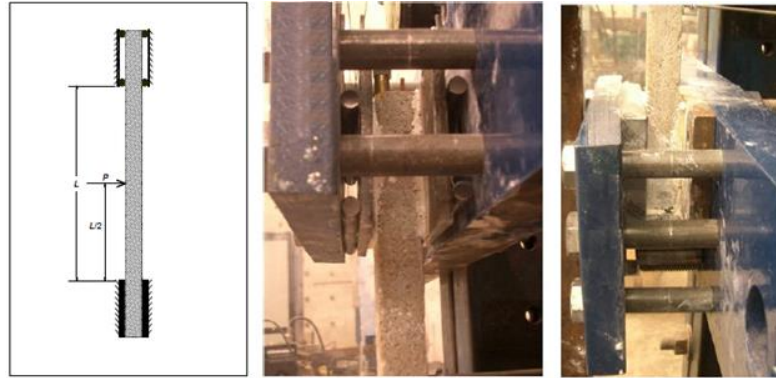
Fig. 4 Support conditions

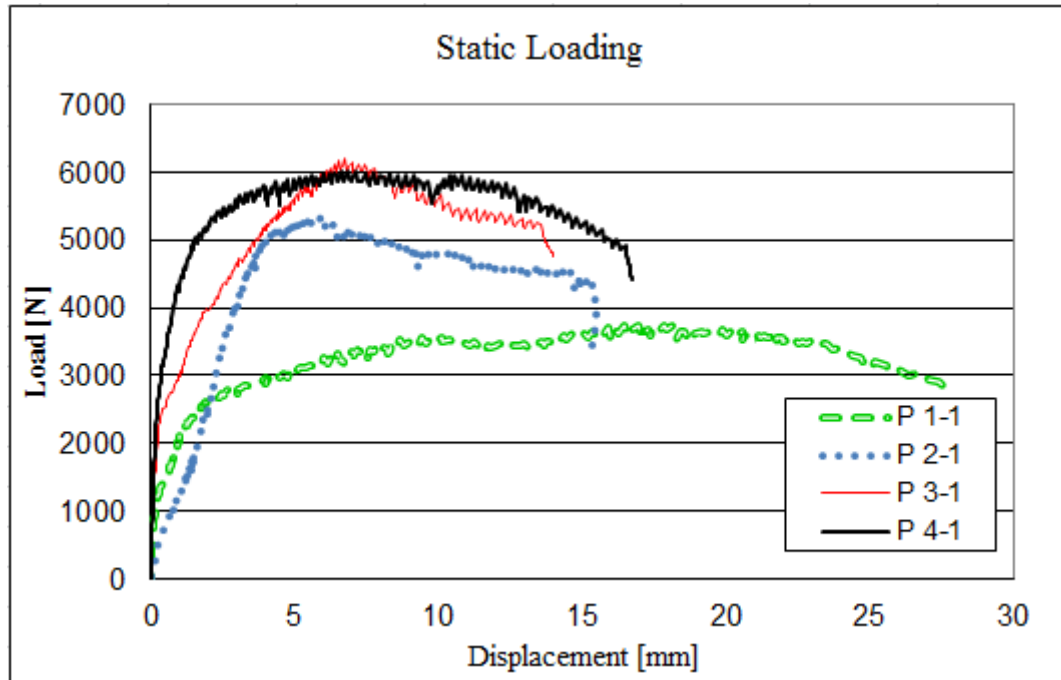
Fig. 6 Load-displacement curves obtained from static tests

Higher fiber ratio improved the flexural strength of the plates as shown in Fig. 6. Specimen P 4-1 consisting 3% of fiber, had almost double the load capacity of P 1-1 specimen without fiber.
