## Effectiveness of R/C jacketing of substandard R/C columns with short lap splices

**Abstract.** The effectiveness of a retrofitting method for concrete columns with particular weaknesses is experimentally evaluated and presented in this paper. Structural deficiencies namely the inadequacy of transverse reinforcement and short length of lap splices are very common in columns found in structures built prior to the 1960s and 1970s. Recent earthquakes worldwide have caused severe damages and collapses of these structures. Nevertheless, the importance of improving the load transfer capacity between the deficiently lap-spliced bars is usually underestimated during the strengthening procedures applied in old buildings, though critical for the safety of the residents' lives. Thus, the seismic performance of the enhanced columns is frequently overestimated. The retrofitting approach presented herein involves reinforced concrete jacketing of the column sub-assemblages and welding of the lap-spliced bars to prevent the splice failure and conform to the provisions of modern design Codes. The cyclic lateral loading response of poorly confined original column specimens with insufficient lap s

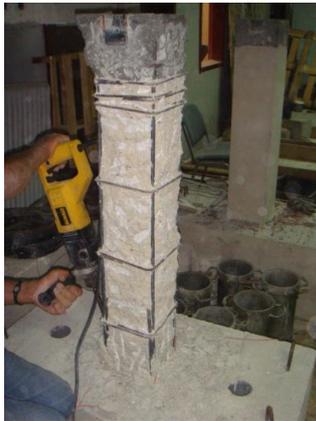
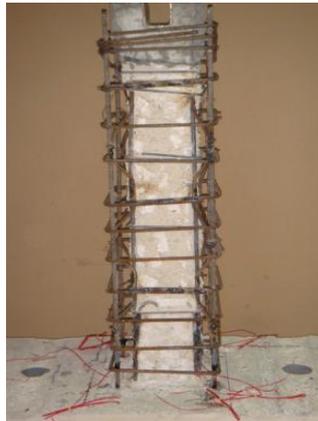
Fig. 1 Retrofitting of the column specimens with deficient lap splices

(a) the cover concrete of the original specimens is chipped away

(b) welding of lap splices in the original column and R/C jacket reinforcement

(c) insertion of epoxy resin

The enhanced columns  $RWL_1$ ,  $RWL_2$  and  $RC_2$  conformed to the modern code standards for seismic design. During the pre-earthquake strengthening process the cover concrete of columns  $L_1$ ,  $L_2$  and  $C_2$  was chipped away (see Fig. 1(a)). Before the construction of the reinforced concrete jackets additional measures were undertaken to ensure the increasing of load transfer and the continuity of the spliced bars. Hence, the spliced bars of columns  $RWL_1$  and  $RWL_2$  were welded-up as shown in Fig. 2, to satisfy the requirements of the Code of Steel Reinforcement Technology for Concrete (CSRTC 2008). A four-sided cement grout jacket with additional longitudinal and transverse reinforcement was subsequently constructed according to the recommendations of the Greek Code for the Design of Reinforced Concrete Structures (C.D.C.S., 2000) and to the provisions of Eurocode 2 and 8 (2004). The retrofitted columns are shown in Fig. 4(b). Reinforcement details of the strengthened specimens are presented in Table 2. The longitudinal jacket reinforcement bars were anchored inside the foundation block of the sub-assemblages, after drilling the needed holes and cleaning them with air-pressure. A flowable, nonshrink epoxy resin was inserted inside the holes by syringe to achieve the bonding between the new bars and the concrete (see Fig. 1(c)). Connection between the longitudinal reinforcement of the jackets and the bars of the original columns was achieved by s-shaped steel segments which were welded to the bars (see Figs. 1(b) and 4(b)), according to the provisions of the Code of Steel Reinforcement Technology for Concrete (CSRTC 2008). The transverse reinforcement of the reinforced concrete jackets consisted of B500C 8mm diameter deformed closed ties with welded ends (welded according to CSRTC (2008)). A premixed, non-shrink, rheoplastic, flowable, and non-segregating mortar of high strength was used for constructing the cement grout jacket of the specimens.

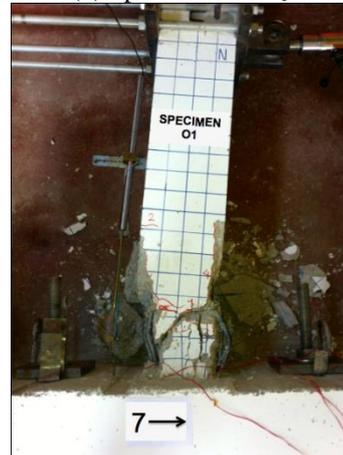
Fig. 12 Post-damage views of the collapsed subassemblages (a) RC<sub>2</sub>, (b) RWL<sub>1</sub>, (c) RWL<sub>2</sub>, (d) O<sub>1</sub> and (e) O<sub>2</sub>

The overall seismic behavior of the specimens, which were subjected to a large number of inelastic cycles, is also reflected in the failure mode of the columns (Fig. 12). Both the original columns  $O_1$  and  $O_2$  with deficient lap splice lengths equal to  $20d_b$  and  $24d_b$ , respectively, exhibited unfavourable, brittle, premature splice failure. During the first cycle of loading hairline cracks were formed around the columns, while the first splitting cracks along the splice length started to form for drift angle,  $R$ , equal to 2.55 percent. During the incremental displacement of the lateral loading, gradual dilation of these cracks resulted in early bond failure between the concrete and the lap-spliced steel bars, loss of the cover concrete and subsequently in disintegration of the core concrete due to the decrease of the load-carrying capacity of the columns. Consequently, after the failure of the transverse reinforcement, the longitudinal bars buckled under the axial load of the specimens. Eventually, the severe accumulated damage in the critical region of the original sub-assemblages resulted in the collapsing of the columns, which were unable to withstand the vertical axial load. The enhanced sub-assemblages exhibited cracking patterns dominated by flexure. After the formation of the main flexural crack at the bottom end of the columns, a few more hairline cracks were formed along the critical height during the first three or four cycles of

loading. No further damage, such as loss of the cover concrete, disintegration of the core concrete or buckling of the longitudinal reinforcement, were observed in the reinforced concrete jackets of the specimens, due to the high strength of the jackets, constructed by a premixed, non-shrink, rheoplastic, flowable, and non-segregating mortar of high strength.

Ultimately, the strengthened sub-assemblages achieved a significant improvement of their flexural strength, stiffness and energy dissipation capacity and showed great seismic performance even for large inelastic deformations. All the retrofitted columns exhibited ductile failure, with the formation of the plastic hinge in the bottom end of the columns.
