Rehabilitation of hospital buildings using passive control systems

C. A. Syrmakelis[†], O. A. Mavrouli[‡] and A. K. Antonopoulos[‡]

*Institute of Structural Analysis and Aseismic Research, School of Civil Engineering,
National Technical University of Athens, 9, Iroon Polytechniou, Zografou Campus, 15773, Athens, Greece*

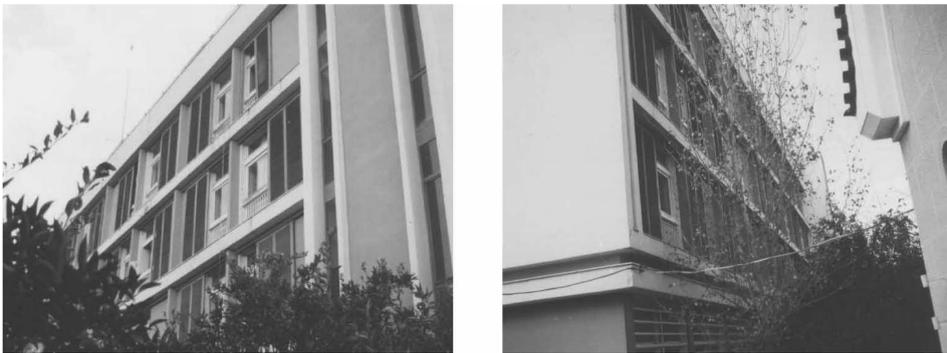
In this article, a hospital building named section B in the hospital complex “Agios Andreas”, in Patras, Greece, is examined. The four-story building was initially designed and constructed in the '60s with a reinforced concrete load-bearing system, as seen in Fig. 1.

Fig. 1 General views of section B of “Agios Andreas” hospital

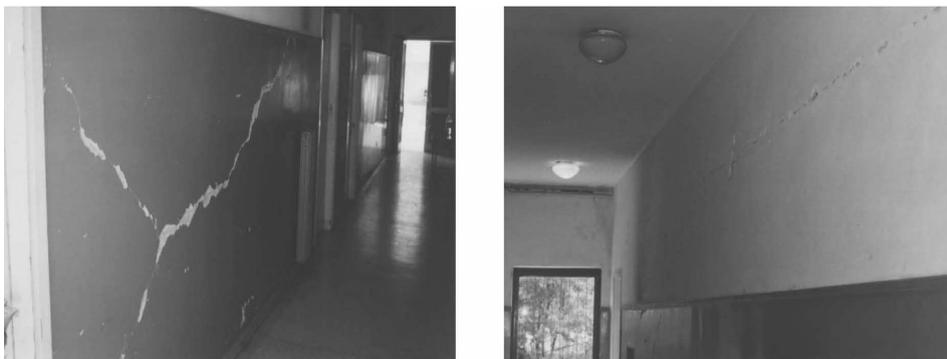
Fig. 2 Wall cracks on the ground floor (left) and infill walls detachment (right)

earthquakes of diverse intensity with considerable resultant effects (Fig. 2): wall cracks, detachment of infill walls from the load-bearing system, load-bearing members cracks, as well as reinforcement corrosion due to humidity. Close observation of the damage reveals that there is a strong possibility of the structure being incapable of withstanding, on an operational level, future earthquake actions.
