Condition assessment of reinforced concrete bridges using structural health monitoring techniques - A case study

Abstract. The paper presents a case study in which the structural condition assessment of the East Bay bridge in Gibsonton, Florida is evaluated with the help of remote health monitoring techniques. The bridge is a four-span, continuous, deck-type reinforced concrete structure supported on prestressed pile bents, and is instrumented with smart Fiber Optic Sensors. The sensors used for remote health monitoring are the newly emerged Fabry–Perot (FP), and are both surface-mounted and embedded in the deck. The sensing system can be accessed remotely through fast Digital Subscriber Lines (DSL), which permits the evaluation of the bridge behavior under live traffic loads. The bridge was open to traffic since March 2005, and the collected structural data have been continuously analyzed since. The data revealed an increase in strain readings, which suggests a progression in damage. Recent visual observations also indicated the presence of longitudinal cracks along the bridge length. After the formation of these cracks, the sensors readings were analyzed and used to extrapolate

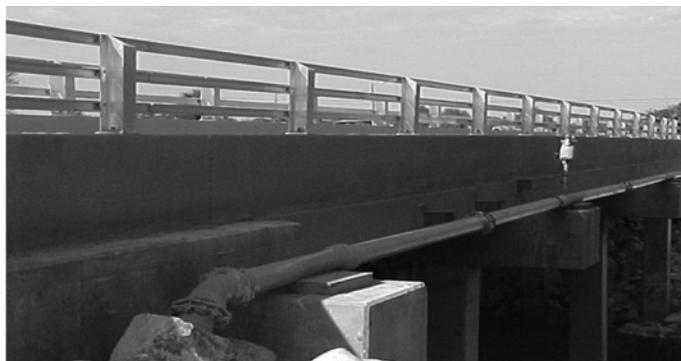
The original bridge was a concrete structure built in the early 1970s. The bridge was classified as functionally obsolete due to severe deck cracking, corrosion of the longitudinal bars, and its narrow width. The replacement bridge is a four-span 120' long and 55' wide structure and is shown in Fig. 1. The interior spans are 33' and the exterior spans are 27' long. The intermediate spans are continuous, and the middle span is fixed over the central bent. The superstructure is composed of 18" thick cast-in-

Fig. 1 Elevation view of the New East Bay Bridge

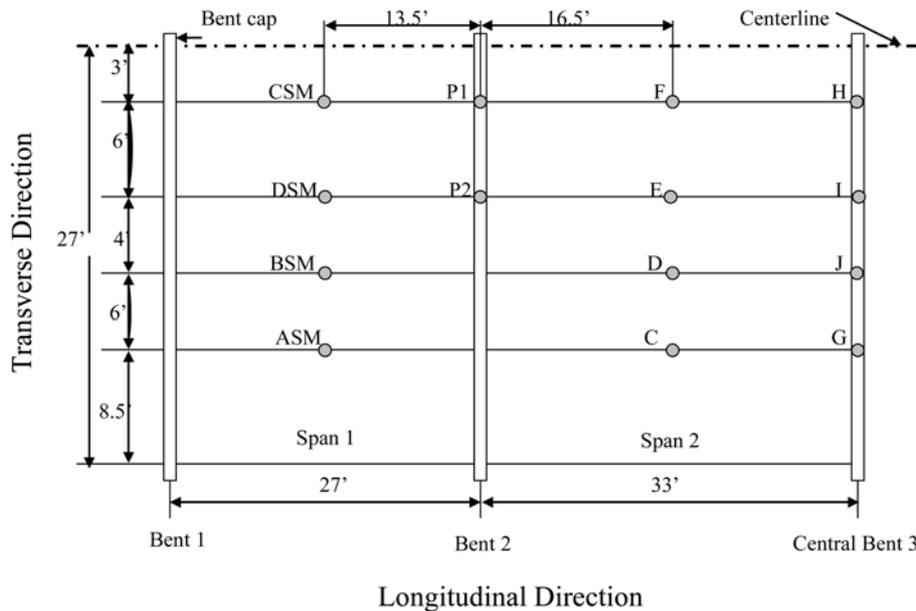
Fig. 2 Sensors location

1. Surface-mount sensors ASM, BSM, CSM, DSM: Bonded with epoxy to bottom deck
2. Surface-mount sensors P1 and P2: Bonded with epoxy to top deck
3. Embedded sensors C, D, E, F: Bonded to bottom reinforcing bars
4. Embedded sensors G, H, I, J: Bonded to top reinforcing bars

A total of sixteen Fabry-Perot strain sensors capable of measuring within a range of +/- 2000 $\mu\epsilon$ were installed on the bridge as part of the health monitoring system. Fig. 2 illustrates the position of the sensors along the bridge length. Three types of sensor are placed in four categories of installation. The three types of sensors are identified as 1) Surface mount, known as Fiso-B (blade), 2) Embedded sensors, and 3) Embedded temperature sensors. The location of these sensors along the deck thickness is identified in Fig. 3. Four embedded sensors were bonded to the bottom longitudinal reinforcing bars, and four blade sensors were surface-mounted to the concrete bottom deck surface. In addition, four embedded sensors were bonded to the top reinforcing bars over the bents, and two blade sensors were surface mounted to the concrete top deck surface. Two more sensors for temperature compensation were installed on the top and bottom bars respectively.

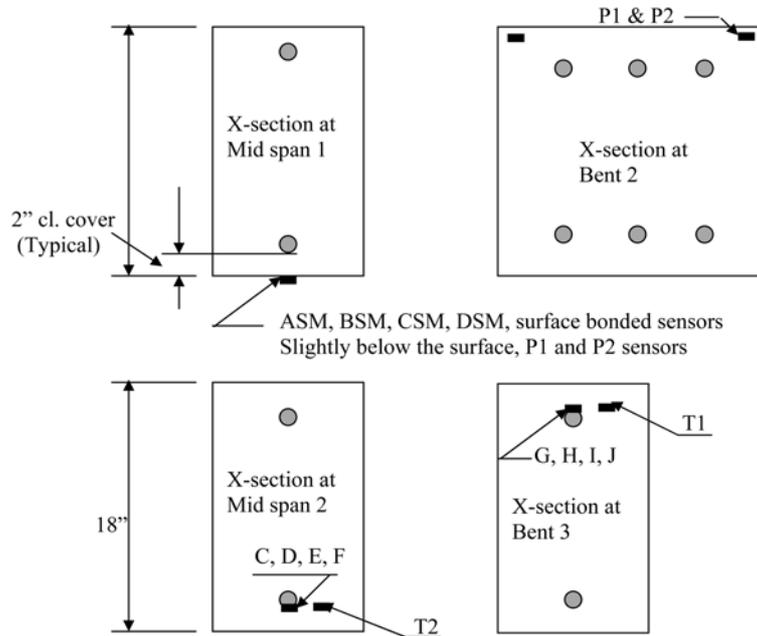
Fig. 3 Sensors location along thickness

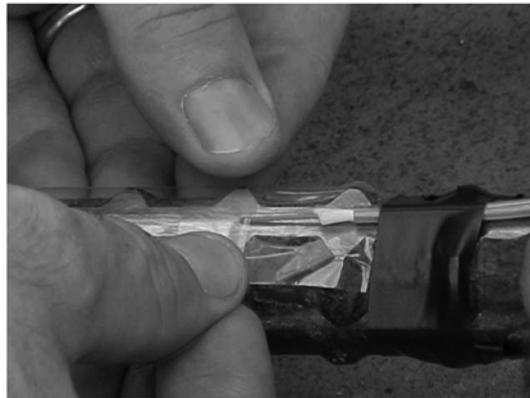
The sensors were carefully installed per the manufacturer’s recommendations, then wrapped in nitrite rubber. Fig. 4 shows a close view of the installation and wrapping process of sensors on reinforcing bars. The micro capillary section of sensors is glass and thus is very sensitive to scratch and impact. Also, optical fibers are very sensitive to bends, kinks, sharp curves and impact. To avoid damage to the system, the fiber optic cables were inserted into 1” diameter schedule-40 PVC pipes. The pipe conduits were guided through the crowded rebar mats to the edge of slab. The openings in the conduits were sealed with nitrate rubber sheet and caulking. The conduits were tightly secured to the rebars. Fig. 5

Fig. 4 Installation of sensors on rebars

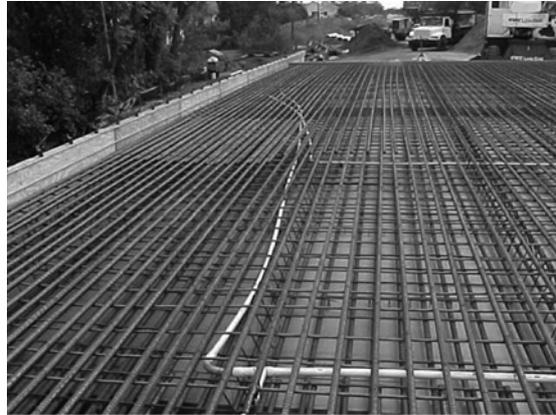
shows a plan view of the conduits within the rebar mats. The conduits containing the fiber optic cables were brought unto the forms of the slab. At this area, the fiber optic cables are most vulnerable to the construction activities such as worker's traffic and placing and removing the forms. A 2" diameter hole was drilled out to allow the conduit to exit the slab. Three small boxes (12"×12"×12") were fabricated to house the cables at the point of exit. The conduits were then guided to the smart box containing the acquisition system. The smart box was attached to the side of bridge and locked for security as shown in Fig. 6. The acquisition system weights only 10 lbs, and has dimensions of 17.7"×12.8"×5.2" and cost around \$14,000, which accounts for less than 1% of the overall cost of the bridge (\$1.5 millions). To access the acquisition system remotely, telephone and power lines that were buried 30" below the surface were brought to the bridge.

Fig. 5 PVC conduit protection

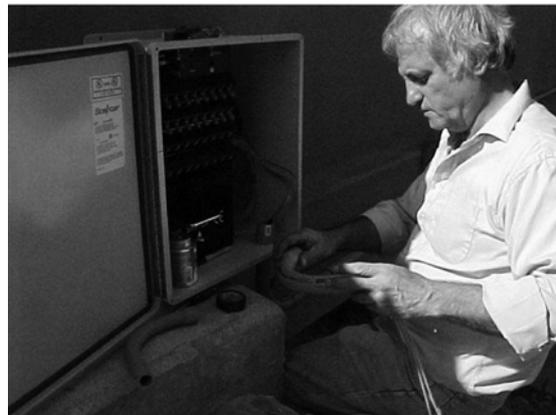
Fig. 6 Smart box on bridge side

The phone line serves to remotely access the smart box through fast DSL connections. The traffic data are currently being continuously collected and analyzed with the purpose of evaluating the bridge structural health. A more detailed description of the installation of the health monitoring system as well as the data collection and analysis is provided in Mehrani (2006).

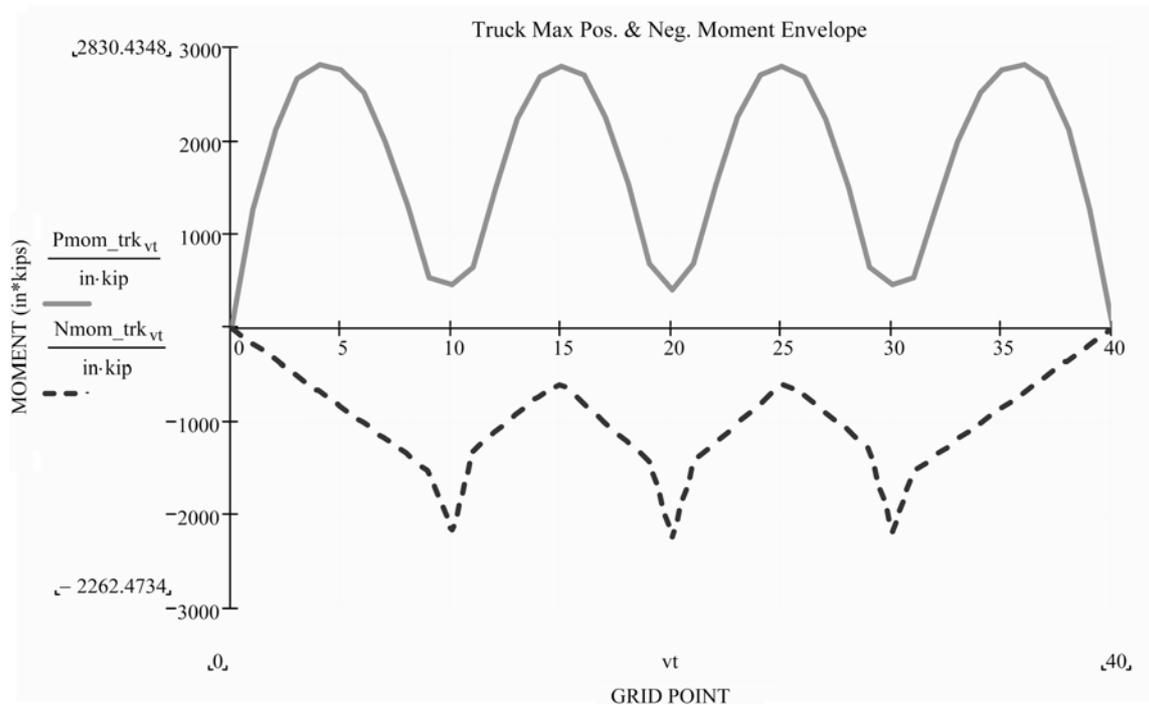
Fig. 7 Bending moments due to HS-20 truck loading

The FDOT MathCAD-based live load generator (2005) was used to obtain all positive and negative moments for service live load. The dead load moment was obtained from beam analysis. The moment envelope for HS-20 truck is shown in Fig. 7. For design purpose, the notional design truck HL-93 is used. The corresponding service moments, cracked and uncracked section results are given below.

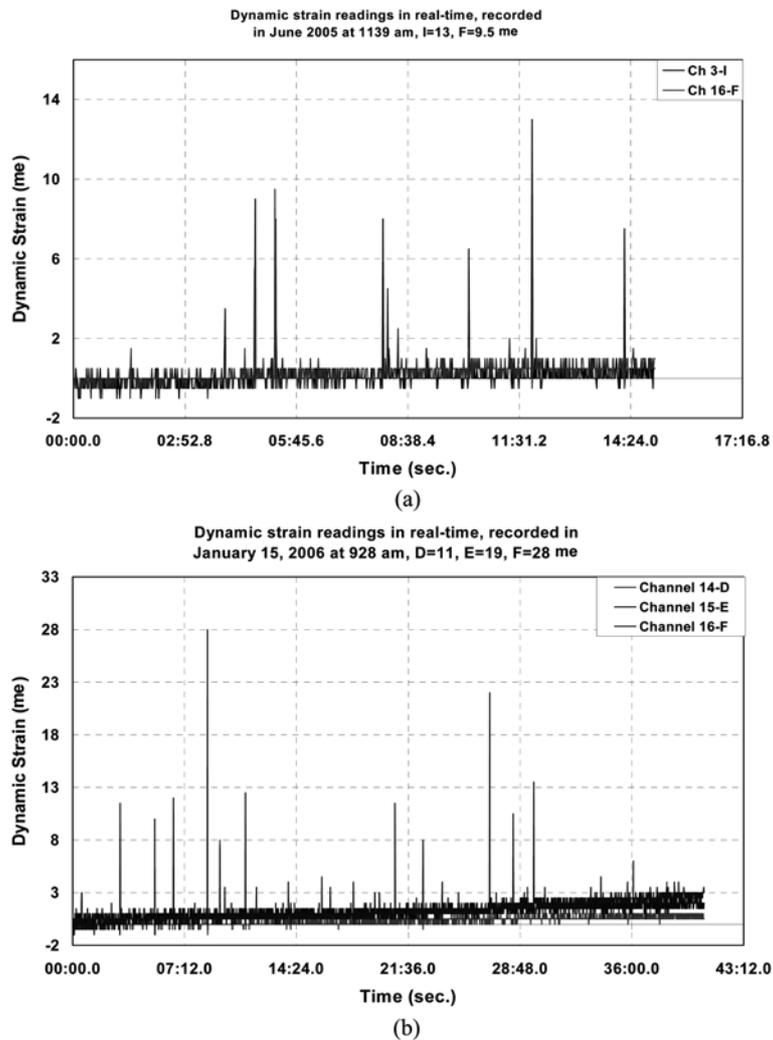
The East Bay bridge has been continuously monitored under the effect of traffic load since its opening in March 2005. Figs. (8a-b) show the strain values of sensor F as designated in Figs. 2 and 3 for two intervals during the first year of service, a reading recorded three months after initial operation and another one seven months later. The maximum value recorded for the first reading was $9.5 \mu\epsilon$ and

Fig. 8 (a) Dynamic strain 06/14/2005 ($\epsilon_{\max} = 9.5 \mu\epsilon$), (b) Dynamic strain 01/15/2006 ($\epsilon_{\max} = 28 \mu\epsilon$)

that of the second reading was $28 \mu\epsilon$. Progression in strain values were evident, although the recorded strain values as well as visual observations at that time indicated that there were no cracks present in the bridge deck underside.

By examining the maximum recorded strain data over the first 12-month period of operation, it was found that they agree well with the design values assuming uncracked conditions and reported in Table 2, rather than those of the cracked conditions shown in Table 1. Additional static and dynamic load tests, as well as finite element analysis of the bridge, were performed by Mehrani, *et al.* (2008) and resulted in the same conclusion. Such uncracked condition was not assumed in the original design of the bridge, which lead the authors to initially believe that current design guidelines are conservative.

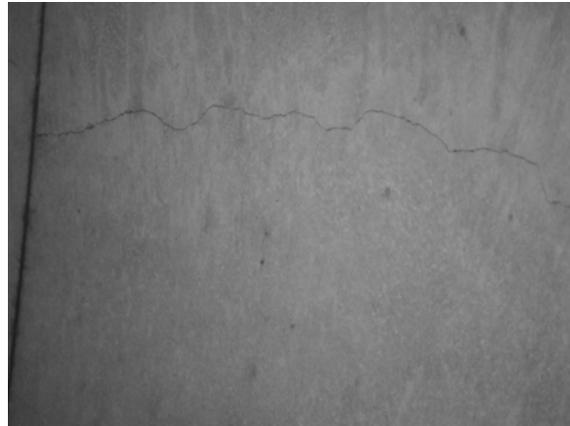
Fig. 9 1st crack on bottom of bridge deck

However, recent visual observations revealed the presence of two discrete cracks on the bottom of the deck propagating along the length of the bridge as shown in Fig. 9. The transverse location of these cracks was approximately at 5ft and 11ft to the west of the centerline respectively. The longitudinal cracks are not believed to be due to splitting failure, since the detailing of the reinforcing bars within the concrete deck was carefully designed. The formation of the longitudinal cracks is more likely due to either restraining shrinkage effects which can result in curling of the deck, lack of concrete consolidation, or overstress in the transverse direction. The latter seems to be the most likely cause since the location of these two cracks is very close to that of the traveling wheel loads. In this case, the longitudinal cracks typically form at the bottom surface along the wheel path as the wheel loads move on the bridge deck in the longitudinal direction (Pedikaris, *et al.* 1993). A combination of overstress in the transverse direction and curling is also a possibility. In any case, these cracks pose concerns as they allow for the intrusion of water and chlorides that can potentially lead to corrosion of the reinforcement bars. A more detailed discussion on the different types of bridge deck cracks and their potential damage is given in NCHRP-380 (1996).

The preceding discussion confirms that the continuous monitoring with Fiber Optic Sensors can provide a good mean for condition assessment of bridges providing its results are analyzed with care. Periodic visual inspection is still necessary in order to capture the different types of damage that could not be directly interpreted from the sensors readings. The sensors data however could be extrapolated and used to track crack initiation and propagation, and more importantly to monitor the steel stress increase following crack initiation.

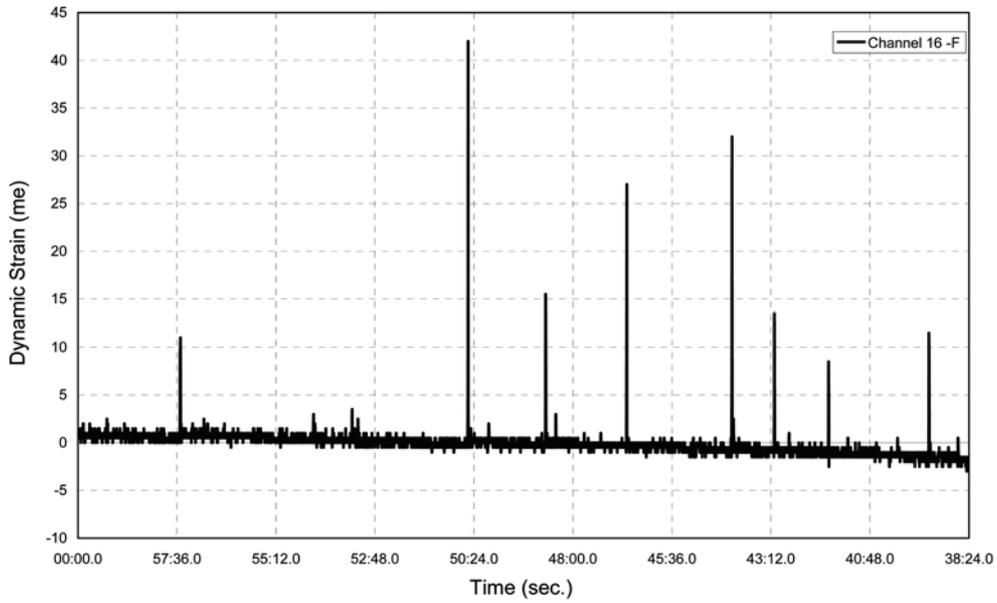
The maximum strain reading of sensor F recorded in August 2008 under the passage of heavy trucks, and after the observation of the longitudinal cracks, is shown in Fig. 10. The figure depicts a maximum value of strain of $42 \mu\epsilon$. Static loading of the bridge using SU-4 trucks was also performed in August 2008, and the recorded strain value of sensor F was equal to $45 \mu\epsilon$. While these values reveal a progression of damage, they do not suggest the presence of cracks, which contradicts the recent visual observations. However, to further understand this phenomena the following study is performed:

Fig. 10 Dynamic strain 08/14/2008 ($\epsilon_{\max} = 42 \mu\epsilon$)

The previous equations are typically used to extrapolate the maximum steel strain at the cracked location after initial cracking of the section. For the case of the East Bay bridge, due to the presence of the longitudinal cracks that were probably formed because of high flexural stresses in the transverse direction, the stress distribution at a section in the longitudinal direction is expected to be as shown in Fig. 13. In this case, the stresses in the bars at the crack location are maximum, while those in the bars away from the crack are minimum. The equations derived earlier could still be used to evaluate the average section strain. Since the load that caused the longitudinal crack to form is unknown, it is assumed that it is the one that corresponds to the last recorded strain value before cracking ($28 \mu\epsilon$). From Eq. (1), $N_{cr} = 82.08$ kips. Assuming the maximum recorded strain to be the averaged smeared strain $\epsilon_m = 45 \mu\epsilon$, Eq. (8) can be used to solve for the only unknown N , which can substituted in Eqs. (1), (3) and (9) to evaluate ϵ_{s1} , ϵ_{s2} and ζ . The solution resulted in the following values: $\epsilon_{s1} = 31 \mu\epsilon$, $\epsilon_{s2} = 118 \mu\epsilon$, and $\zeta = 0.165$. These values suggest that even though the maximum recorded strain was $45 \mu\epsilon$, the expected maximum strain at the crack location is actually $118 \mu\epsilon$, which exceeds the cracking strain of concrete. This observation suggests that the assumption of cracked conditions used in the initial design matches well with the current condition of the bridge. The strain value at the crack location matches better with the design strains evaluated in Table 1 assuming cracked conditions, than with those evaluated assuming uncracked conditions.

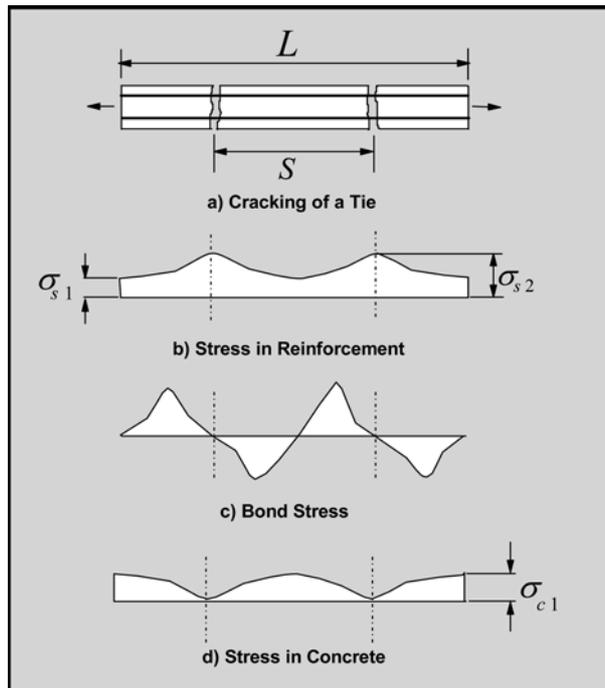
Consider a reinforced concrete member subjected to axial tension as shown in Fig. 11. In this case

Fig. 11 Stresses at cracking

tensile stresses are transmitted across the crack through the bonded reinforcing steel. If the axial stress does not exceed the tensile strength of concrete, the member is ideally free of cracks. This state is referred to as state 1. The steel and concrete strains, ϵ_{s1} and ϵ_{c1} , respectively, are compatible along the

where N is the value of the axial force, A_c and A_s are the cross sectional areas of concrete and steel and $n = E_s/E_c$ with E_s and E_c being the moduli of elasticity of steel and concrete respectively. When the concrete stress exceeds the tensile strength, cracks appear. At a crack the stress is completely carried by the reinforcement and the concrete stress is zero. This condition will be referred to as state 2. The steel stress and strain are given by:

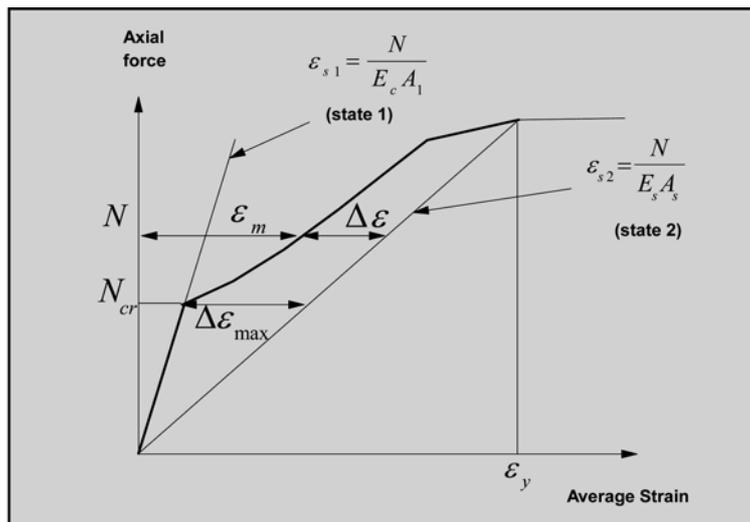
In the portion between two cracks, part of the tensile stress carried by the steel at the crack is transferred to the concrete through bond. The stress and strain are in an intermediate state between states 1 and 2, as depicted in Fig. 12. Midway between consecutive cracks, the section is in state 1 and the steel stress is less than σ_{s2} . At a crack the section is in state 2 with the steel stress at its maximum value σ_{s2} and with the concrete stress equal to zero. The difference in steel stress is transmitted to the concrete through bond, so that the member elongates less than the bare steel. Denoting the average or smeared strain of the cracked member in Fig. 11(a) as ϵ_m , then

Fig. 12 Axial force vs. average strain for an axially loaded reinforced specimen

From the graph in Fig. 12:

$\zeta = 0$ for an uncracked member. The difference between the solid line and the line representing the bare steel in Fig. 12 is referred to as tension stiffening. It represents the increase in stiffness due to the concrete contribution between cracks. Tension stiffening can be significant up to the yielding of the reinforcement, but drops considerably near the yield point. After yielding of the reinforcement at the most critical section, the member elongates without significant increase in load and the tension carried by the concrete becomes negligible.

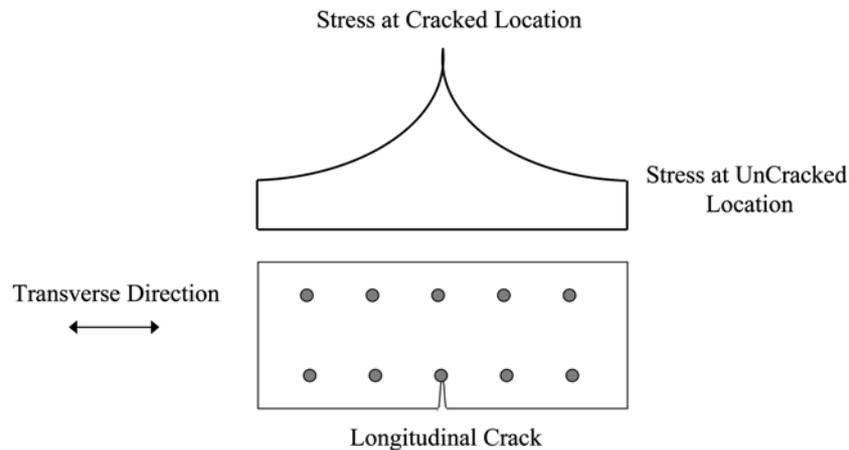
Fig. 13 Stress distribution of cracked section
