## Vulnerability model of an Australian high-set house subjected to cyclonic wind loading

D. J. Henderson<sup>†</sup> and J. D. Ginger<sup>‡</sup>

*Cyclone Testing Station, School of Engineering,  
James Cook University, Townsville, Qld 4811, Australia  
(Received December 12, 2006, Accepted March 22, 2007)*

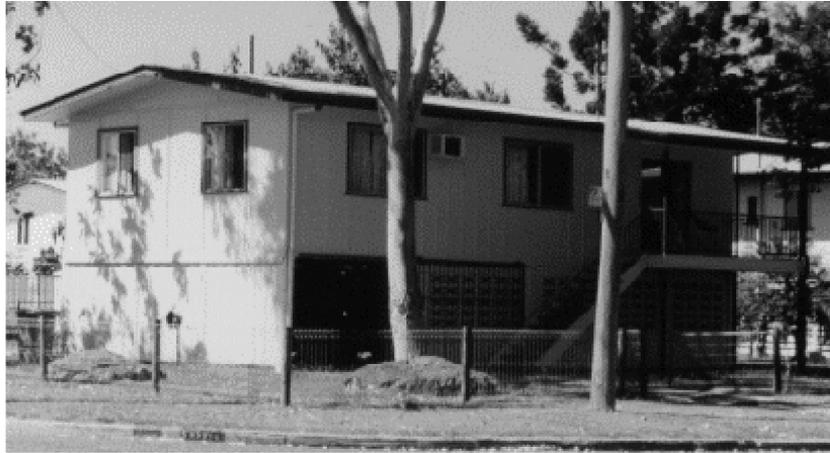
Fig. 2 High-set house – Townsville

External features of the type of high-set house constructed during the 1960s and into the mid 1970s were collected and recorded in the survey of the housing stock in Townsville, as part of the Tropical Cyclone Coastal Impacts Program (Henderson and Harper 2003). Detailed descriptions, including sizes, types and spacings of structural frame members and connections, were also surveyed in a sample of these houses and presented in that report. Descriptions of these houses built in Darwin have been taken from the Cyclone 'Tracy' damage investigation report by Walker (1975), with reference to selected external feature survey and building plans of typical housing of that era. Examples of this type of house found in the cities of Townsville and Darwin are shown in Figs. 2 and 3, respectively.

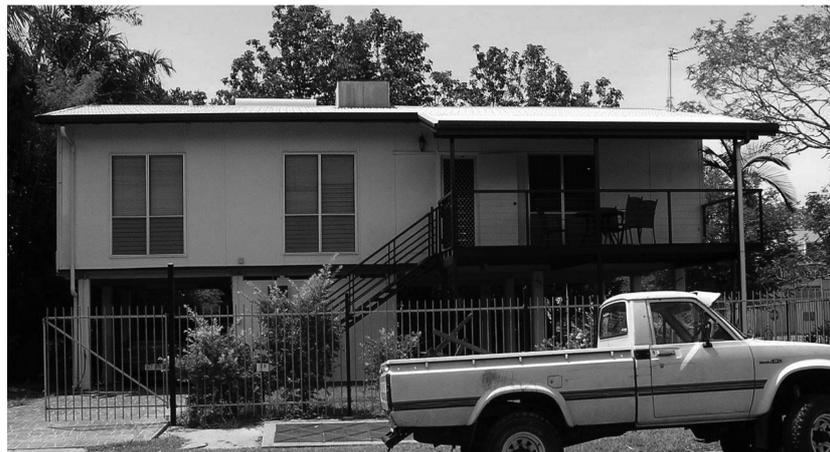
Fig. 3 High-set house - Darwin

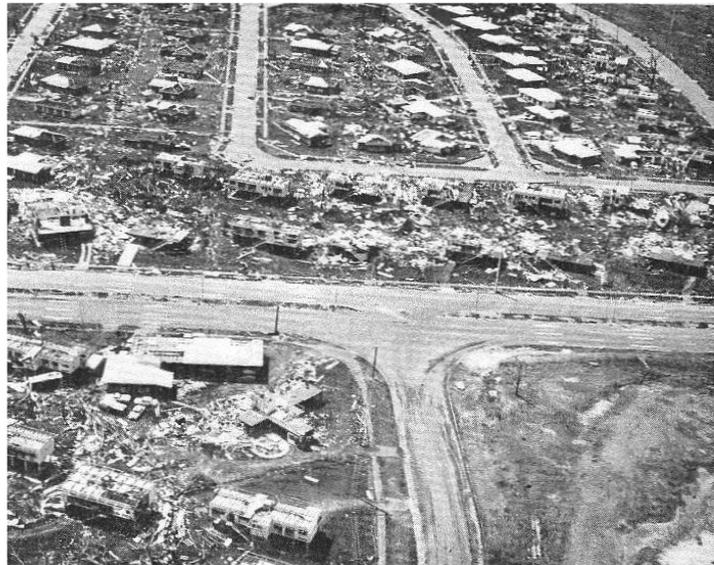
Fig. 8 Damage to housing following Cyclone ‘Tracy’ (Walker 1975)

Fig. 8 shows an aerial view of a small portion of the damage to housing in Darwin following Cyclone ‘Tracy’. The photo shows that there is a spread of damage in the high-set houses ranging from loss of roof envelope through to destruction of complete structure.
