## Response evaluation of historical crooked minaret under wind and earthquake loadings

**Abstract.** Turkey has been hosted various civilizations throughout centuries and it has become one of the oldest settlements all over the world due to the geographical location. Therefore, it has accommodated innumerable historical structures remain from the past civilizations. Protection and conservation of these historical constructions should be the major points for continuity of history. Crooked minaret is one of between these historical invaluable structures. It is located at the city of Aksaray and it dates back approximately 800 years. The minaret has lost its vertical position in time and bends on the North-West direction. In this study, general information is given about minarets and some restoration recommendations are given for crooked minaret based on performed some finite element structural analyses. These analyses are considered into three cases; 1-Dead loading, 2- Wind loading, and 3-Earthquake loadings. Results from the analyses are discussed detailed and some useful recommendations are given in the end of the study.

**Keywords:** crooked minaret; Aksaray; finite element met

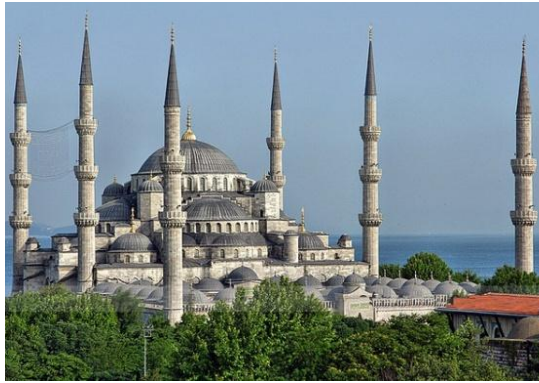
(a) Sultanahmed Mosque in Istanbul (URL-1)

Fig. 1 Minaret applications at classical ottoman period

found their most mature form during classical Ottoman Mosques (Fig. 1). Stone, brick or wood materials are generally used for the minarets, while cubic, cylindrical or polygonal shapes are selected as the cross section. A classical period of the Ottoman minarets consists of from bottom to up; footing, pulpit, transition segment, cylindrical body, balcony and spire. The base or boot is usually square or polygonal, and is sometimes called the pulpit by architects (Fig. 2). The minaret contains interior spiral stairs running all the way up to the highest balcony level which are not externally visible.

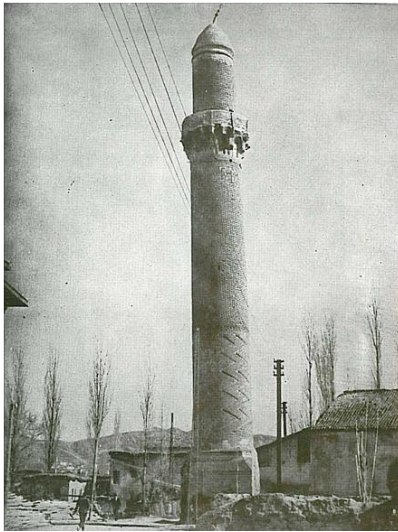
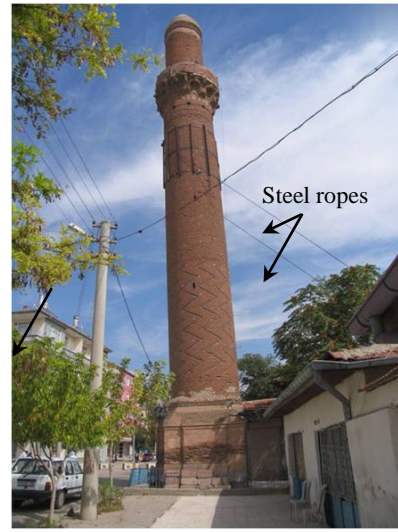
Fig. 3 Historic and current views of the minaret

(a) At 1931 from Albert Gabriel (1962)

(b) Today view

The minaret has a history of about 800 years. It is lost vertical position with time and bending on the North-West direction. The minaret bound with steel ropes to the ground by the General Directorate of Foundations in order to prevent the destruction in 1995. In 1931 and as of today in view of the minaret can be seen from Fig. 3. Translation at the top of the structure increases in time, and has exceeded 1100 mm.

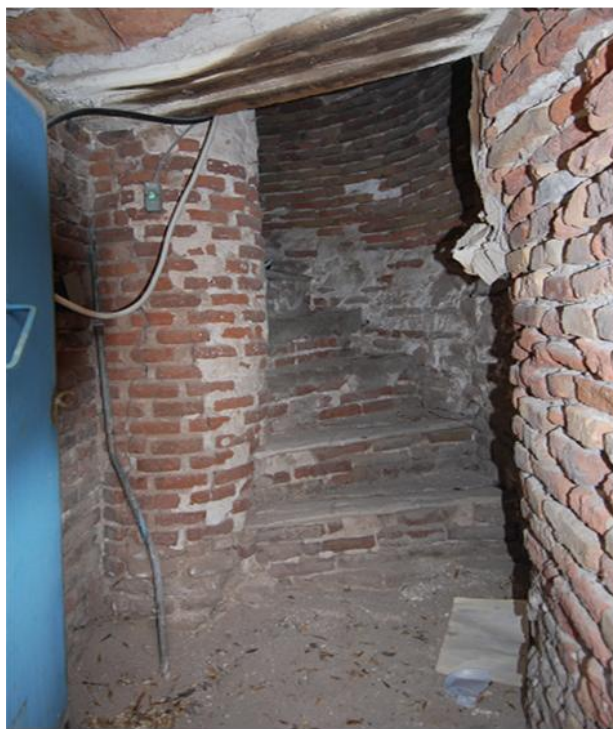
Fig. 4 Entrance of the minaret

(a) View from inner part of the minaret

(b) Schematic view of the damage parts

Crooked Minaret is a separate structure next to the mosque. It is resting on a four corners pedestal, cylindrical body, a single balcony and spire. It was built with masonry construction technique and it has a total height of 30.06 m. The pedestal of the minaret, and boot, also called the upper part of the pedestal, including the transition segment were built with masonry brick material. Masonry bricks were also used at cylindrical body, balcony, upper part of the minaret body and spire. Khorasan mortar was used between these bricks. Load-bearing stairs on the inside of the minaret, which is part of the system, was designed as brick stairs as seen from Fig. 4(a). Besides, significant degree cracks and deformations can also be seen from Fig. 4(b).

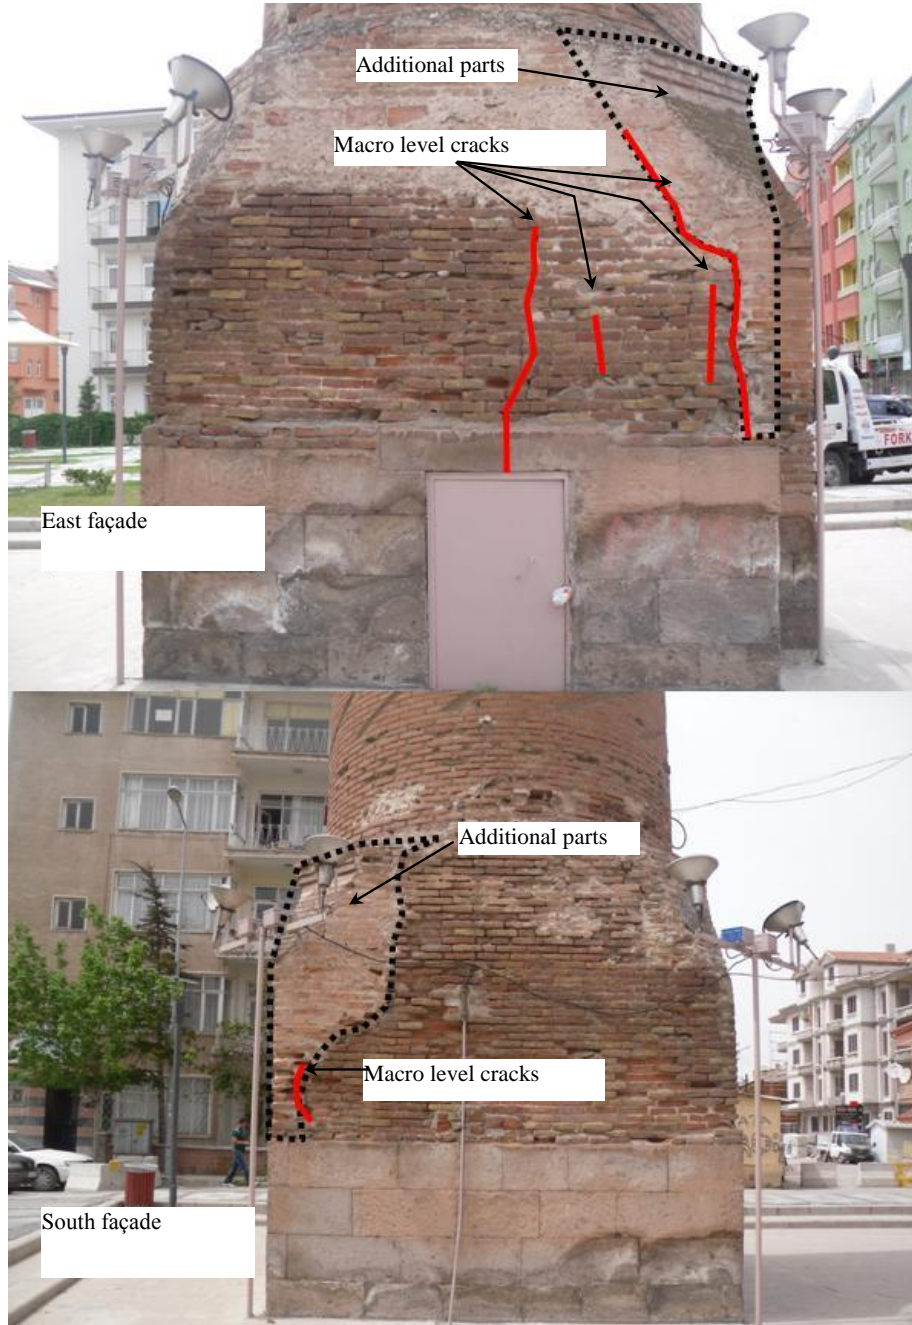
Fig. 6 Some damages on boot segment of Crooked Minaret

Upper part of the boot has brick damages as shown in Figs. 6 and 7. Other than that no damage was found at the bottom of the boot part of the minaret. Therefore, the pedestal has undergone significant loss of cross-section due to deteriorating and diminishing of bricks. Also in this section there are vertical cracks in the bricks besides separation and degradation.

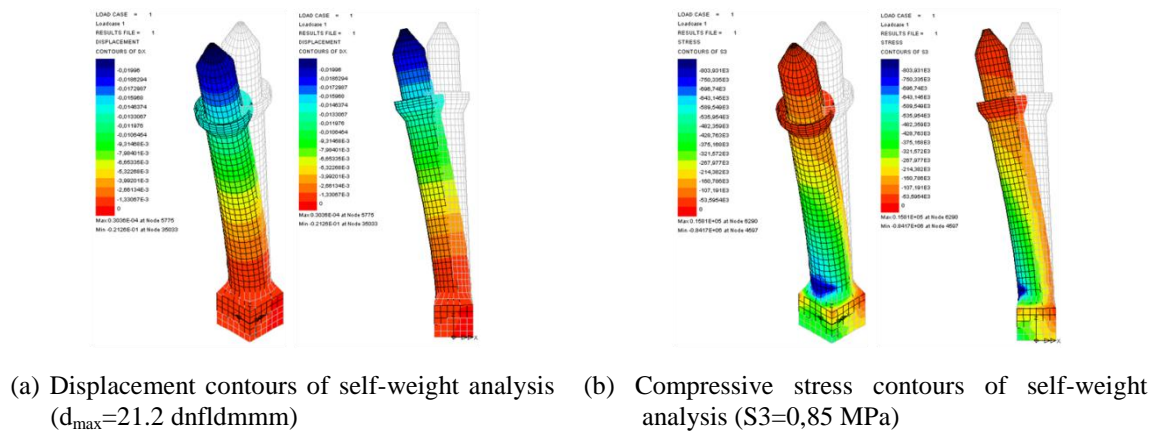
Fig. 9 Results from dead load analysis

The linear analysis was performed under its own weight. Performed the first set of the analysis and resulting displacements and compressive stresses are shown in Fig. 9, on the deformed model of the minaret.

Regions have shown in blue shows parts of the largest displacements (Fig. 9). From displacement contours occurred under its own weight, the maximum displacement in the horizontal direction, as has occurred 21.2 mm from the compressive stress contours, the maximum stress has occurred at the bottom of the cylindrical body as 0.85 MPa.

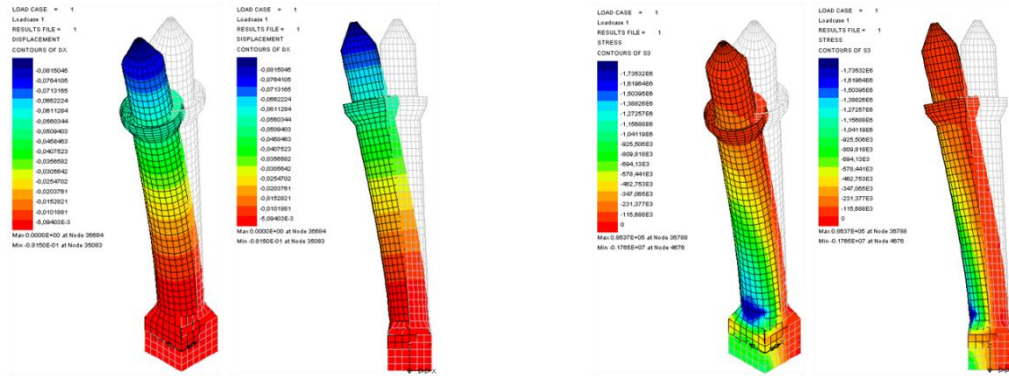
Fig. 11 Results from wind loading analysis

Performed a second set of analysis and resulting displacements are shown in Fig. 11(a) on the deformed model. Parts of the regions, shown in blue in the figure, show the largest horizontal displacements. When displacement contours occur under the influence of wind loading, the maximum displacement of 81.5 mm in the horizontal direction has occurred. Compressive stresses occurring in the minaret are also given in Fig. 11(b).

(a) Displacement contours of self-weight analysis ( $d_{\max}=81.5$  mm) (b) Compressive stress contours of self-weight analysis ( $S3=1.77$  MPa)

As shown in the Table 2, under its own weight 1MPa compression stress, while under the influence of wind is approaching the values of 2 MPa. These values can be considered as high values for degraded and decomposed masonry brick. On the other hand, the tensile strength of 0.81 MPa of the wind analysis, the value is extremely dangerous. Because tensile stress should not be occur on masonry structures such as slender minarets.

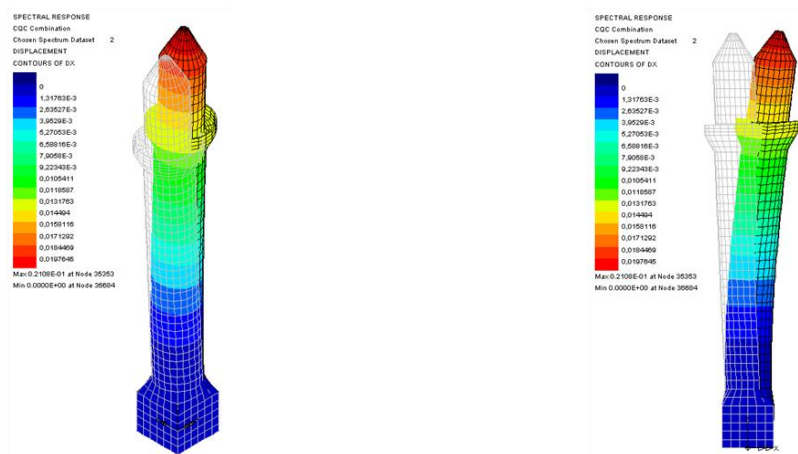
4<sup>th</sup> degree earthquake zone as defined in the Turkish Earthquake Code (TEC, 2007), design spectra considering the seismic analysis was carried out according to the method of combining modes (CQC method). Displacements obtained from the analysis were determined and shown in Fig. 13 on the deformed mesh of the minaret.

Fig. 13 Displacement contours of seismic analysis( $d_{\max}=21$  mm)
