# Typhoon damage analysis of transmission towers in mountainous regions of Kyushu, Japan

**Abstract.** In the 1990s, four strong typhoons hit the Kyushu area of Japan and inflicted severe damage on power transmission facilities, houses, and so on. Maximum gust speeds exceeding 60 m/s were recorded in central Kyushu. Although the wind speeds were very high, the gust factors were over 2.0. No meteorological stations are located in mountainous areas, creating a deficiency of meteorological station data in the area where the towers were damaged. Since 1995 the authors have operated a network for wind measurement, NeWMeK, that measures wind speed and direction, covering these mountainous areas, segmenting the Kyushu area into high density arrays. Maximum gusts exceeding 70 m/s were measured at several NeWMeK sites when Typhoon Bart (1999) approached. The gust factors varied widely in southerly winds. The mean wind speeds increased due to effects of the local terrain, thus further increasing gust speeds.

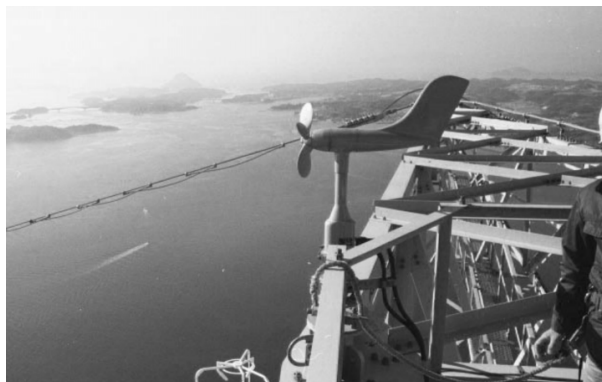
- (1) The system has 122 observation points at approximately 20 km intervals throughout the Kyushu area.
- (2) An anemometer is positioned at the top of each transmission tower designed as an observation point. (Photo 2) The towers range in height from 12 m to 195 m, and have elevations between 0 m and 1,118 m from sea level. Figs. 5 and 6 show the anemometer's positioned height from the ground and the elevation of the observation points, respectively.

Photo 2 Anemometer

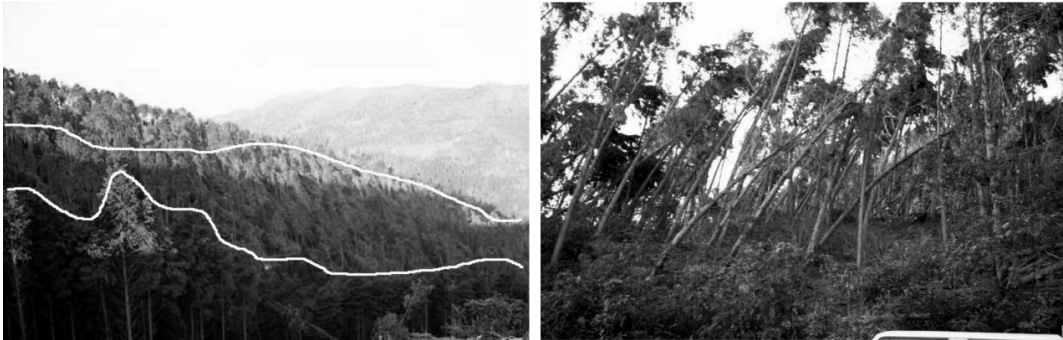
The authors surveyed the distribution of the fallen timber in two areas. Fig. 13 illustrates the location of damaged towers and the area of fallen timber in the shallow valley terrain. In the figure, the arrows represent the direction of the collapsed towers and fallen timber. The black square locates the observation point of NeWMeK No.72. In this area four 500 kV transmission towers collapsed. Wind directions were southeast to south at about 5 a.m., when the maximum gust speed reached around 65 m/s based on NeWMeK data. The observed record at No.72 is shown in Fig. 10. The fallen timber was distributed on southward-facing slopes and the trees fell along the wind direction. Photo 3 shows the damage to timber.

Photo 3 The distribution of the fallen timbers (the shallow valley terrain)

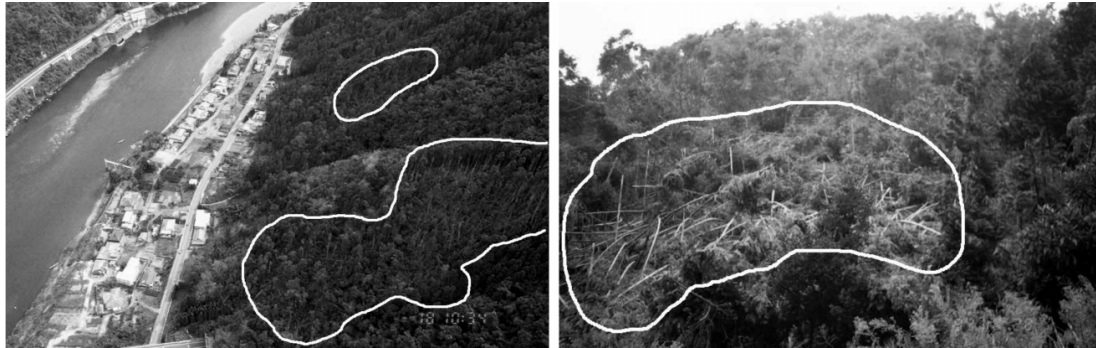
Photo 4 The distribution of the fallen timbers (the deep valley terrain)

this area two towers collapsed and one was broken. Photo 4 shows the damage to the timber. Maximum wind gust speeds exceeded 50 m/s on the NeWMeK record. The wind directions were southeast to south at about 5 a.m. The observed records of No.68 and No.69 are shown in Fig. 10. The areas of damaged trees are spread discontinuously; most were found in areas of the river's curve. The falling directions of the timbers didn't always correspond to the representative wind directions of Bart. Rather, many of the directions coincided with the valley direction. This direction was identical with that of the tower that collapsed first, too. It is guessed that wind converging along the deep valley changed its wind direction and increased its speed much more.
