Assessment of efficacy of drainage system in Rajshahi City Corporation, Bangladesh

Shahidul M. Islam* and Aminul M. Islam^a

Department of Civil Engineering, Rajshahi University of Engineering & Technology,
Rajshahi-6204, Bangladesh

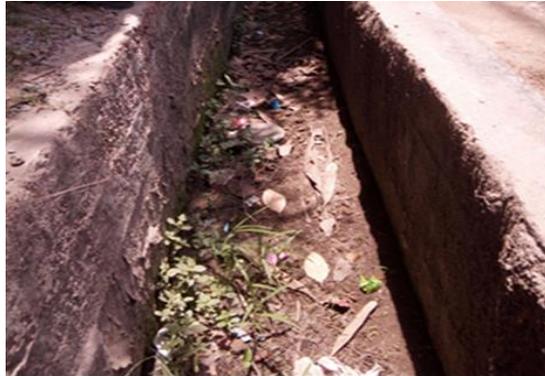
Fig. 3 indicates a tertiary drain that was totally dry. Among 522 tertiary drains, 12% drain was found dry. Depth of these tertiary drains varies from 0.45m to 0.75m. Of which, 0.15m thick layer of soil with sludge was found at the bottom of drain. During field inspection, sufficient slope was not found to carry the sewage water at the outlet. The longitudinal gradient was less than 0.6%. Besides, sludge accumulation was found higher at the inlet. As a result, the drain didn't get enough discharge from upstream, making the drain dry. Among 522 tertiary drains, 35% drain was found stagnant with water. During the field investigation, both deposited and suspended solids were found in sewage water, as shown in Fig. 4. More than 25% of sludge was found to be deposited in 47% tertiary drain. Self-cleansing velocity was less than 0.3m/s. Longitudinal slope varied from place to place due to suspended and deposited solids. But the slope was less than 1% in all conditions. As a result, drain became stagnant and flooded with water. When this water overflows the pavement, it deteriorates the road surface making potholes and removing the carpet of the

Fig. 3 Totally dry drain

- Proper drainage cross-section needs to be maintained to provide desired self-cleansing velocity and longitudinal slope. This will reduce the suspended particles to settle and wash load.

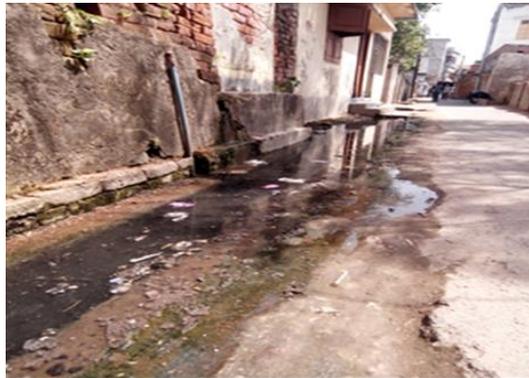
Fig. 4 Water stagnant drain

bituminous layer of pavement. From field observation, it was found that the road experienced edge damage, raveling, and cracking at different portions of the road. As previously described, stagnant water is a breeding place of other disease vectors like mosquito can transmit diverse infectious pathogens and parasites that cause diseases such as dengue, Zika, Chikungunya, or malaria. So, passers-by who cross the road beside these drains have to suffer the bad smell causing different health issues.

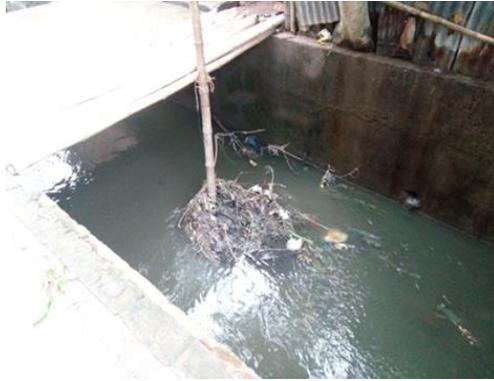
Fig. 5 shows a primary drain of width 1.5m. This drain was seen in a flowing condition. But Constrictions and constructions over the drain were found to interrupt the normal flow of drainage water. People made a temporary platform with different local materials at several locations over the drain to pass the drain to go to their houses. Floating domestic waste was found accumulated around these temporary structures built in the flow path of drains. At these locations, the velocity of water was observed to decrease, and waste accumulated at the bottom resulting in thick sludge deposition. Fig. 6 shows a stagnant water drain over which a shop is constructed. During field inspection, a large amount of sludge was found at the bottom of the shop. Local people confirmed that cleaning work couldn't be performed properly due to these constructions made over the drain. These wastes clog the path of flowing water and create dry drains at the downstream location. Backwater condition was also observed in those drains, which made the entire drainage system ineffective connected to it.

Fig. 5 Obstruction inhibiting the natural flow of drain

- Any encroachment on the drainage path has to be removed. Shops, garages over the drains are to be evicted.
- Finally, people need to be made aware of proper waste management by making documentaries, posters, short films, advertising.

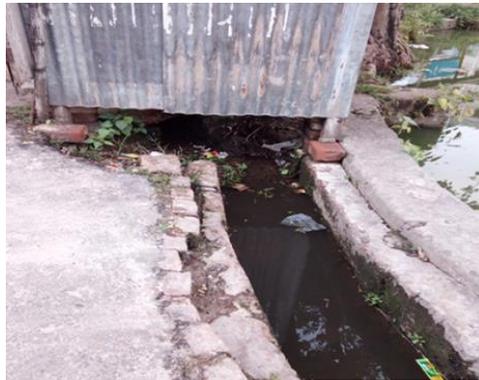
Fig. 6 Construction over drain interrupting the cleaning work

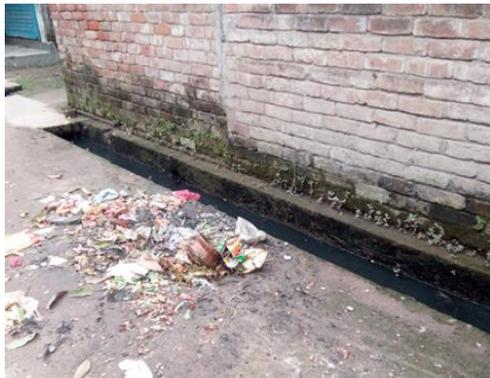
Fig. 7 Domestic waste materials thrown near drain

During the field investigation, illegal sludge disposal was found at different locations in the city. Due to ignorance of solid waste management, People in the residential area and also pedestrians throw their waste after their use near the drain, which increases the amount of sludge in the drain when they are swept away and washed by stormwater. A typical scenario can be seen in Fig. 7. Due to the increase in population density, demand for constructing buildings and houses

- To prevent blockage in the drainage system and to ensure proper flow, drains are to be cleaned regularly at a suitable interval of time.
- Flaws in the existing drainage system should be identified and fixed according to their priority as part of the routine maintenance work.

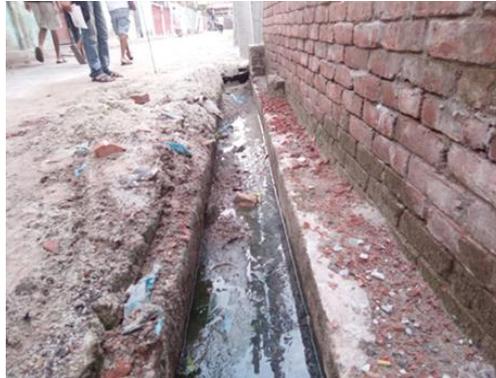
Fig. 8 Accumulation of construction materials due to improper maintenance

is increasing day by day. But, knowledge of proper maintenance of building materials is necessary. Due to lack of appropriate maintenance, construction materials come into drains and add to the drain's sludge. Fig. 8 shows a drain with a thick slurry of cement, and water covered the maximum depth of drain. This slurry hardened with time after a permanent setting. As a result, the capacity of the drain decreased to carry sewage water.
