Monitoring concrete bridge decks using infrared thermography with high speed vehicles

Shuhei Hiasa^{1,2a}, F. Necati Catbas^{*1}, Masato Matsumoto^{3b} and Koji Mitani^{3c}

¹Department of Civil Environmental and Construction Engineering, University of Central Florida, 12800 Pegasus Drive, Suite 211, Orlando, Florida 32816, USA

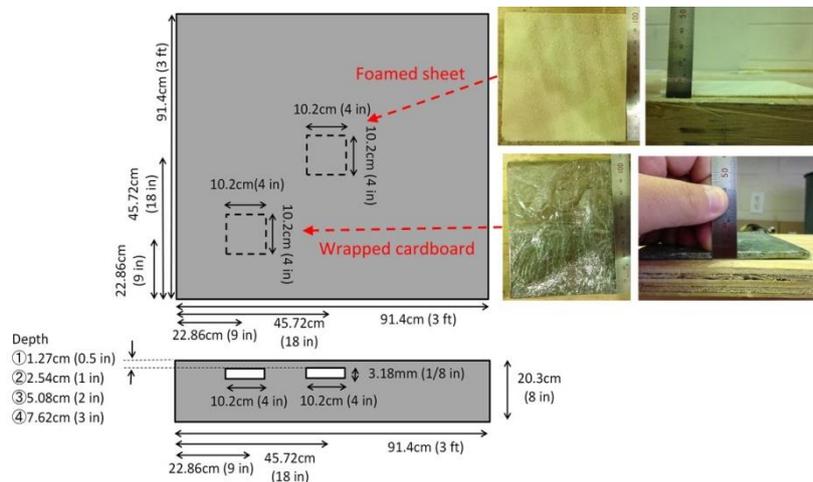
Fig. 1 Size of concrete test specimen

Foamed sheet was installed at the center part of the specimen and wrapped cardboard was embedded at a corner as shown in Fig. 1. The thermal conductivity of air, which exists at the delaminated area of concrete and creates the temperature difference between sound and delaminated parts of concrete surface, is 0.0241 W/m \cdot °C. Foamed sheet and cardboard were chosen to generate the artificial delamination to simulate similar thermal conductivity properties.

The thermal conductivity of the foamed sheet is $0.024 \text{ W/m}\cdot^{\circ}\text{C}$, and the cardboard has a lot of airspace on the inward side.

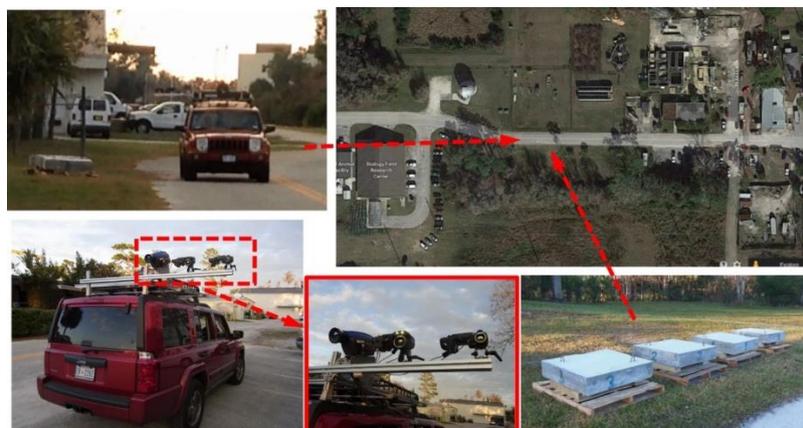
Fig. 2 Test location and method

Fig. 2 shows the test location, Ara Drive, in front of the Stormwater Research Lab at the University of Central Florida. The field test was conducted on January 21, 2015. As shown in Fig. 2, 4 concrete test specimens were set up along the roadside. In this experiment, concrete blocks were put on wooden stands and pallets to make space through which wind blows under concrete slabs as shown in the picture. IR images were taken from a vehicle equipped with the three IR cameras at the same time while driving down the road at varying speed, from 0 to 48 km/h (30 mph). 0 km/h refers to an idling stop, so that the engine was working during the photography. Therefore, there was some vibration of the car due to idling even when the speed was 0 km/h. IR images were taken at multiple times, 9 am, 3 pm, 8 pm and 12 am.

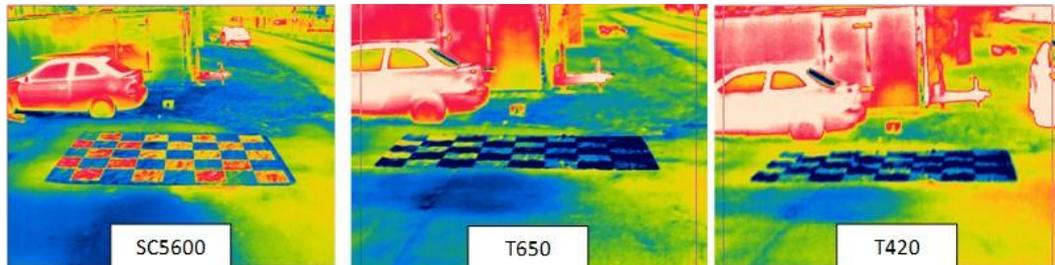
Fig. 3 Camera position

Each camera's position was set up with an angle between 45° to 50° (where 0° is perpendicular) to capture the same width at the center of the image. As shown in Fig. 3, each camera's position was calibrated with the help of a plastic calibration sheet (3.5×2.42 m). The width was assumed to capture one lane of roadway width at one time. Due to the different Field of View for each IR camera, their images look different when comparing SC5600 with the other two cameras.

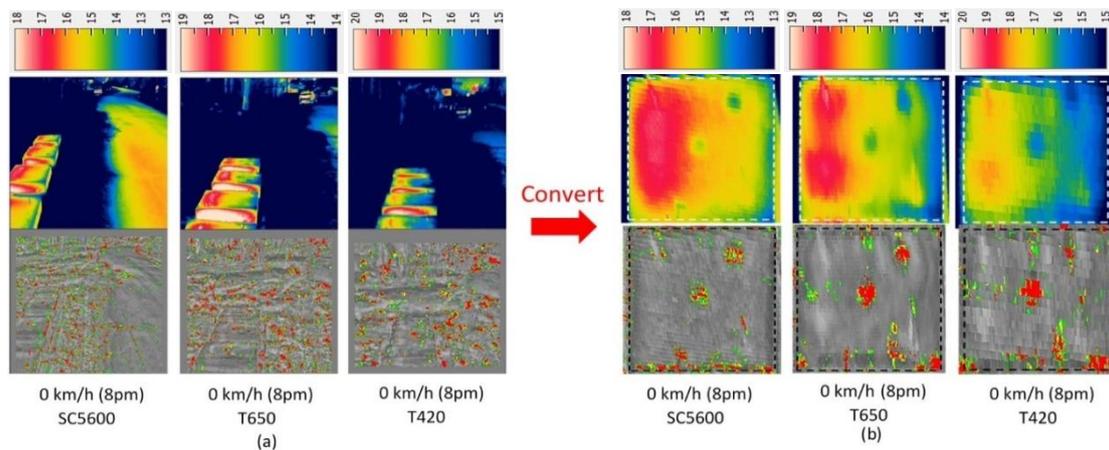
Fig. 4 Original IR and processed images (a) and converted images and (b) at 8 PM (Temperature: °C)

Theoretically, delaminated areas show a hot spot during daylight and a cool spot at nighttime. However, it is not always possible to detect subsurface delaminations in concrete structures only from the color variation of raw infrared imagery since the concrete structure itself tends to have a temperature gradient depending on location and orientation with respect to the sun as discussed by Washer *et al.* (2010). Since specific processes are desirable to obtain a better result from IRT as mentioned in (Kee *et al.* 2012, Oh *et al.* 2013), an infrared image processing software (Matsumoto *et al.* 2012) was utilized in this study. This software indicates potential delaminated areas which have cooler (hotter) temperature distribution than the surroundings during nighttime (daytime) with three categories, red, yellow and green colors in the order of severity, classified depending on magnitude of the temperature contrast. In this software, the higher contrast area is evaluated as a more severe delamination. Fig. 4 shows the methodology of analysis in this study. Since IR cameras were mounted on top of the vehicle and images of test specimens on the roadside were taken at a certain angle, the original IR images become like the upper images of (a) with rainbow color. In the original IR images, since the concrete blocks were located at the left side of the image with a certain angle, it was difficult to compare each specimen and figure. Furthermore, as shown in the lower images, even images processed by the software produce a lot of noise because the specimens were placed on a grass field. Therefore, these images were deskewed into plain view to make it much easier to compare with others by compensating the original image. Since the size of the specimens were known, the surface is $91.4 \text{ cm} \times 91.4 \text{ cm}$, each image of a test specimen was compensated into plain view, and other parts were trimmed except for the surface of concrete test specimens as shown in the (b) of Fig. 4.

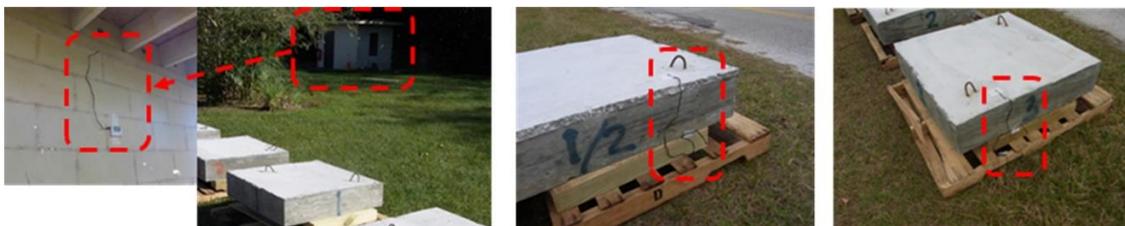
Fig. 5 Temperature measurement

Through the experiment, ambient temperature and surface temperature of test specimens were recorded by thermocouples. For the test specimens, thermocouples were attached onto them with

artificial delaminations at 1.27 cm and 7.62 cm depth. One thermocouple was attached on the sound concrete surface, and another one measured ambient temperature for each test specimen as shown in the right two images of Fig. 5. Furthermore, in order to monitor the ambient temperature of the test field, one thermocouple was attached on a shed wall in the shade for the day's entirety near the test site as shown in left image of Fig. 5. The temperature record is shown in Fig. 6. In this graph, the records of thermocouples attached on a concrete slab with 1.27 cm deep delamination are described as "con 1.27", which attached on the surface, and "con 1.27 air", which set up a shaded part made by the specimen to measure air temperature near the concrete slab. The legends of thermocouples attached on a concrete slab with 7.62 cm deep delamination are similarly provided. The "air" shows the temperature that measured ambient temperature of the test field at the shed. In terms of ambient temperature, the temperature difference between the highest and lowest air temperature in a day (from 8 am to 1 am in this study) was approximately 12°C by "air" (max: 23.7°C, min: 11.6°C), and approximately 16°C near concrete slabs ("con 1.27 air": 26.9 and 10.8°C, "con 7.62 air": 26.6 and 10.6°C). Regarding surface temperatures, thermocouples seem to be affected by sunlight since those temperatures are unstable in the daytime and sometimes they decreased drastically. It can be considered that clouds and trees around the test field made shadows sometimes, and they caused temperature variations in the daytime.

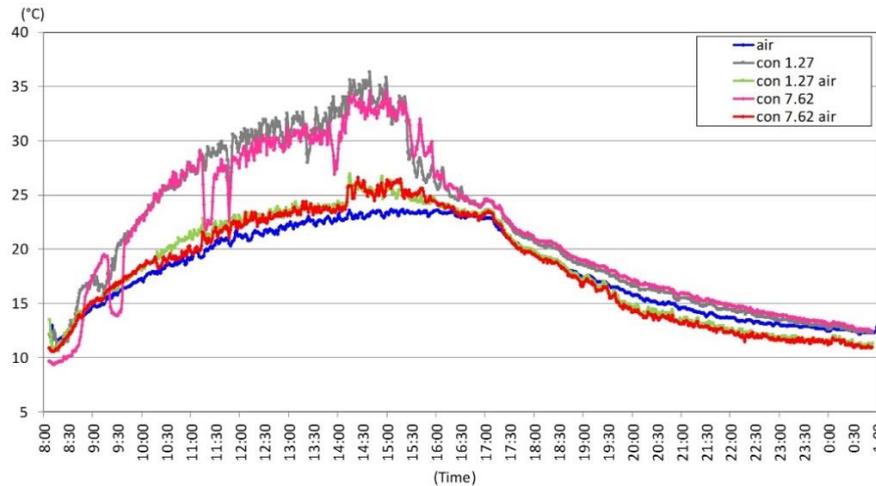
Fig. 6 Temperature during test

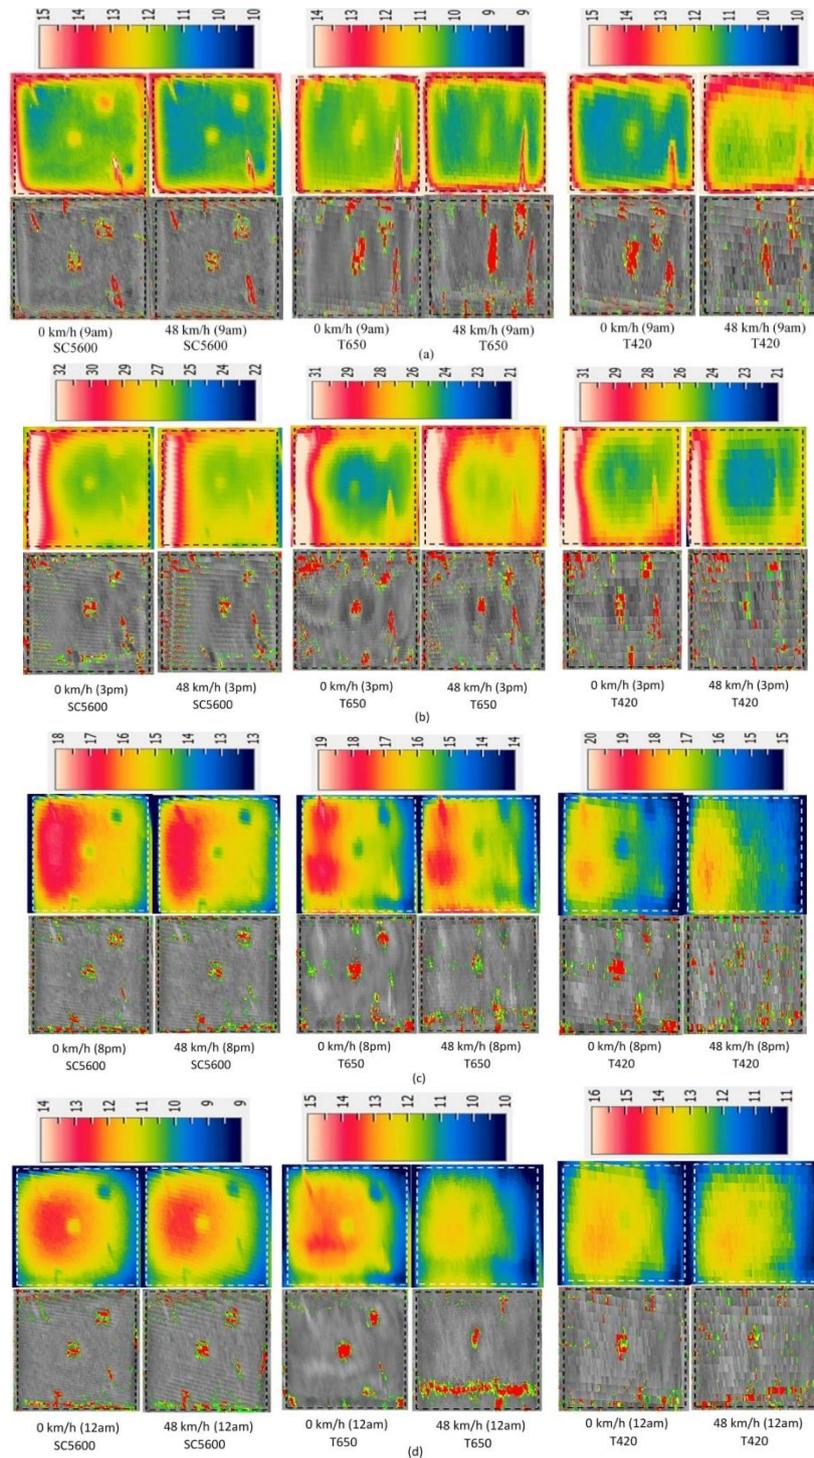
Fig. 7 Comparison of 1.27 cm (0.5 in.) depth images taken at 0 km/h (left) & 48 km/h (right): (a) 9 am, (b) 3 pm, (c) 8 pm and (d) 12 am (Temperature: °C)

Fig. 7 shows raw IR and processed images of the concrete slab with 1.27 cm depth of delamination taken at 9 am, 3 pm, 8 pm and 12 am at 0 km/h and 48 km/h. The temperature range of the IR images is set up to 5 K for all images except images at 3 pm (10 K) since the temperature distribution at 3 pm is much wider than at other times. Two types of delamination described in Fig. 1 were embedded at the center and the corner of the block (upper right side for 1.27cm depth). In this study, both raw IR and processed images were investigated to determine whether those images could detect delaminated spots or not.

Regarding the effect of pixel resolution, images of T420 are much rougher than images of the other two cameras as can be seen in Fig. 7, and that makes it difficult to detect delaminations. Since T420 has 4 times lower resolution than the other two cameras, each pixel of T420 image can be distinguished easily from Fig. 7, and the larger pixels make T420 more insensitive than the other two cameras. In this study, three cameras set up to take one whole lane of a roadway as mentioned in section 3.3, so that the distance to the concrete slabs might be out of the coverage for T420. The approximate size of each pixel is as follows; SC5600 and T650sc: 0.5 cm × 2.0 cm, T420: 1.0 cm × 4.0 cm, although each pixel size is not always the same since IR images were taken with a certain angle. The upper side of the image was rougher than the underside of the image, and they were not taken at the exact same locations. It can be concluded that the main factor for lower performance of T420 than T650sc was the lower pixel resolution. When the camera angle of T420 was changed to make the distance between the camera and concrete slabs, the images became much clearer as shown in the left image of Fig. 8. In this image, each pixel size is approximately 0.3 cm × 0.7 cm. However, even though the image quality was improved drastically by taking a closer distance, the area that can be taken at one time became much smaller, here it was about 1 m width. Therefore, if T420 is used for bridge deck inspection and it is

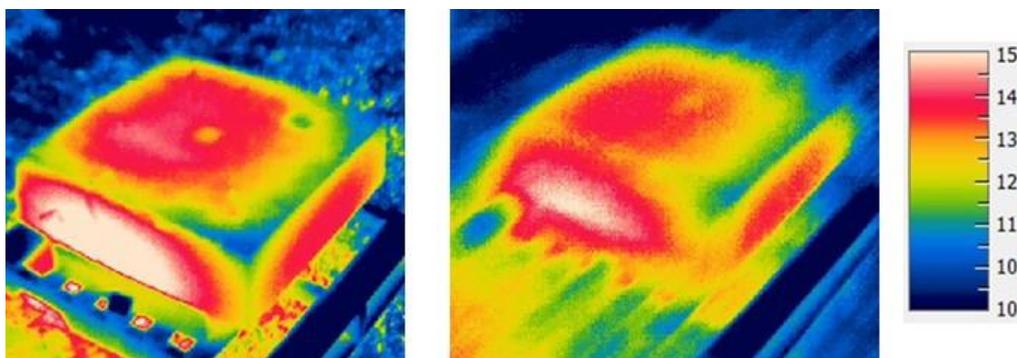
Fig. 8 IR image taken by T420 with different angle and closer distance (left: 0 km/h, right: 48 km/h, 12 am, 1.27 cm, Temperature: °C)

This comparison also found that processed images are very useful to detect delaminated parts when IR data are collected from moving vehicles. Especially for uncooled cameras, the performance of damage detection for high-speed inspection improved drastically: about 80% for T650sc and 150% for T420. Therefore, it can be concluded that when IRT with uncooled cameras are utilized for high-speed inspection, the IR image is affected by the speed of the data collection. However, relatively reliable data can be obtained by processing the images, although the performance is worse than cooled cameras.

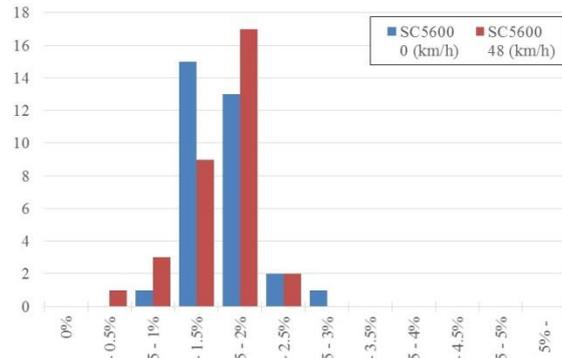
Fig. 9 Distribution of indicated damage area size ratio by SC5600

Furthermore, Fig. 9 to Fig. 11 show histograms of the ratios of indicated area to the slab surface at 0 km/h and 48 km/h regardless of raw or processed IR images. From Fig. 9, it is obvious that almost every result of SC5600 distributes between a 1 to 2 percent range of both 0 km/h and 48 km/h. This result proves that SC5600 detects very accurately even when it is utilized on a moving vehicle at normal driving speed. As for T650sc, the range became wider, from 1 to 2.5%, at 0 km/h, and when it was used at 48 km/h, the distribution became wider than those taken at 0 km/h and in some cases it failed to detect delaminations as shown in Fig. 10. T420 degraded more than T650sc when it was used at 48 km/h as described in Fig. 11. Therefore, this study concludes that these two cameras are strongly affected by data collection speed, and the main factor is their much longer time constant than cooled IR cameras.

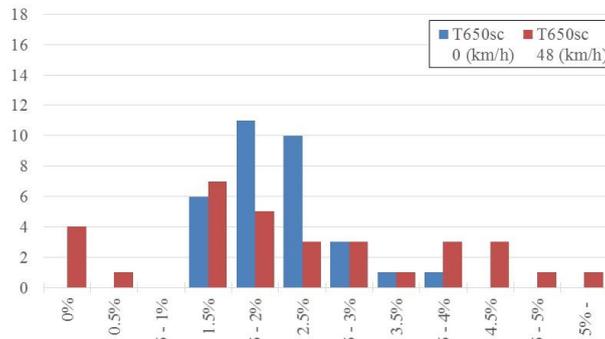
Fig. 10 Distribution of indicated damage area size ratio by T650sc

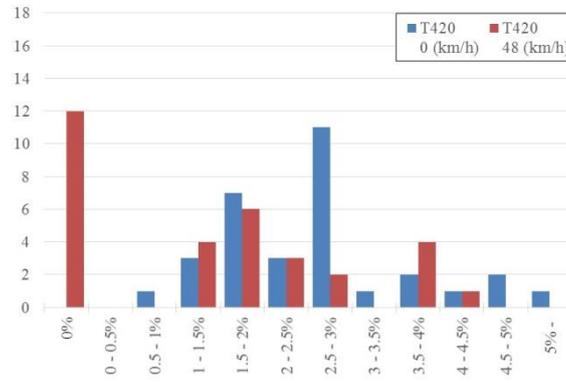
Fig. 11 Distribution of indicated damage area size ratio by T420

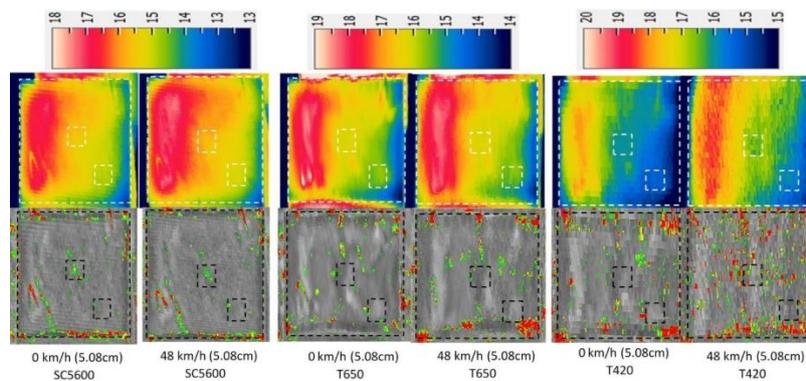
Fig. 12 Comparison of 5.08 cm depth images taken at 0 km/h and 48 km/h at 8 pm (Temperature: °C)

Furthermore, for 5.08 cm (2 in.) depth delamination, only SC5600 indicates the potential that can detect delamination up to 5.08 cm by processed images in any speed as shown in Fig. 12, although the shapes are not exactly square. In some research, however, IRT detected 5.08 cm or deeper delaminations; therefore, it can be considered that SC5600 might be able to detect delamination at 5.08 cm depth from the surface under the desirable environmental condition, or if larger size of delamination is used as assumed in section 1.2.

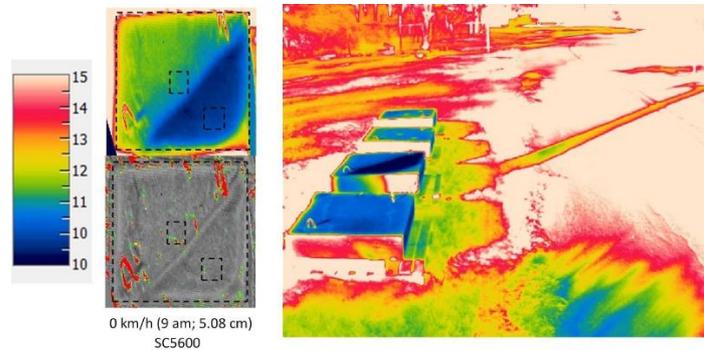
Fig. 13 Effect of sunlight: left; deskewed, right; original (9 am: SC5600; 0km/h)

The images on the left of Fig. 13 show deskewed IR and processed images taken at 9 am at 0 km/h by SC5600 for the test piece has 5.08 cm deep delamination, and the image on the right is the original IR image. Both IR images clearly show a temperature difference between the upper left side and lower right side of the concrete surface. This difference was caused by the shadow of a tree which was located behind the test site. This result shows that if there is a shaded part on the concrete surface, the result of IRT is strongly affected by sunlight and shadow even in the morning. As a matter of fact, measured concrete surface temperatures of 1.27 and 7.62 cm depth delamination test specimens in Fig. 6 show drastic temperature changes sometimes from after sunrise until sunset respectively at different times even though they are located close to each other. It can be explained by the effect of shadows due to clouds or surrounding trees. Furthermore, the range of temperature change on the concrete surface during daytime, around 11 am to 5 pm, is much larger than the range during the morning or nighttime. As shown in Fig. 7(b), in spite of the temperature range of IR image at 3 pm being 2 times wider than at other times, the left edge part shows much higher temperature than the right part; actually, it exceeds the temperature range. It is also apparent that the concrete surface temperatures vary from one place to another. Therefore, it can be assumed that there is more “noise” during the daytime since the concrete surface temperature is randomly changing with a much wider range than morning or nighttime from time to time, and from one place to another as it is mentioned by Kee *et al.* (2012). Based on these results, it can be concluded that direct sunlight strongly affects the assessment results of IRT, and nighttime would be the suitable time window for IRT due to less false detections and interferences of sunlight, although further experiments are needed.
