Seismic vulnerability and preservation of historical masonry monumental structures

Adem Dogangun*¹ and Halil Sezen²

(Received January 31, 2011, Revised September 30, 2011, Accepted October 12, 2011)

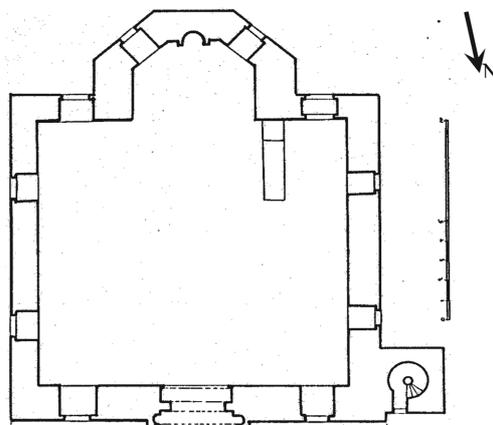
Fig. 3 Kadi mosque floor plan

more like an apse in older church structures. Typical thickness of the stone masonry walls is approximately 1.5 m. The square base of the circular masonry minaret in the northwest corner was constructed integrally with the mosque walls. It was reported that the original structure had a dome, however the current structure has a timber roof (Kenthaber 2006, Archive 2006).

Several cracks formed through the mortar and stone blocks on the sides and above the main entrance door during the earthquakes (Fig. 5). The stone masonry minaret collapsed right above its base because the minaret base was integral with minaret walls (Fig. 3) and was quite stiff compared to the cylindrical minaret body. The Kadi mosque recently went through a retrofit program. The walls were repaired and a new minaret with a more modern appearance was constructed (Fig. 6(b)).

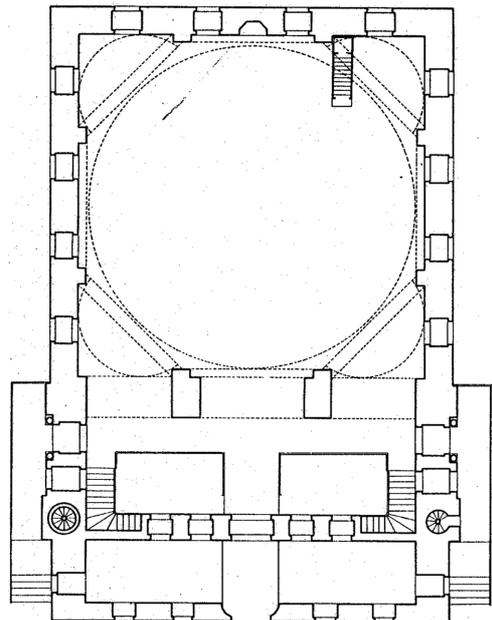
Fig. 10 Plan of Yildirim Bayezid mosque

The Yildirim Bayezid mosque was originally built in 1382 and was burned down in the 19th century (Kenthaber 2006, Archive 2006). A new structure was constructed after the fire, and it was severely damaged during the 1944 Gerede-Bolu earthquake ($M_s = 7.3$). Subsequently, the structure was rebuilt (Fig. 9). The plan view of the current mosque is shown in Fig. 10. The top of the square main prayer hall is covered by a large dome. The square bases of two circular unreinforced stone minarets are constructed monolithically with the eastern and western walls near the entrance.

The mosque was damaged during the 1999 earthquakes and was closed for a period of time. The shops under the mosque were back in business a few weeks after the November 12 earthquake. On the south side of the mosque, portion of the walls above and below the windows were subjected to larger shear stresses (compared to solid wall sections) during the strong ground shaking. Higher shear demand in those parts of the relatively thick walls created serious cracks and openings between the stone blocks (Fig. 11).
