19th May 2011 Simav (Kütahya) earthquake and response of masonry Halil Aga Mosque

Ali Ural*

Keywords: structural damages; simav (Kütahya) earthquake; masonry buildings; strong ground motions

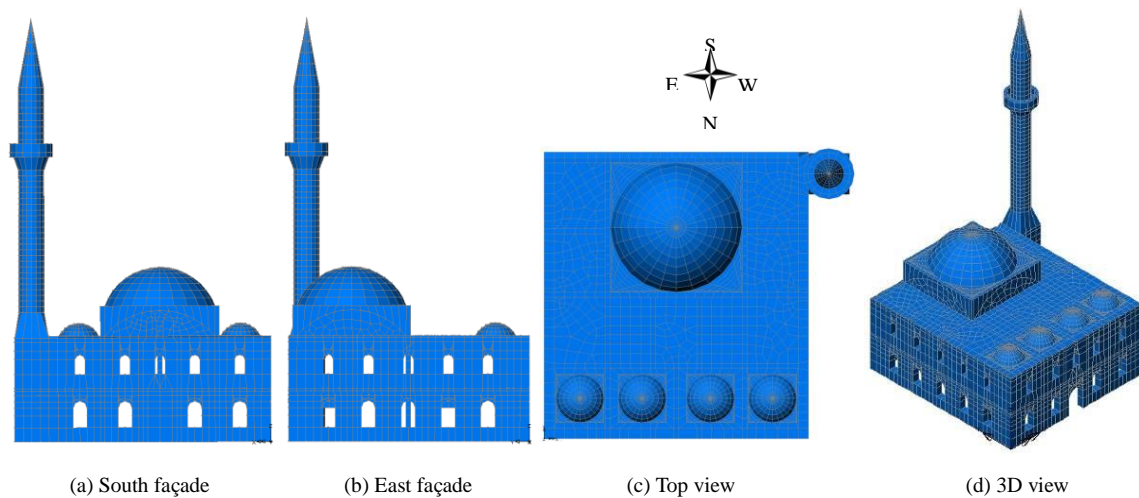
Fig. 8 Finite element model of the Halil Aga Mosque.

As mentioned above, Halil Aga Mosque was one of the most damaged structures around the region due to the Simav Earthquake. Determining the dynamic characteristics of this structure, response spectrum analysis has been performed using earthquake data taken from Gediz station of the main event. Gediz station is approximately 37.6 km distance from the mosque. Three dimensional finite element model of the mosque has been developed using the LUSAS 14.7 software (2013). This software can be used for linear and nonlinear, static and dynamic analyses of 2D and 3D model structures. However it cannot be taken into account dynamic analyses with nonlinear material properties. Therefore, analyses have been performed under linear material assumptions. Rayleigh damping with 5% damping ratio is used in the dynamic analyses.
