Field investigation and seismic analysis of a historical brick masonry minaret damaged during the Van Earthquakes in 2011

Abstract. The paper presents the field investigations and seismic analyses of a historical masonry brick minaret damaged during October 23 (Erciş) and November 9 (Edremit), 2011 Van earthquakes in Turkey. Ulu Mosque Minaret located on Tebriz Kapı Street in the city centre of Van, Turkey is selected for investigation. Two earthquakes hit the minaret within seventeen days, causing progressive damage. It was seen from the field investigations that the minaret was heavily damaged. To validate the field investigations, three dimensional finite element model of the minaret is constituted by ANSYS software using relieve drawings. Finite element model of the minaret is analyzed under the Van earthquake records to determine the seismic behavior. The displacements, maximum and minimum principal stresses and strains are obtained from the analyses and compared with field observations.

4.1 Ulu Mosque Minaret

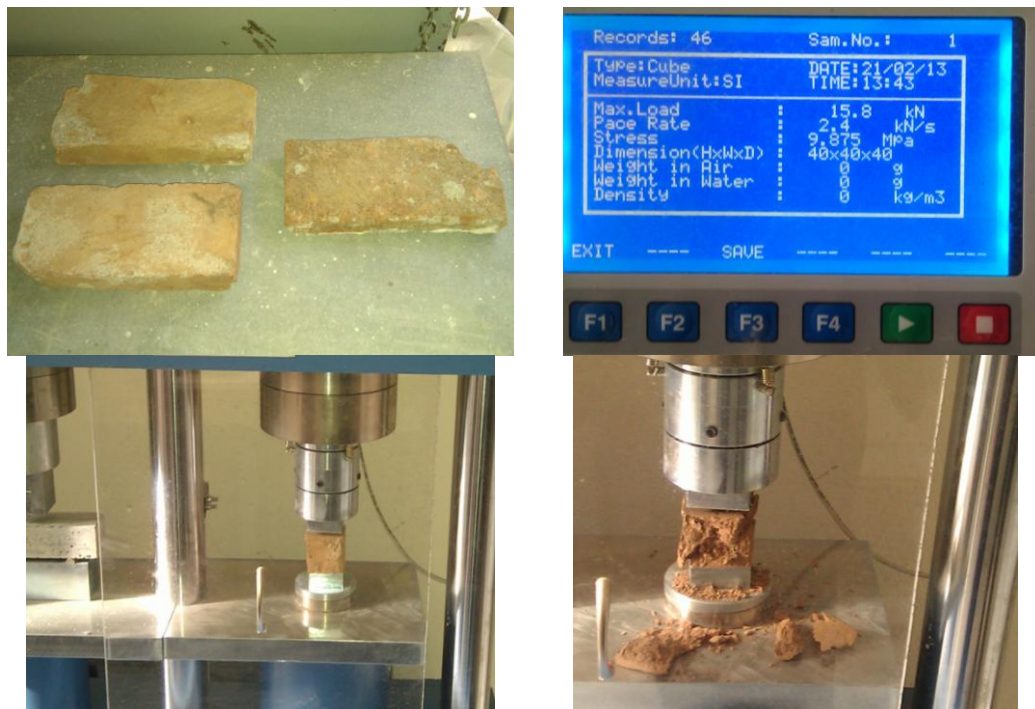
Determination of material properties and boundary conditions that must be taken into account in the finite element analysis is very important for thin and tall structures such as minarets. For this purpose, the bricks samples taken from the minaret were tested in the laboratory conditions to determine the mechanical properties. According to the experimental studies, the compressive strength of the bricks was obtained as 9.875MPa. Some views of the samples and laboratory tests can be seen in Fig. 7.

Fig. 7 Some views of the samples and laboratory tests

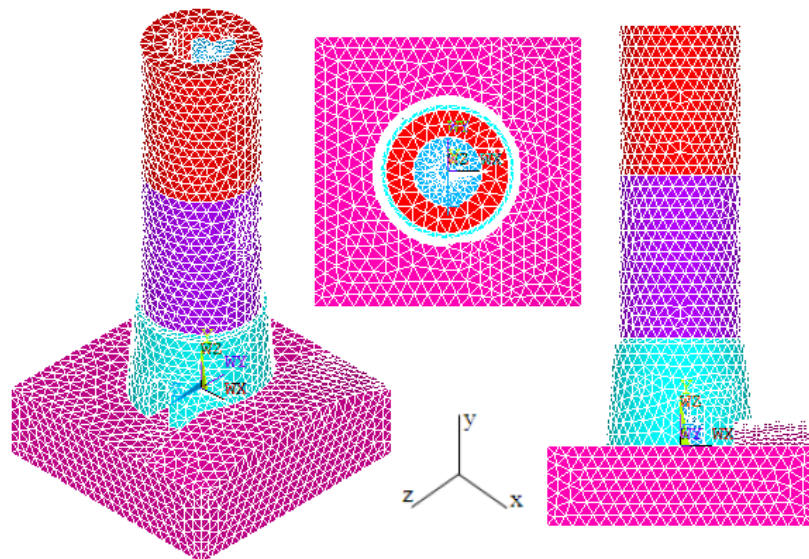
The minaret was taken in place rock soil. As initial boundary conditions, all of the degrees of freedom under the footing part of the minaret are selected as fixed. The 3D finite element models of the minaret including concrete block and stairs is shown in Fig. 8. According to the convergence studies, optimum mesh size is chosen as 50cm. Therefore, 49286 SOLID186 elements are used in the finite element model.

Fig. 8 3D finite element models of the minaret

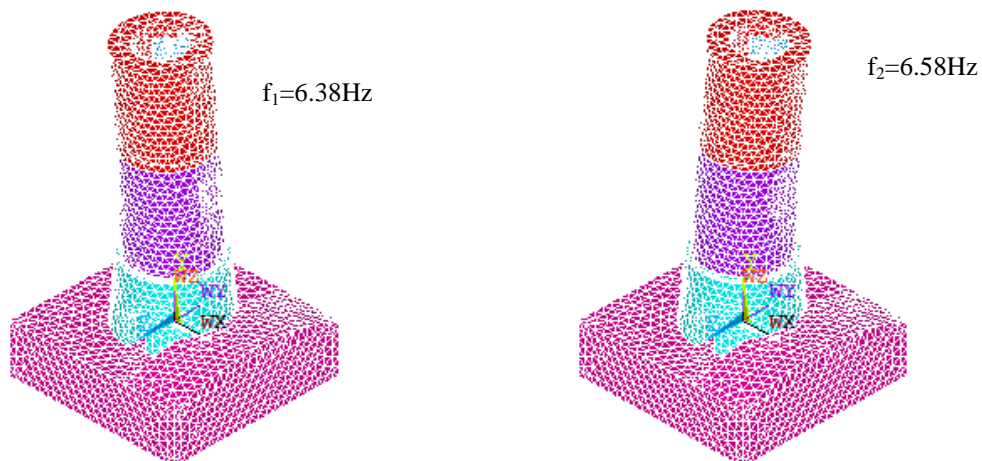
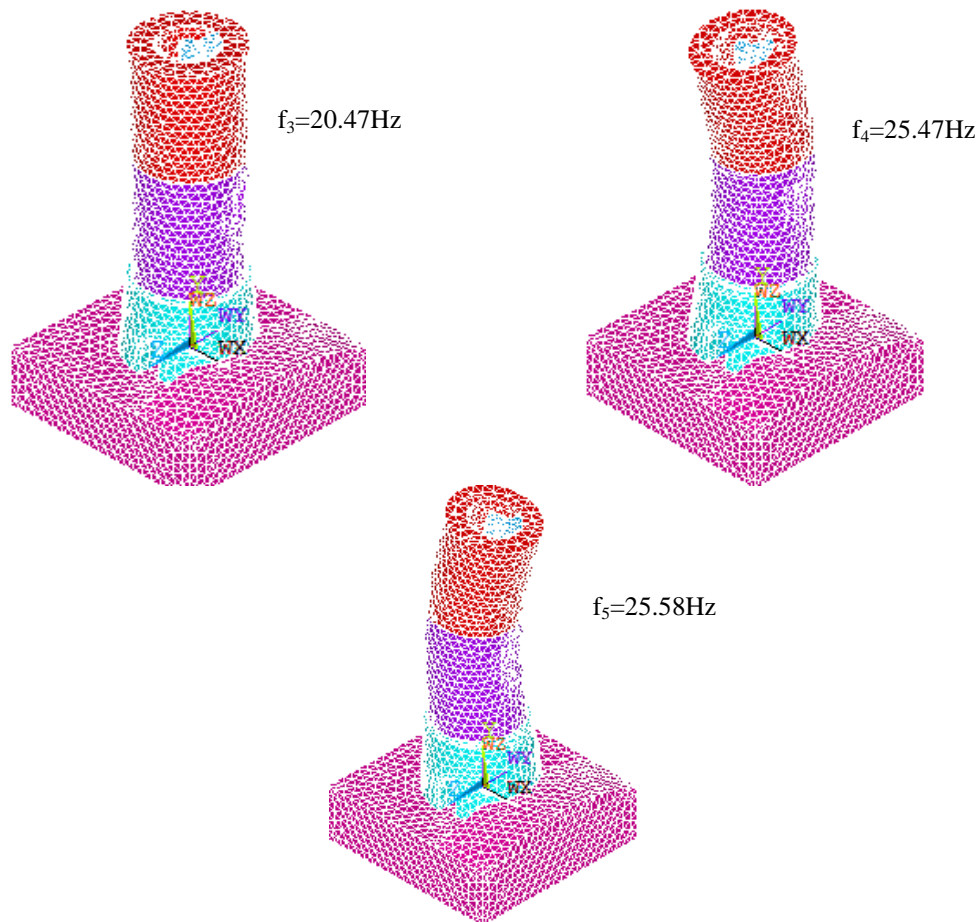
A total of 5 natural frequencies of the minaret were obtained with a range between 6.38-25.59 Hz, respectively. When the first five modes are examined, the first two modes of the minaret are lateral modes in the z and x directions, the third mode is a torsional mode and last two modes are lateral modes in the z and x directions as seen in Fig. 9.

Fig. 9 Natural frequencies and corresponding mode shapes of the minaret

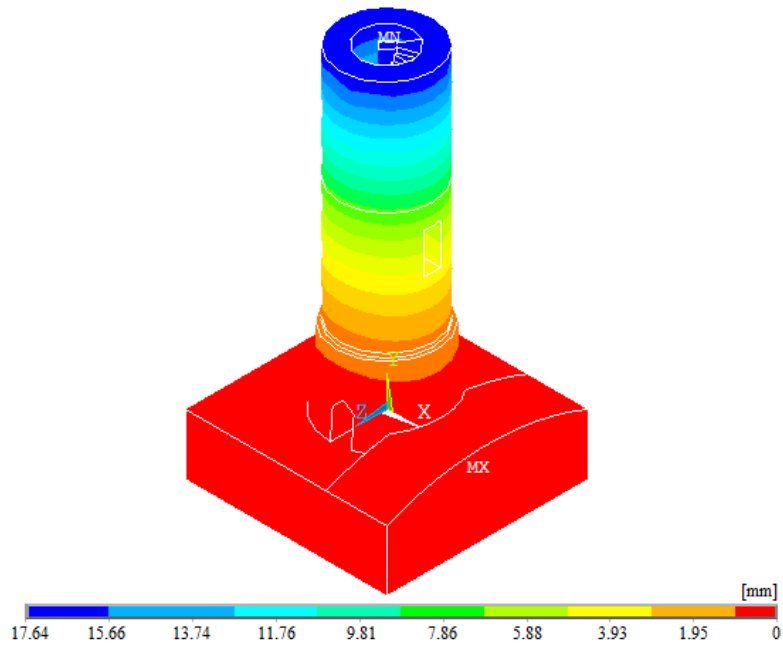
Fig. 10 points out the contours of maximum horizontal displacement. These displacement contours represent the distribution of the peak values reached by the maximum displacement at each point within the section. It is seen that the displacements increase along the height of the minaret and the maximum displacement (at the top of the minaret) is obtained as 17.64 mm.

Fig. 10 Maximum displacement contours of the minaret

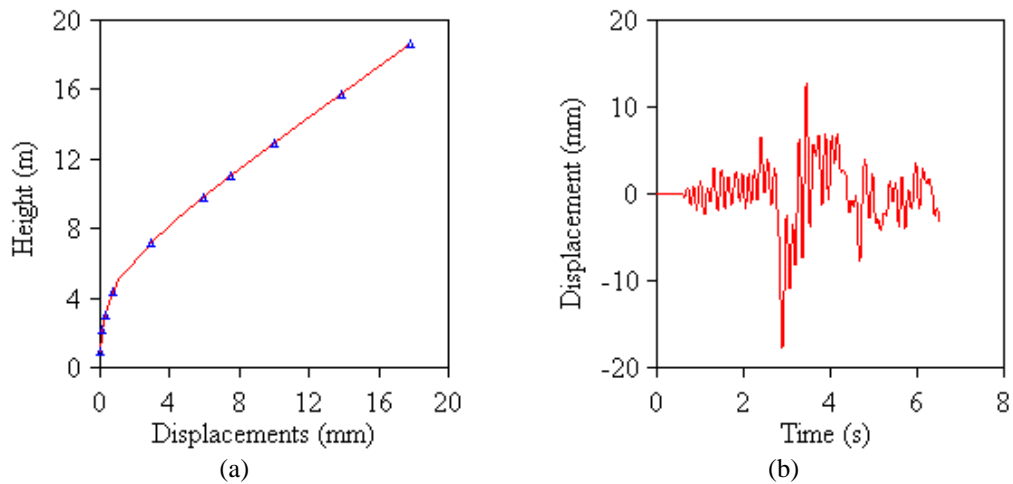
The horizontal displacements along to the height of the minaret at the time of maximum response are given in Fig. 11(a). Also, the time histories of the horizontal displacements (with a peak value of 17.64 cm) at the top of the Ulu Mosque historical masonry minaret subjected to the ground motion is presented in Fig. 11(b).

Fig. 11 Variation of the maximum displacements along to the height of the minaret and the time histories of maximum displacements at the top of the minaret

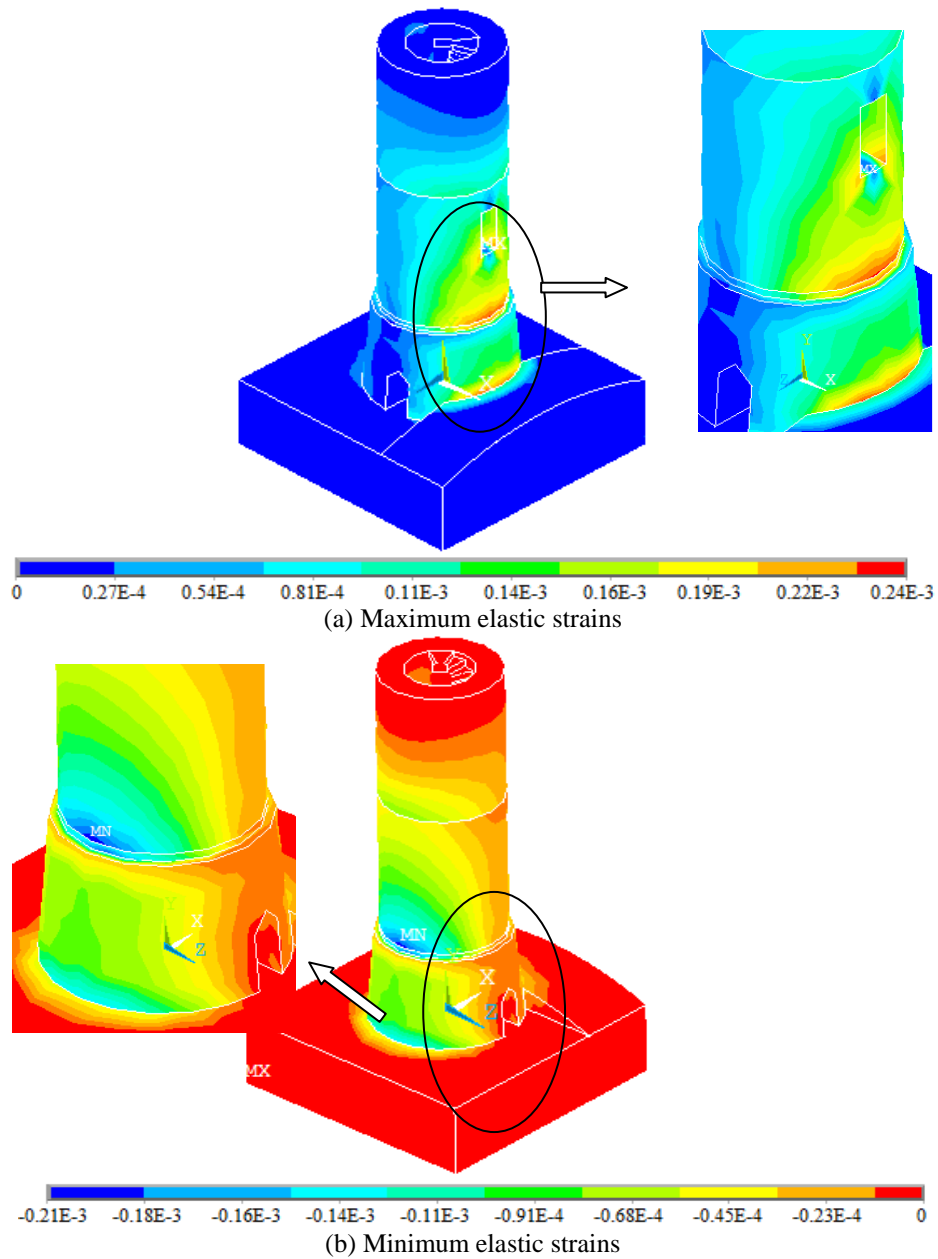
The maximum and minimum elastic strains contours which represent the distribution of the peak values reached by the elastic strains at each point within the section are given in Fig. 13. The maximum and minimum elastic strains were occurred as 0.24E-3 and 0.21E-3, respectively.

Fig. 13 Maximum and minimum elastic strains contours of the historical minaret
