Structural damage distribution induced by Wenchuan Earthquake on 12th May, 2008

Abstract. Based on the reconnaissance of buildings in Dujiangyan City during 2008 Wenchuan earthquake, China, structural damage characteristics and the spatial distribution of structural damage are investigated, and the possible reasons for the extraordinary features are discussed with consideration of the influence of urban historical evolution and spatial variation of earthquake motions. Firstly, the urban plan and typical characteristics of structural seismic damage are briefly presented and summarized. Spatial distribution of structural damage is then comparatively analyzed by classifying all surveyed buildings in accordance with different construction age, considering the influence of seismic design code on urban buildings. Finally, the influences of evolution of seismic design code, topographic condition, local site and distance from fault rupture on spatial distribution of structural damage are comprehensively discussed. It is concluded that spatial variation of earthquake motions, resulting from topography, local site effect and fault rupture, are very important factor leading to the extraordin

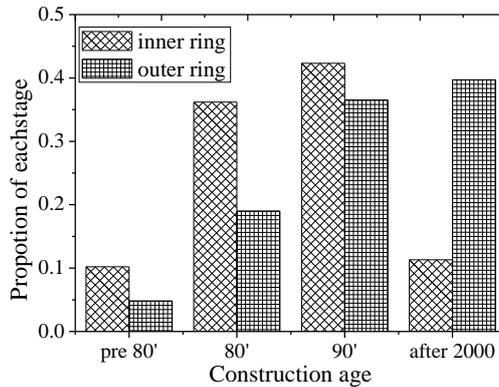
Fig. 11 Proportion of masonry buildings in inner and outer region during each stage

From the reconnaissance data of buildings in Dujiangyan city, the major structures in the city are multistory masonry structures, which were severely damaged during the earthquake. In this study, the spatial distribution pattern of multistory masonry is taken as an example to carry out the quantitative and comparative investigation. The survey covers 1065 multistory masonry structures which are evenly distributed in both rings: 392 in the inner ring and 673 in the outer ring. Fig. 11 shows the proportion of masonry structures built in inner and outer regions during different construction periods, reflecting the evolution of urban building construction age at the same time. It can be seen from the masonry buildings investigated that most of those in inner ring were built in 1980s and 1990s and very few buildings were built after 2000, while those built in the outer ring are gradually increasing in these stages.

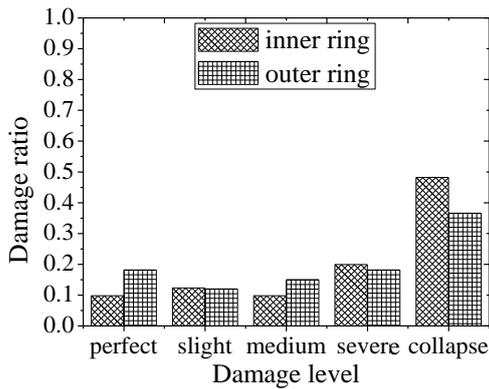
Fig. 12 Damage ratios of masonry buildings in Pre80s'

Figs. 12-15 show the seismic damage statistics of multistory masonry structures during these four stages in the inner ring. It can be seen that no matter which stage the structures were built, nearly all the structures in inner ring are more severely damaged than those in the outer ring, especially for those buildings before the year of 2000, which revealed a strong spatial distribution pattern. Structures built after 2000 were all slightly damaged no matter whether they are located in the inner ring or the outer ring. These figures also reveal that those structures built before 1980s are most severely damaged while those built after 2000 are slightly damaged or in perfect condition. However, it is noteworthy that those built in 1990s are relatively more severely damaged than

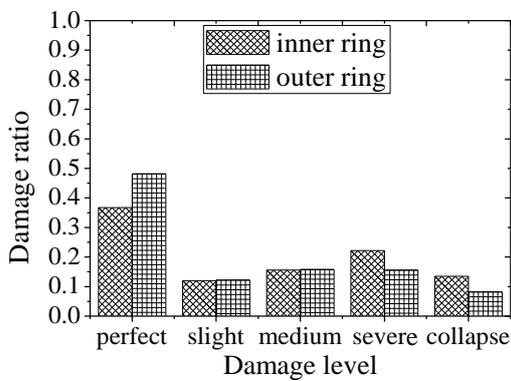
Fig. 14 Damage ratios of masonry buildings in 1990s'

those built in 1980s. Further studies need to be carried out to dig the deep-seated reason for this phenomenon.

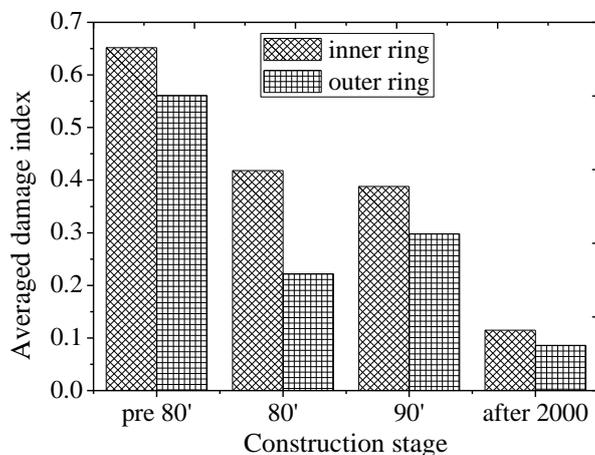
Fig. 16 Averaged damage index of masonry buildings of inner and outer ring part in each age

The seismic damage index of all the investigated multistory masonry structures calculated by Eq. (1) is shown in Fig. 16. Nearly all the structural seismic damage in both rings become slighter when the building age is relatively newer. In the inner ring, the seismic damage index of structures built before 1980s, in 1980s and in 1990s are 5.7, 3.6 and 3.4 times of that of structures built after 2000, while in the outer ring, the seismic damage index of the former three changes into 6.5, 2.6 and 3.4 times of structures built after 2000. Comparing the seismic damage index between the inner ring and outer ring on the same seismic capacity level, the seismic damage index of buildings built before 1980s in inner ring is 1.16 times, 1.88 times, 1.30 times and 1.34 times of the indexes for structures in the corresponding construction stage in outer ring, respectively. Thus, it can be observed that the further the structure is away from the mountain, the slighter it is damaged, and the spatial distribution effect in virtue of terrain influence may be a vital factor of seismic damage of buildings.

With the evolution of the construction age of buildings, new buildings and old buildings are distributed in different places in the city. Along with the update of the seismic design specifications, newly built structures reveal a better seismic capacity than the early built structures. Fig. 16 shows that the seismic damage index of old buildings can reach 6.5 times that of new buildings. This distribution is the most important factor affecting the spatial distribution pattern of the urban building damage (Lin *et al.* 2009). A study on severe damages and collapses of buildings in moderate to severe earthquake intensities caused by the Wenchuan earthquake was carried out, it is concluded that the seismic design of buildings strictly follows the Code for Seismic Design of Buildings (GB50011-2001) of China, the quality construction and seismic capacity of buildings is assured (Wang 2008). Three different levels of safety margin of buildings structures, referred as fundamental safety margin, integrated safety margin and accidental safety margin, is proposed by
