Rainfall induced instability of mechanically stabilized earth embankments

Abstract. A 10.4-m high highway embankment retained behind mechanically stabilized earth (MSE) walls is under construction in the northeastern part of the Indian state of Bihar. The structure is constructed with compacted, micaceous, grey, silty sand, reinforced with polyester (PET) geogrids, and faced with reinforced cement concrete fascia panels. The connections between the fascia panels and the geogrids failed on several occasions during the monsoon seasons of 2007 and 2008 following episodes of heavy rainfall, when the embankment was still under construction. However, during these incidents the MSE embankment itself remained by and large stable and the collateral damages were minimal. The observational data during these incidents presented an opportunity to develop and calibrate a simple procedure for estimating rainfall induced pore water pressure development within MSE embankments constructed with backfill materials that do not allow unimpeded seepage. A simple analytical finite element model was developed for the purpose. The modeling results were found to agree with the observational and meteorologic

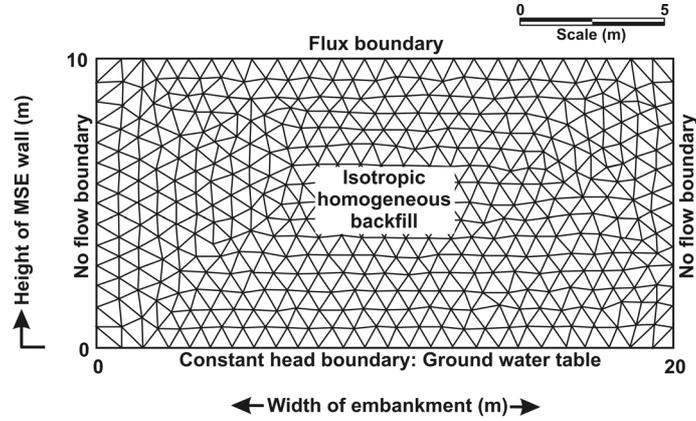
Fig. 7 Finite element seepage model

A cross section representative of the highest configuration of the MSE embankment was modeled numerically using three-node triangular elements (Fig. 7). The backfill material was assumed to be homogeneous and isotropic. For the backfill soil the soil water characteristic curve shown in Fig. 8 and hydraulic conductivity function shown in Fig. 9 were used in the analyses. The volumetric water content for the embankment material with respect to the suction was estimated using the soil water characteristics curves following Fredlund *et al.* (1997). The hydraulic conductivity function was estimated according to the modified Campbell method (Fredlund 1996, 2004) as applicable for silty sand backfill.

It needs to be highlighted that the numerical model used for assessing rainfall induced pore water pressure rise is expected to provide conservative estimated because the following factors were neglected: (a) out of plane seepage across the fascia panels (in spite of the permeable nature of the

joint between individual fascia panels), (b) in-plane drainage capacity of the geogrids, and (c) longitudinal runoff along the MSE embankment. These simplifying assumptions allowed setting up a numerical model that is simple and user-friendly yet capable of capturing the groundwater seepage through unsaturated soils.

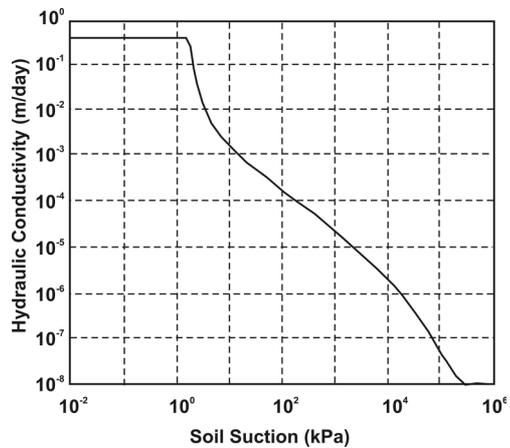
Fig. 9 Hydraulic conductivity function

Fig. 11 presents the critical infiltration flux above which the infiltration-induced pore water pressure begins to build up as a function of the saturated hydraulic conductivity of the backfill material. The hydraulic conductivity function presented in Fig. 9 was arithmetically scaled up for developing the hydraulic conductivity functions used in these computations. As for Fig. 10, these results represent the pore water pressure response of the backfill following 24-hour of simulated infiltration of a constant flux through its top surface. The results presented in Fig. 11 represent infiltration flux of up to 60 m/d. Such an infiltration flux is approximately four times greater than the maximum daily rainfall observed at the site (800 mm/d) over the last five years. The MSE wall designer needs to make a decision regarding the design infiltration flux with duly considering the severest expected rainfall intensity and the likelihood of piping and clogging, and the consequent reduction in the flow capacity through the backfill.
