Collapse of steel cantilever roof of tribune induced by snow loads

Ahmet C. Altunışık*, Şevket Ateş and Metin Hüsem and Ali F. Genç

Department of Civil Engineering, Karadeniz Technical University, Trabzon, Turkey

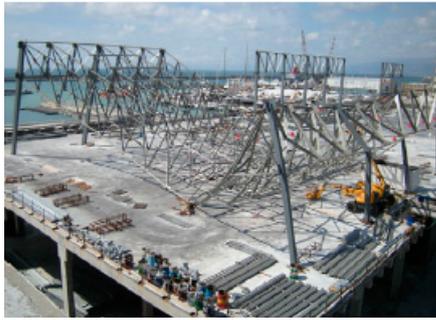
(a) Public fair pavilion in Italy

Fig. 1 Some views from the collapsed engineering structures

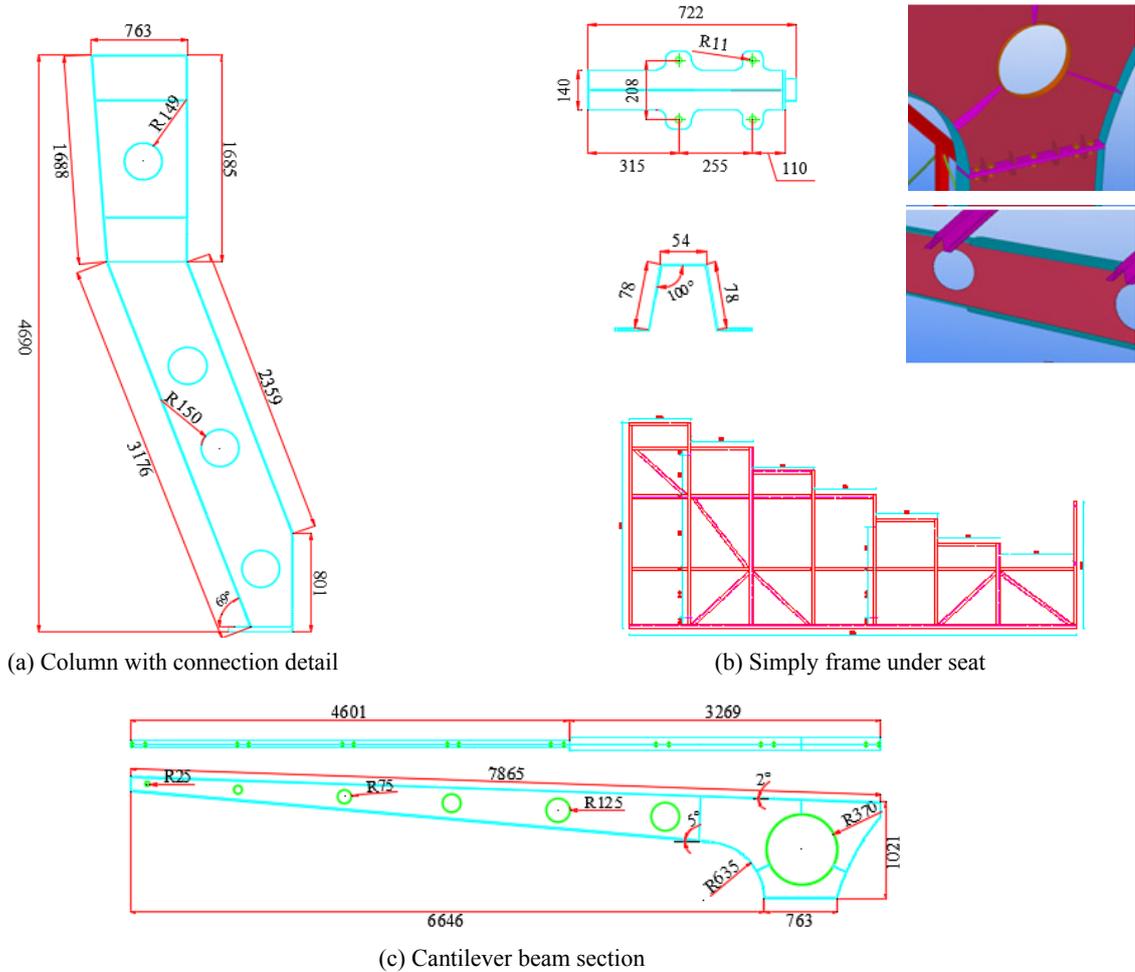
Fig. 2 Some detail drawings of the designed project

two lateral directions are allowed to move freely, while the vertical displacements are not permitted. Each cantilever has 7 holes with different diameter on web and variable section with 16 cm and 80 cm height at the end point and beam-column connection joints, respectively. Also, top flange width of the cantilever beams has a decreasing trend from the start to end point. Some detail drawings of the designed project are shown in Fig. 2.

Besides, the columns were not fixed to the strip foundation (Fig. 4(c)). According to the static project drawings (some drawings can be seen in Fig. 2), the

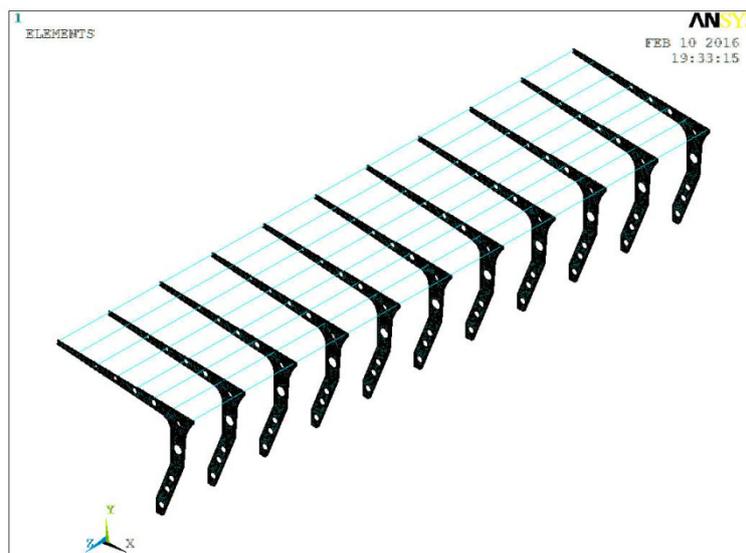
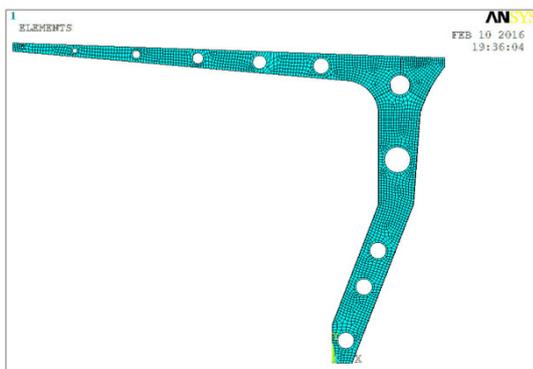
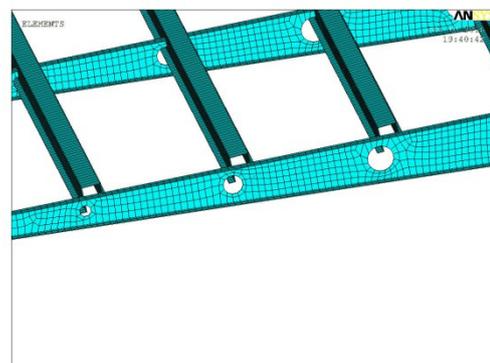
Fig. 5 The finite element model of the main structural elements of tribune

3D finite element model of the tribune was built in ANSYS (2014) software using the geometrical dimensions shown previously in Fig. 2. A mesh refinement study was also undertaken and a model with 46880 Shell281 and 5824 Beam189 elements was deemed sufficient for yielding a series of numerically converged solutions. The Shell281 element has 8 nodes, with each node having three translational and rotation degrees of freedom. In defining the boundary conditions, all degrees of freedom under the columns were assumed as fixed. The finite element model of the main structural elements of tribune is given in Fig. 5.

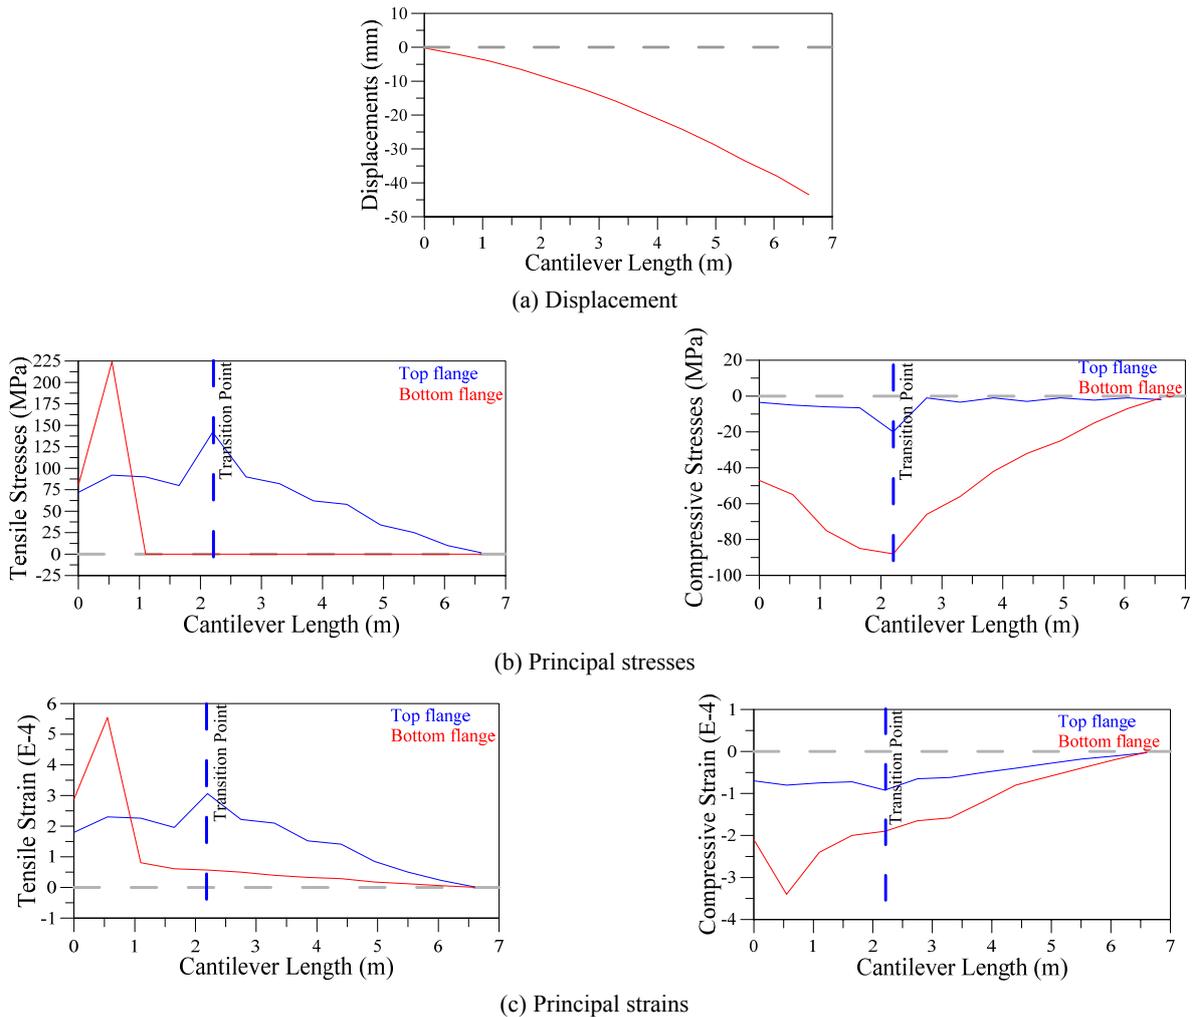
Fig. 10 Changing of displacements, principal stresses and strains with cantilever length

The behavior and evaluation forces are tired to additionally present in graph format in Figs. 10 and 11.
