Analysis of a damaged industrial hall subjected to the effects of fire

Abstract. The results of diagnostics and analysis of an industrial hall located on the premises of a thermal power plant severely damaged by fire are presented in the paper. The comprehensive failure-related diagnostics, non-destructive and destructive tests of steel and concrete materials, geodetic surveying of selected structural members, numerical modelling, static analysis and reliability assessment were focused on two basic goals: The determination of the current technical condition of the load bearing structure and the assessment of its post fire resistance as well as assessing the degree of damage and subsequent design of reconstruction measures and arrangements which would enable the safe and reliable use of the building. The current mechanical properties of the steel material obtained from the tests and measured geometric characteristics of the structural members with imperfections were employed in finite element models to study the post-fire behaviour of the structure. In order to compare the behaviour of the numerically modelled steel roof truss, subjected to the effects of fire, with the real post-f

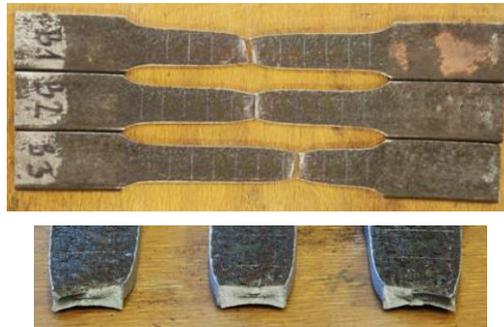
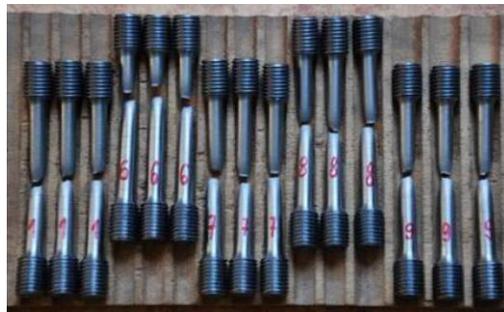
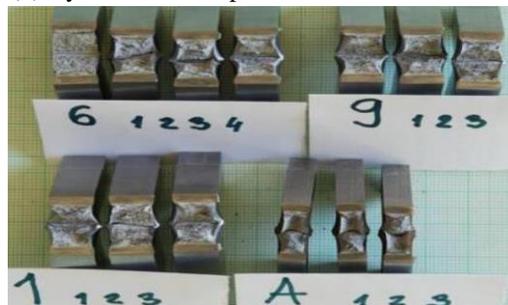
Fig. 11 View of the test specimens

The preparation of specimens taken from a column is illustrated in Fig. 10. Tensile tests were performed on a ZWICK 1387 tensile machine under standardized conditions. A view of the test specimens after the tensile tests is shown in Fig. 11(a) and Fig. 11(b).

zone (16 axis) did not confirm a decrease of toughness. A view of the broken steel specimens after the Charpy V-notch impact tests is shown in Fig. 11(c).

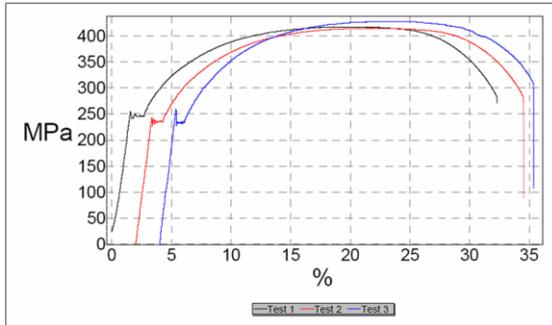
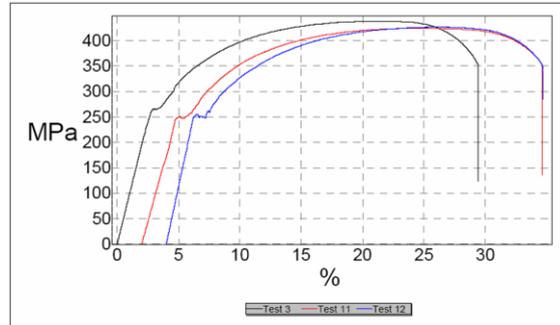
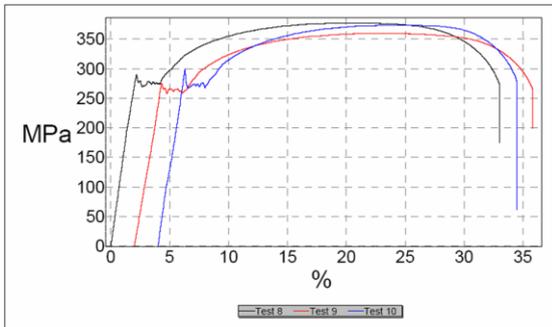
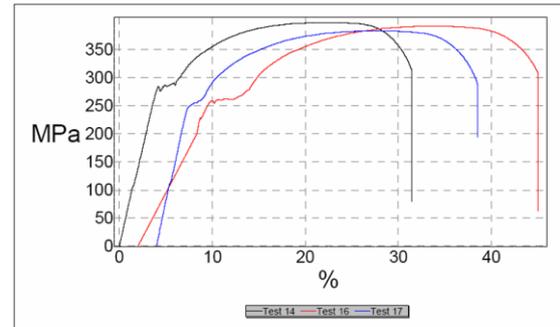
Fig. 12 Typical stress-strain diagrams of tested steels obtained from tensile tests at ambient temperature; with a denotation: $R_{p0.2}=f_{p,0.2}$ is the 0.2 % proof stress, $R_{eH}=f_{y,u}$ is the upper yield point, $R_{eL}=f_{y,l}$ is the lower yield point and $R_m=f_u$ is the ultimate strength

Regarding the tensile tests, specimens taken from the horizontal roof bracings (Fig. 12(c)) and from the transverse stiffeners of the crane runway beam (Fig. 12(d)) in the fire zone showed a 10 % decrease in mechanical properties (yield strength and ultimate strength) compared to the properties of the specimens taken from the zones unaffected by the fire, while other specimens taken from the columns (Fig. 12(a) and Fig. 12(b)) in the fire zone (15 and 16 axes), did not show significant decreases. This can be explained as follows. Columns were situated at a distance of approximately 4 m from the burnt-out area which was about 6 m above the floor, at the place where the turbine generator unit was located. Thus, the columns were not exposed to direct flame in contrast to the horizontal roof bracings, which were closest to the fire, and were directly exposed to flames. This was also confirmed by the results of analyzes. Calculations showed that the columns were not subjected to a temperature of 800 °C after 20 minutes of fire effects but only to 427°C.

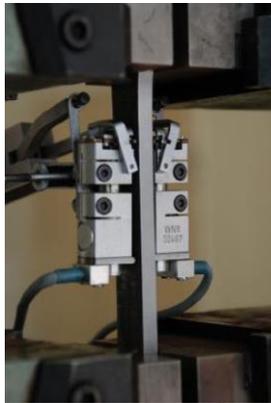
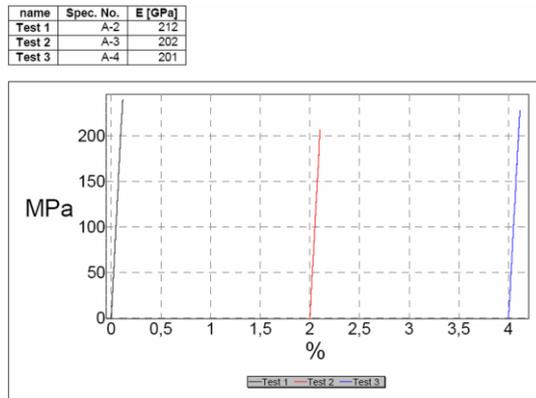
Fig. 13 Determination of the current Young's modulus E

For Young's modulus a special ZWICK 7852 extensometer with a high accuracy was used (Fig. 13(a)). Stress-strain diagrams for the determination of Young's modulus for selected steel specimens are shown in Fig. 13(b). Three specimens for each variable were tested. The Young's modulus was calculated from the initial slope of the stress-strain curve. The Young's modulus remained relatively unchanged for the given steel. The steel revealed an approximately 4% reduction in Young's modulus due to elevated temperatures.

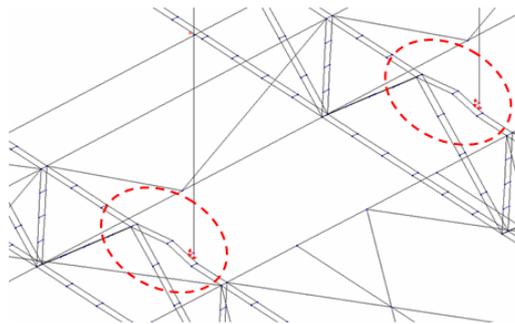
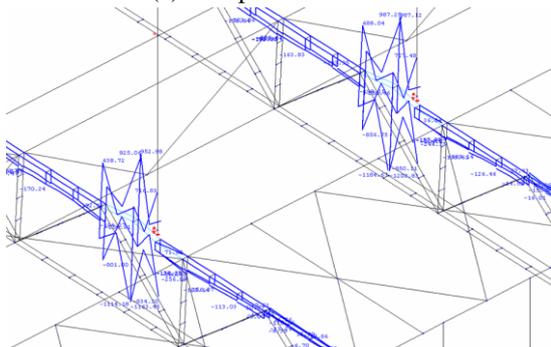
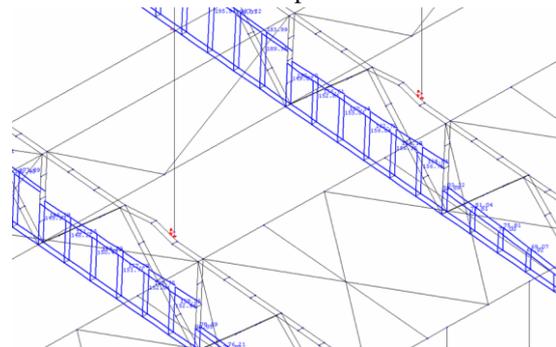
Fig. 14 Analysis of the damaged structure with current properties

For the analysis and reliability assessment of the damaged structure with current properties a deviation of the top chords of the trusses in the fire zone (between the 15 and 16 axes) with a size of 200 mm was considered (Fig. 4(a)). Computational models of the trusses with the introduction of imperfections as well as resultant distributions of stresses in the top and bottom chords of the trusses are shown in Fig. 14. Results of the static analysis confirmed that the stresses in the top

chords of the trusses (in the areas of considered imperfections) are beyond the elastic limit and chords are characterized by a plastic behaviour (Fig. 14(b)).

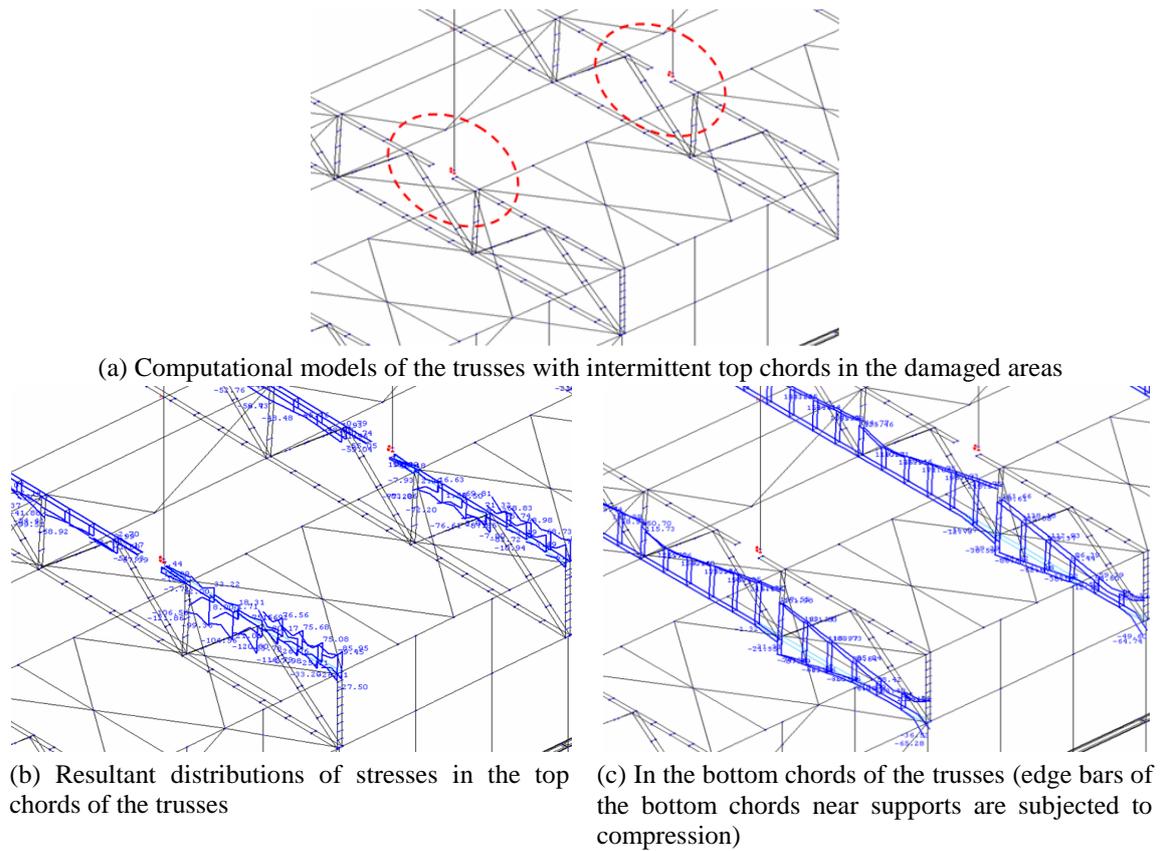
Fig. 15 Analysis of the damaged structure with the current properties

Computational models of the trusses with intermittent top chords in the damaged areas and resultant distributions of stresses in the top and bottom chords of the trusses are shown in Fig. 15. An analysis of the diminished structure with the current properties confirmed that the edge bars of the bottom chords near supports are subjected to compression which correspond to the real damage of the bottom chord of the truss as is revealed in Fig. 4(b).

Based on diagnostics, investigations, tests and numerical analyses the following safety measures were undertaken: Temporary protection of the damaged structural members, removal of the concrete roof panels from the relevant area in order to unburden the damaged roof trusses and subsequent reconstruction of the hall.

In accordance with those provisions a stabilization and unburdening of the roof trusses in the 15 and 16 axes by means of the placement of temporary supporting struts under the purlins in the areas between the 14-15, 15-16 and 16-17 axes were performed. These provisional arrangements helped achieve the required reliability of the roof structure during the subsequent reconstruction. A

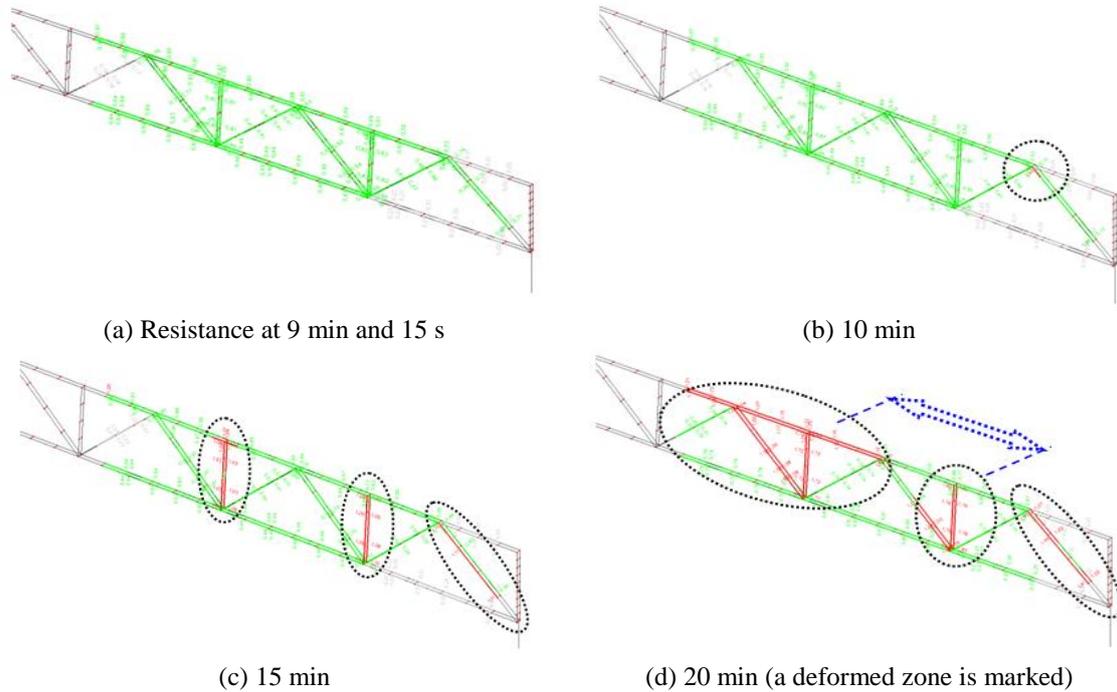
In the resistance domain, the resistance of the truss and its members subjected to a temperature exposure is checked after the imposed time. Resistance of the individual members of the steel truss subjected to the fire effects depending on the time, where the members with the unsatisfactory resistance at the individual times are marked is shown in Fig. 20. Resistance of the structure decreases with time due to a decrease of the relevant values of the material properties of the steel subjected to elevated temperatures.

It should be noted, that the applied stresses in all the marked members of the steel truss (Fig. 20) are larger than the design strengths of steel at the corresponding temperatures. A structural member of the truss is considered to fail when the applied stress of the member σ is greater than the design value of strength at corresponding elevated temperature $f_{d,fi}$ which can be written as

Fig. 20 Resistance of the individual members of the steel truss subjected to the fire effects depending on the time, where the members with the unsatisfactory resistance are marked

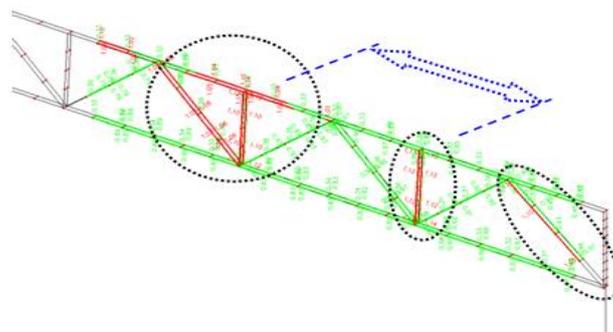
Fig. 21 Assessment of the individual members of the steel truss subjected to the effects of fire in the temperature-time domain with the marked members which reached temperatures higher than the critical temperature over a period of 20 min (a deformed zone is marked)

The assessment of the individual members of the steel truss subjected to fire effects in the temperature-time domain with marked members reached temperatures higher than the critical temperature over a period of 20 min is shown in Fig. 21 (a deformed zone is marked). The critical temperature was identified for each structural member by means of an iterative process.
