Seismic repair of exterior R/C beam-to-column joints using two-sided and three-sided jackets

Alexander G. Tsonos[†]

Abstract. The use of local two-sided and three-sided jacketing for the repair and strengthening of reinforced concrete beam-column joints damaged by severe earthquakes is investigated experimentally and analytically. Two exterior beam-column joint specimens (O_1 and O_2) were submitted to a series of cyclic lateral loads to simulate severe earthquake damage. The specimens were typical of existing older structures built in the 1960s and 1970s. The specimens were then repaired and strengthened by local two-sided or three-sided jacketing according to UNIDO Manual guidelines. The strengthened specimens (RO_1 and RO_2) were then subjected to the same displacement history as that imposed on the original specimens. The repaired and strengthened specimens exhibited significantly higher strength, stiffness and better energy dissipation capacity than the original specimens.

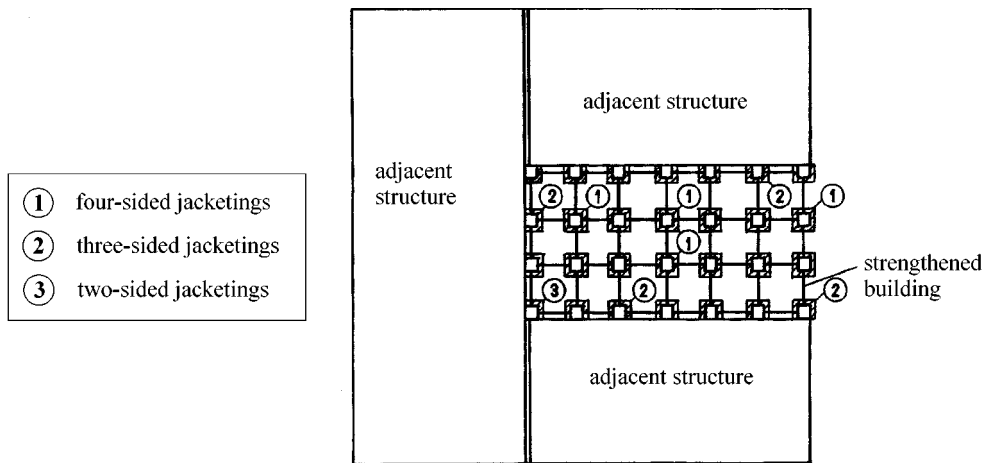
Fig. 1 Type of jacketing of columns and beam-column joints of strengthened building with adjacent structures

Although it is strongly recommended by the UNIDO Manual that columns and beam-column joints be jacketed on all four sides for best performance in future earthquakes, it also gives examples of three-sided or two-sided jacketings of columns and beam-column joints. These types of jacketings are inevitable when there are adjacent structures abutting the original building to be strengthened, from one or more sides, as shown in Fig. 1.

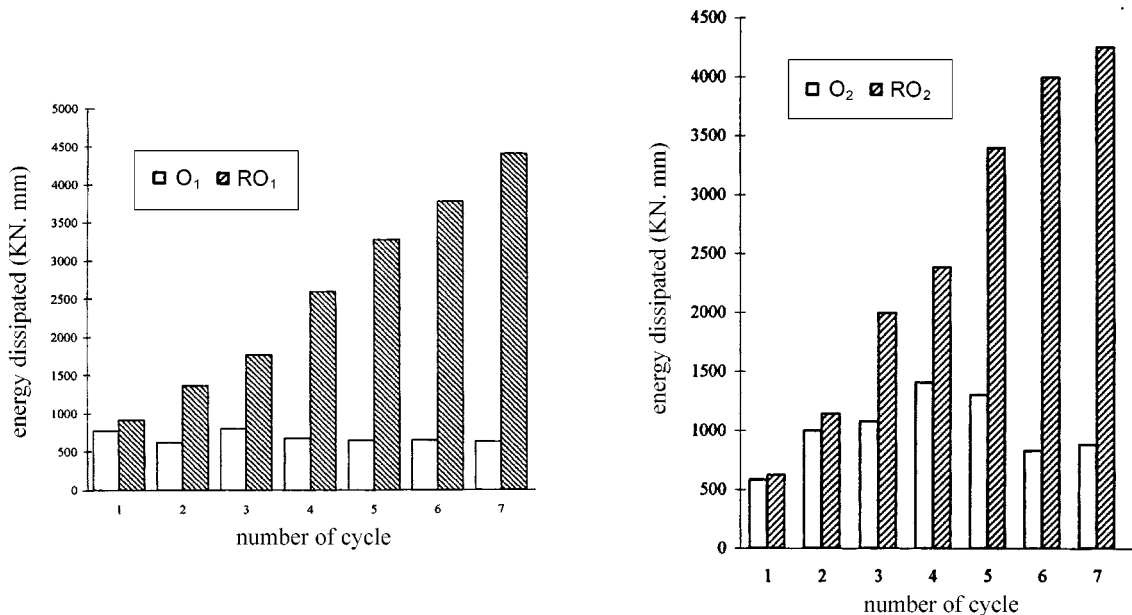
Fig. 16 Energy dissipation comparison between original and strengthened subassemblages

The peak-to-peak stiffness and energy dissipated for every load cycle of each specimen are illustrated in Fig. 15 and Fig. 16 respectively. Fig. 17 compares the peak strength observed throughout the tests. The comparison is made by observing the ratio of the peak strengths of the strengthened subassemblages to that of the original subassemblages. From these diagrams, it is clearly seen that
