Behavior of FRP strengthened RC brick in-filled frames subjected to cyclic loading

Balvir Singh^{1a}, R. Siva Chidambaram^{2b}, Shruti Sharma^{*1} and Naveen Kwatra^{1c}

Abstract. Fiber reinforced polymer (FRP) sheets are the most efficient structural materials in terms of strength to weight ratio and its application in strengthening and retrofitting of a structure or structural elements are inevitable. The performance enhancement of structural elements without increasing the cross sectional area and flexible nature are the major advantages of FRP in retrofitting/strengthening work. This research article presents a detailed study on the inelastic response of conventional and retrofitted Reinforced Concrete (RC) frames using Carbon Fibre Reinforced Polymers (CFRP) and Glass Fiber Reinforced Polymers (GFRP) subjected to quasi-static loading. The hysteretic behaviour, stiffness degradation, energy dissipation and damage index are the parameters employed to analyse the efficacy of FRP strengthening of brick in-filled RC frames. Repair and retrofitting of brick infilled RC frame shows an improved load carrying and damage tolerance capacity than control frame.

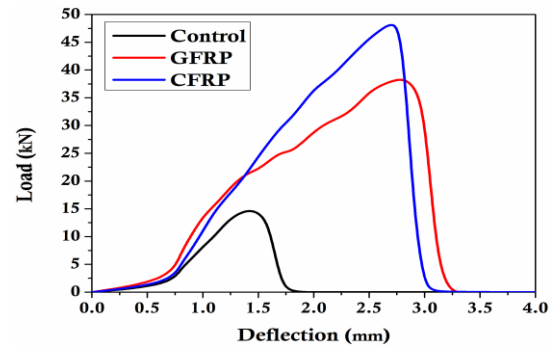
Fig. 6 Load -deflection behaviour of control and FRP repaired prisms

From the load deflection behavior of prism specimens tested under two point loading in Fig. 6, it is observed that the FRP strengthened specimens show drastic improvement in the load-deformation characteristics as compared to control prisms. In particular, the specimen repaired at the bottom with higher modulus CFRP possesses better load carrying capacity and the occurrence of crack in un-strengthened part shows the efficiency of the bonding. The

specimen repaired with GFRP splits into two halves at mid-span and the experiment demonstrates the importance of higher modulus FRP in resisting loads.

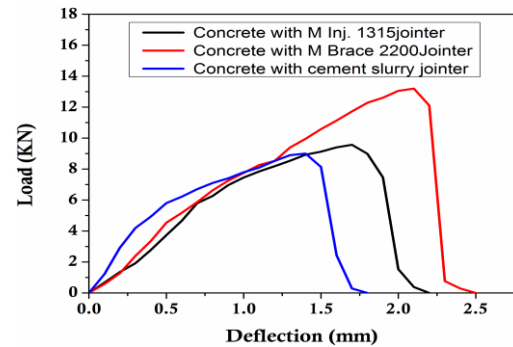
Fig. 7 Flexural strength of reconnected prisms

The load deflection behaviour of reconnected specimens shows the importance of bonding materials (Fig. 7). The specimen with cement slurry records the least performance over other reconnected specimens. The epoxy enabled specimens show different peak response with respect to the employed epoxy. It proves that the epoxy injection will act as better bonding agent in creating the contact between cracked surfaces. The failure pattern also approves the same trend (Fig. 5). The M Brace 2200 jointer shows the best results and would be further employed for repair of the RC frames.

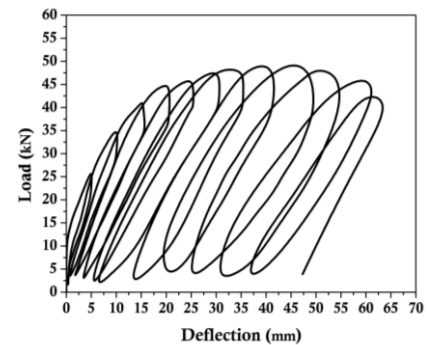
(a) Control frame

(b) Retrofitted frame

Fig. 10 Hysteretic behavior

The conventional scaled model frame was constructed and tested under quasi-static load. Load was applied by increasing deflection of 5mm in each cycle at the middle of top floor to simulate different level of controlled damage (Fig. 9). The hysteretic behaviour / load - displacement of control and retrofitted frame is shown in Fig. 10. The envelope curve of conventional and retrofitted frame is represented in Fig. 11. The load-displacement envelope curve is used to estimate the lateral deformation capacity (ductility) of the structure at different seismic performance

2. Hysteresis behavior of the FRP repaired RC frame shows better post yield behavior and enlarged loop area under cyclic loading. Also, the residual deflection is lesser in FRP strengthened than the control specimen due to better damage tolerance. It shows that the FRP strengthened frame offers better elastic and inelastic behavior.

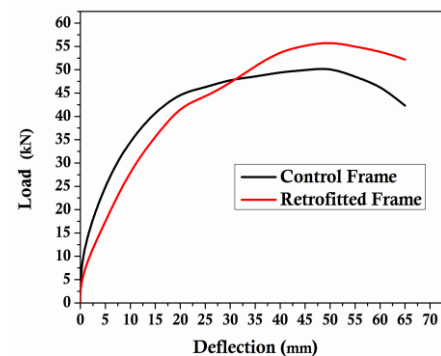
Fig. 11 Envelope curve of conventional and retrofitted frame

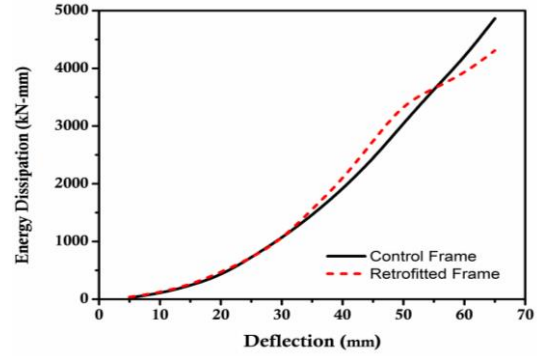
Fig. 13 Energy dissipation V/s deflection of control and retrofitted frame

Energy dissipation is estimated by area under the load deformation curve. Fig. 13 shows the energy dissipation curve of the control and retrofitted frames. The performances of both the frames are similar upto a deflection of 45 mm. As a result of severe cracking in the hinge region, the conventional frame failed to show better post peak load carrying capacity and a decrease in the energy dissipation capacity after 45 mm is noticed in the conventional control frame. On the other hand, in the retrofitted frame, no sudden failure is observed and better post peak performance is seen. The retrofitted frame shows

gradual and increased energy dissipation capacity as compared to the control frame.

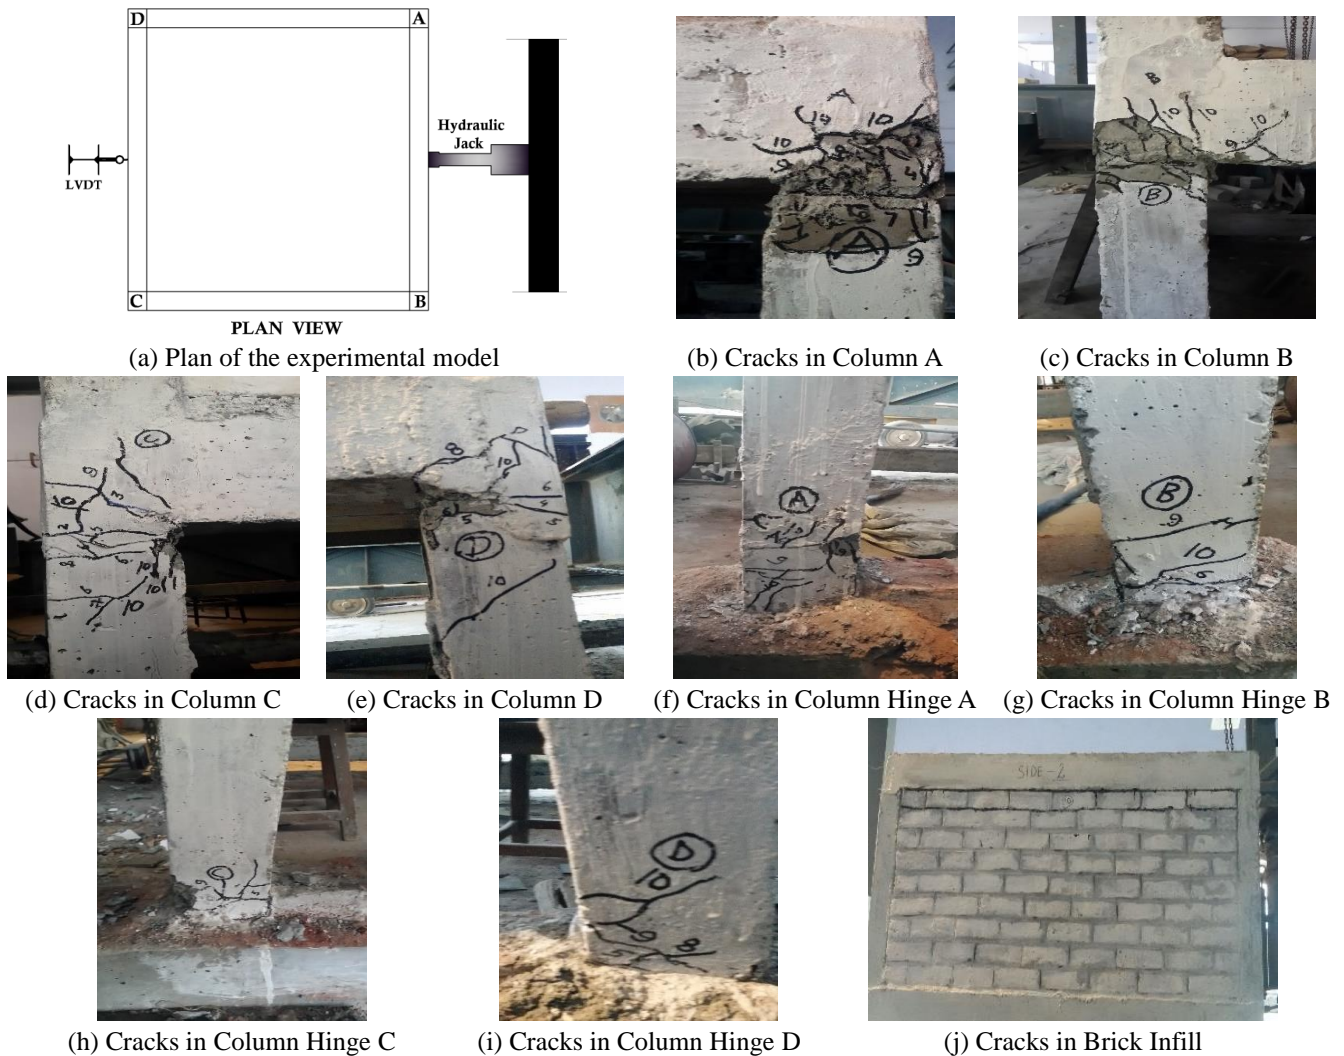
Fig. 15 Damage in column-beam and column-foundation after loading in control frame

The crack pattern was critically monitored and marked on the surface of the specimen during the testing. Four columns were marked as A, B, C, D for identification as shown in Fig. 15(a). The brick infill in the first and second storey made the ground storey soft and hence the failure intensity was high in the ground storey. The plastic hinge formation was noticed exactly below the first floor beam-column joint connection and at the column foundation connection. Initially flexural cracks were noticed at the beam-column connection region followed by joint shear cracks. As the deformation increased, dense cracks were noticed at the foundation hinge region as depicted in Fig. 15 (b)-(i). Predominant cracking was observed in the first floor

beam-column joint region whereas the second and roof have no evidence of cracking because of the soft storey effect. The witnessed horizontal crack below the joint region reduced the stiffness and restricted the deformation capacity even though followed by shear cracks in the joint region. As a result of the dense crack concrete cover spalling was occurred in the joint region. The effect of seismic detailing supports the RC frame to deform but the brittle nature of concrete exhibits concrete crushing failure at the foundation hinge region. There is no severe damage in the infill; horizontal sliding cracks were noticed in the infill at the mortar joints as shows in Fig. 15(i).

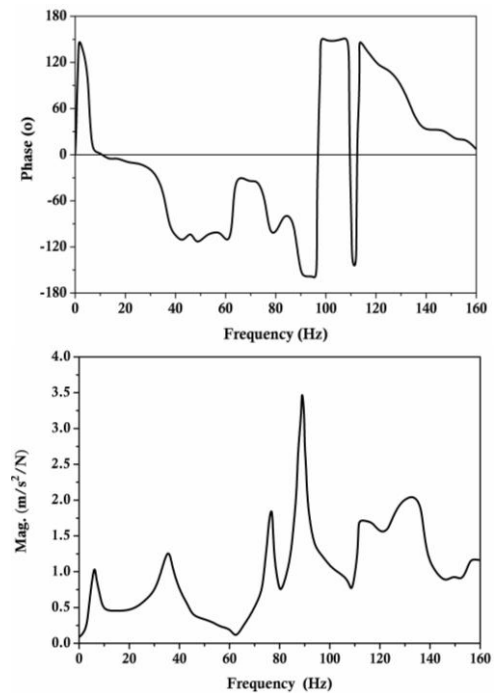
Fig. 17 Frequency response function

The dynamic characteristics of a structural system can be estimated from the frequency response function (FRF) shown in Fig. 17 and Time History plot shown in Fig. 18. The FRF based damage index is one of the most effective ways in health monitoring. The change in fundamental frequency and magnitude of FRF of a system defines the damage behaviour. In this study, an impact hammer and accelerometer were used to acquire the FRF and the logarithmic decrement defines the equivalent damping response. The usual aim of vibration measurement is to predict response given force in different damage status. The specific frequencies at which resonance amplitudes occur are called the natural frequencies of the structure. These frequencies and the corresponding distribution of amplitude are global properties. The calculated frequency and damage index are presented in Table 3.

The conventional and retrofitted frame shows similar kind of frequency response. The test results show a reduction in the natural frequency as the damage level increases. The conventional specimens show natural frequency ranging from 7-4.8 Hz with the change in damage index 0 to 0.669. The natural frequency reduces as the damage level increases; thus, it shows a 31.4% reduction in natural frequency at failure stage. The FRF magnitude is found to decrease and damping ratio is found to increase with the increase in deformation. Thus, the conventional frame shows a 66.9% reduction in FRF magnitude and a 64% increase in damping ratio.

The retrofitted frame specimen shows a similar trend to conventional frame frequency response. The observed natural frequency of conventional specimen varies from 7.6 to 4.8 Hz with the change in damage index 0 to 0.662. It shows a 36.8% reduction in natural frequency at failure stage. This proves the effectiveness of the strengthening technique adopted in restoring the frame. There was a tremendous change in FRF magnitude and damping ratio, showing remarkable energy dissipation capacity of the retrofitted frame as compared to conventional frame. The observed FRF reduction of the retrofitted frame is 66.2% and 72% increase in damping ratio.
